PROJECT INFORMATION

SITE LOCATION: 330-346 Bloomfield Avenue, Montclair, New Jersey 07042

PROPERTY SURVEY, AREA MAP, EXISTING PHOTOGRAPHS, PROJECT INFO

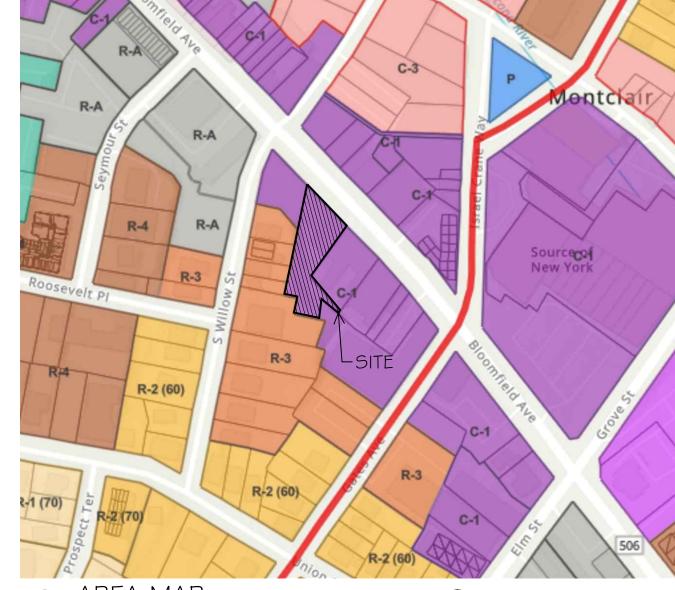
5 DAMAGED CENTRAL COLUMN SCALE:N.T.S.

OWNER: 330 Bloom, LLC NATURE OF APPLICATION: The subject property includes two buildings. This application's primary focus is the easterly building, 330-334 Bloomfield Avenue. This building is a 3-story brick edifice, circa 1900, with a full basement, containing retail spaces on the ground floor and apartments on the upper floors. Unfortunately, the existing facade is in very poor condition. It is leaking in several areas, is cracking in many others, and the parapet is overturning. Several lintels and a major storefront column are severely damaged.

This project proposes removing the existing face brick, retaining and stabilizing the inner wythes of masonry, and then installing new face brick to match what is currently there.
