# 16 PRESERVATION BRIEFS

## The Use of Substitute Materials on Historic Building Exteriors

National Park Service  
U.S. Department of the Interior  
Technical Preservation Services

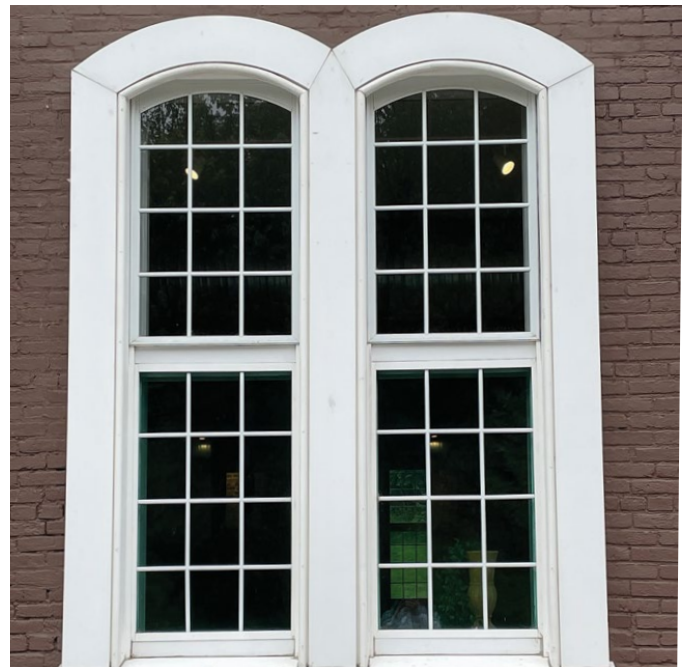
*Figure 9. Previously bricked-in openings below the flood line were reopened and new aluminum windows installed with cellular PVC trim detailed to hold back moderate flood waters and survive exposure to water. Photo: John Sandor, NPS.*

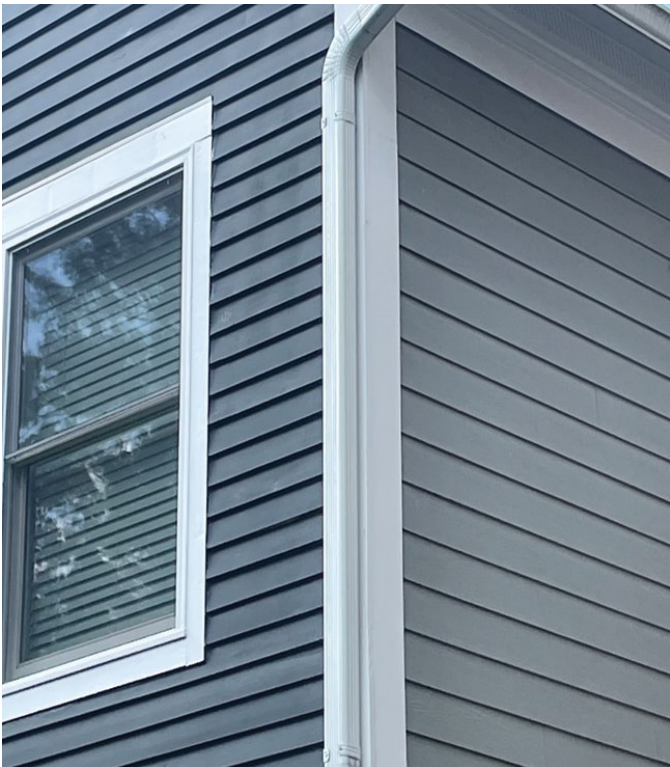
Figure 11. The thickness of the wood siding on the front (left) creates a deeper shadow line than is achieved with the fiber cement siding used on the side (right) elevation. While the exposure can be adjusted, fiber cement siding is not available in a matching thickness. Photo: John Sandor, NPS.

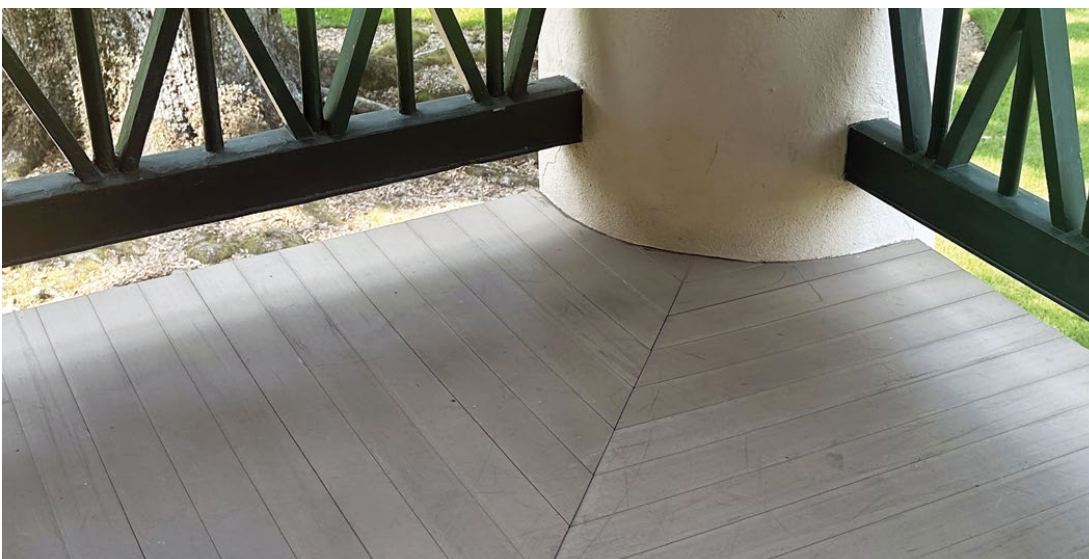
*Figure 15. Tongue-and-groove porch flooring is manufactured in several different substitute materials. Each type has different properties, though most are more moisture-resistant than wood. The prefinished product shown can be painted when worn, but repainting is not recommended for some product choices. Photo: Oak Alley Foundation.*
