Label Street Area in Need of Redevelopment Study

March 4, 2022

Prepared by the Township of Montclair Department of Planning and Community Development

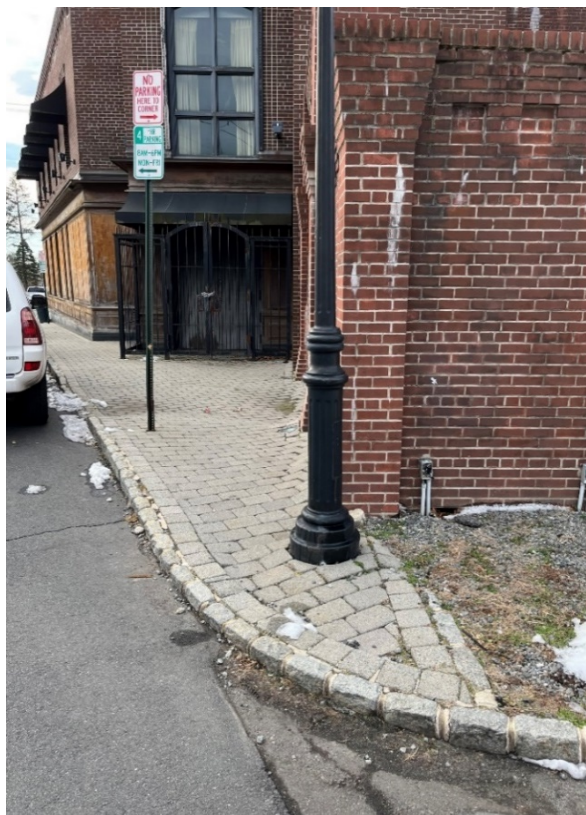
Pedestrian circulation onsite and around the site is limited. There are four-foot concrete sidewalks in the right-of-way on Label Street bordering Parcel 1 to the south, but no other pedestrian amenities aside from a narrow and uneven sidewalk alongside 2 Erie Street. This sidewalk is impeded by parking signage, street lighting, and an elevated manhole cover. Figures 14 and 15 demonstrate that the site layout and placement of underground stormwater utilities on Erie Street are not properly coordinated. There is no sidewalk provided adjacent to the property along Oak Place, which adjoins a residential neighborhood.

Figure 14: Narrow sidewalk along Erie Street in front of 2 Erie Street

There is a lack of pedestrian facilities along Erie Street and Oak Place, and lack of pedestrian access to Parcel 1 from the sidewalks along Label Street. This creates an unsafe and unwelcoming environment for those wishing to access the site on foot and travel along these roads to the train station and other uses in the Walnut Street business district.

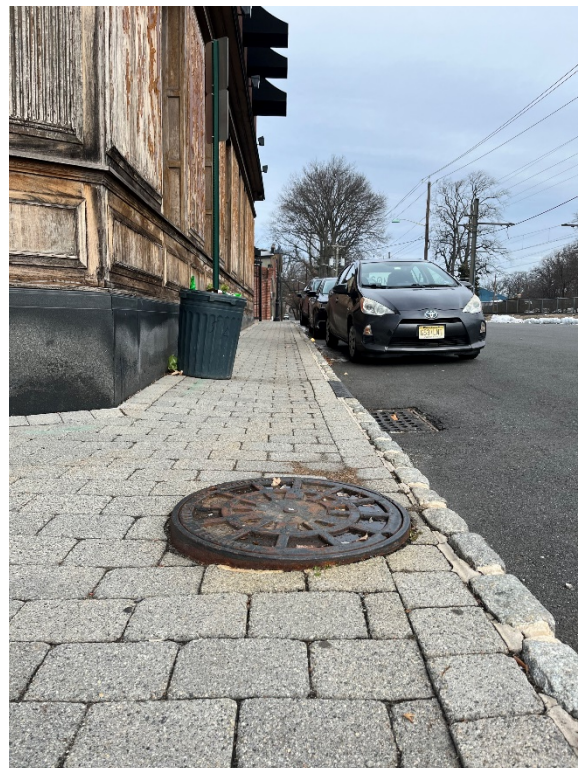
Figure 15: Underground stormwater utilities running beneath the sidewalk along Erie Street

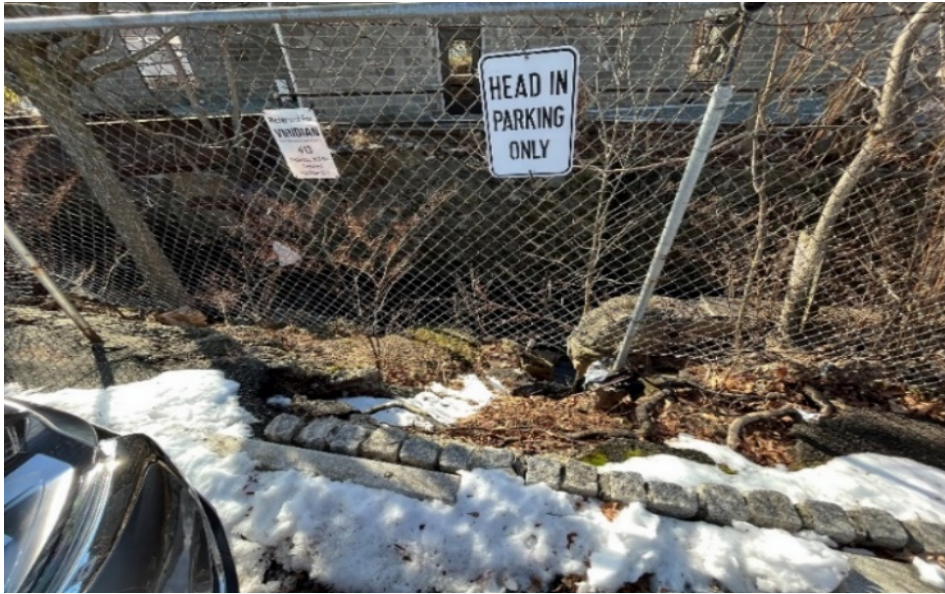
The west edge of Parcel 1 is bordered by a culverted tributary of the Second River, known as Toney’s Brook. The entirety of the portion of the tributary adjacent to Parcel 1 is under the ownership of the adjacent property, Lot 6 on Block 3307. The surface parking lot on Parcel 1 extends to the edge of the property along the tributary, which is bordered by a chain-link fence and a steep bank down to the culvert. In certain areas erosion of the bank can be seen, such as in Figure 17, which has begun to damage the asphalt.

Figure 17: Visible erosion along the Second River tributary bank

The site is largely impervious, with outdated drainage facilities. This is problematic since Toney's Brook, a tributary of the Second River, is adjacent to the property. Erosion is visually evident along the western edge of the site where asphalt has deteriorated.

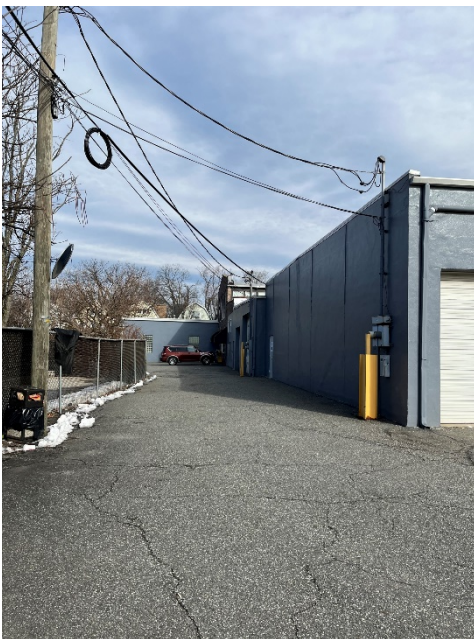
Parcel 1 suffers from vehicular pinch points at the western edge along the tributary. Circulation onsite between the parking area on Oak Place and the parking area on Erie Street is directed through this pinch point, where large garage storage spaces and several light manufacturing businesses are located as shown in Figures 18 and 19.

Figure 18: Vehicular pinch point next to the tributary

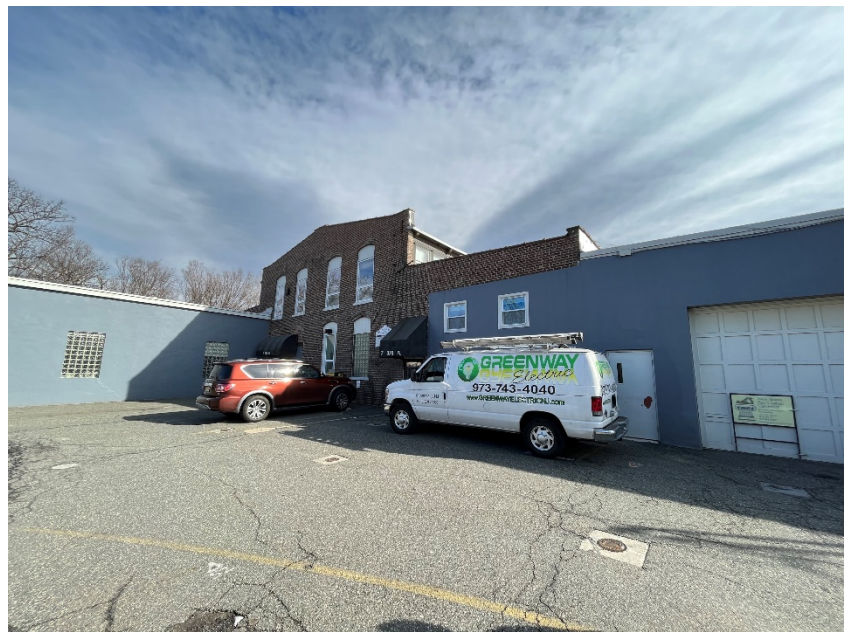
Figure 19: Garage spaces and light manufacturing uses at the pinch point as viewed beside tributary

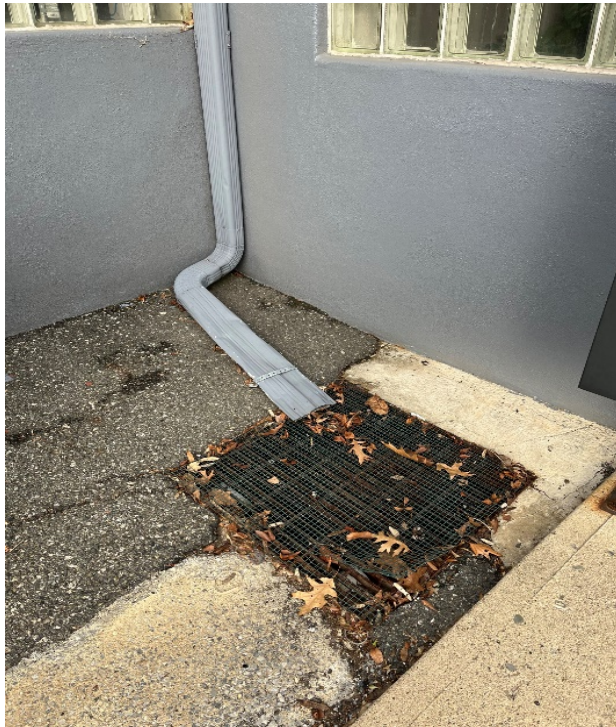
Outdated and unmaintained drainage facilities can be found throughout the site as shown in Figures 20 and 21. This site is listed as remediated for previous contamination of the groundwater by trichloroethylene using the site for industrial purposes, but is still listed as an active site, #494272, on the New Jersey Department of Environmental Protection’s Site Remediation Program inventory. There are monitoring wells located throughout the site as pictured below.

Figure 20: Outdated and ineffective stormwater management facilities.

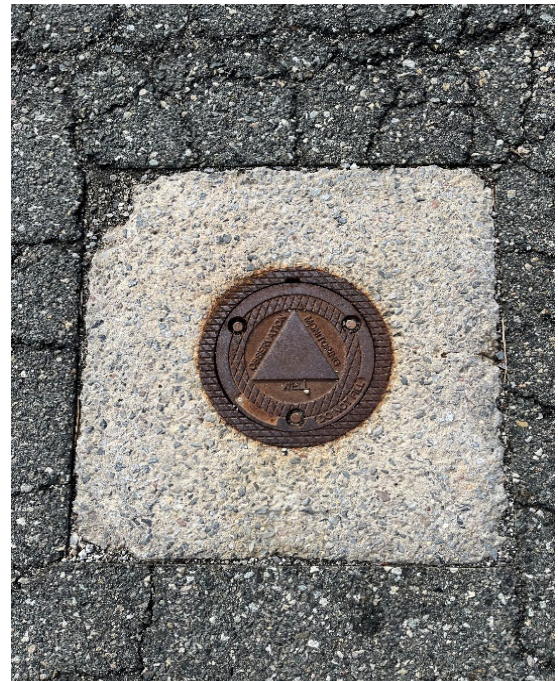
Figure 21: Groundwater contamination observation well

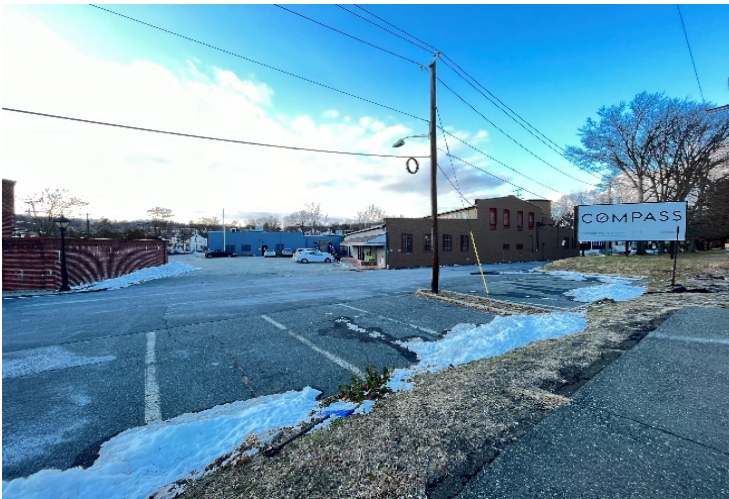
Figure 22: 4 Erie Street as viewed from the Walnut Street Station neighborhood platform

4 Erie Street, shown in Figures 22 and 23, is the original industrial portion of the building. It is currently occupied by dFit gym on the ground floor. The second floor, addressed as 7 Oak Place and accessed from the parking area on Oak Place, contains office spaces that were sectioned off as part of the rehabilitation of the site in 1985. See more information on the second floor in the 7 Oak Place section below. Overall, this building has a weak architectural relationship to the surrounding buildings, which include detached residences to the north along Oak Place. See Appendix 2 for additional photos of the area including Oak Place (Photos 48-51), the Walnut Street train station (Photos 7-10), and the neighborhood commercial buildings on Walnut Street (Photos 56-66), Label Street (Photos 34-45), and Forest Street (Photos 18-26).

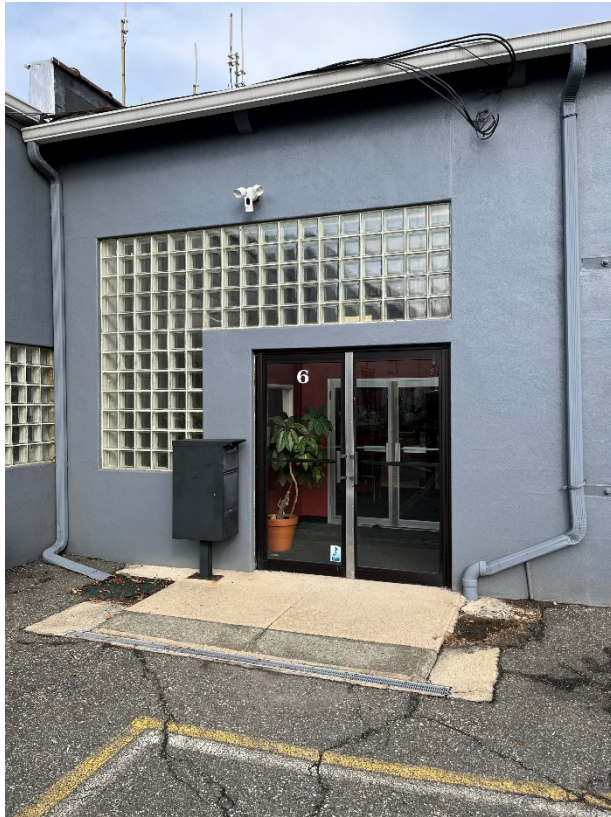
Figure 24: Entrance to 6 Erie Street

6 Erie Street, shown in Figures 24 and 25, is part of the ground floor of the original industrial building at 4 Erie Street. This space is currently leased as a large office space for Tarsus. Due to the COVID-19 pandemic, the space is still rented, but currently unoccupied, with most office workers working from home. The deep space stretches from the parking area on Erie Street to the north elevation of the building, with few windows in the intermediate spaces.

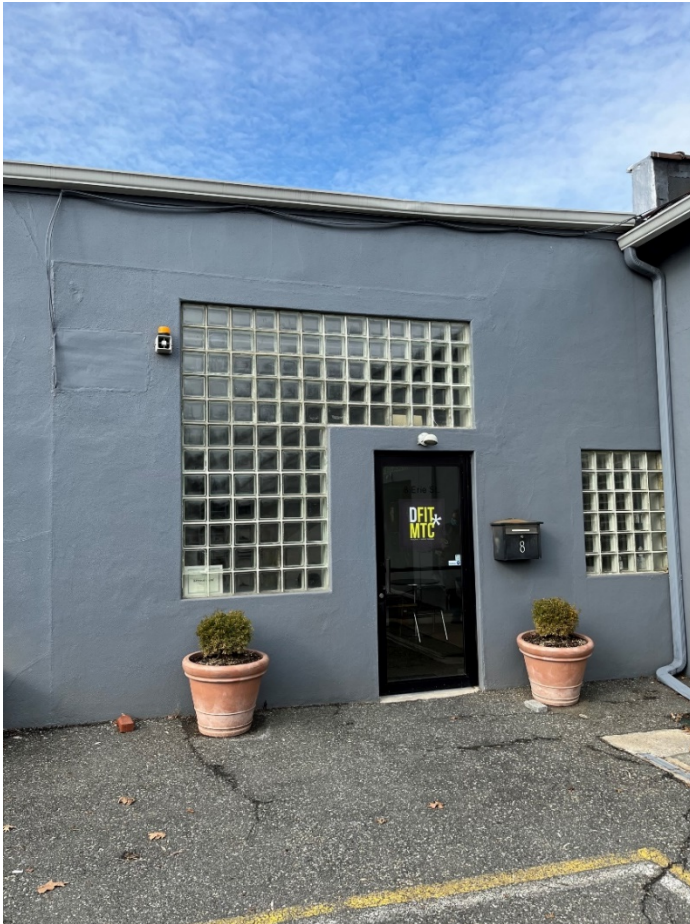
Figure 26: Exterior of 8 Erie Street

8 Erie Street, shown in Figure 26, is located within an addition to the original industrial portion of the building. This space houses a juice bar and biking studio for fitness classes conducted by the dFit gym tenant at 4 Erie Street. The two gym spaces are physically separated from one another by 6 Erie Street and do not have any interior connections. There is a loft level office space without any windows to the exterior of the building. The cycle studio also has no exterior windows. This space is connected to the lobby of 7 Oak Place, discussed in further detail below.

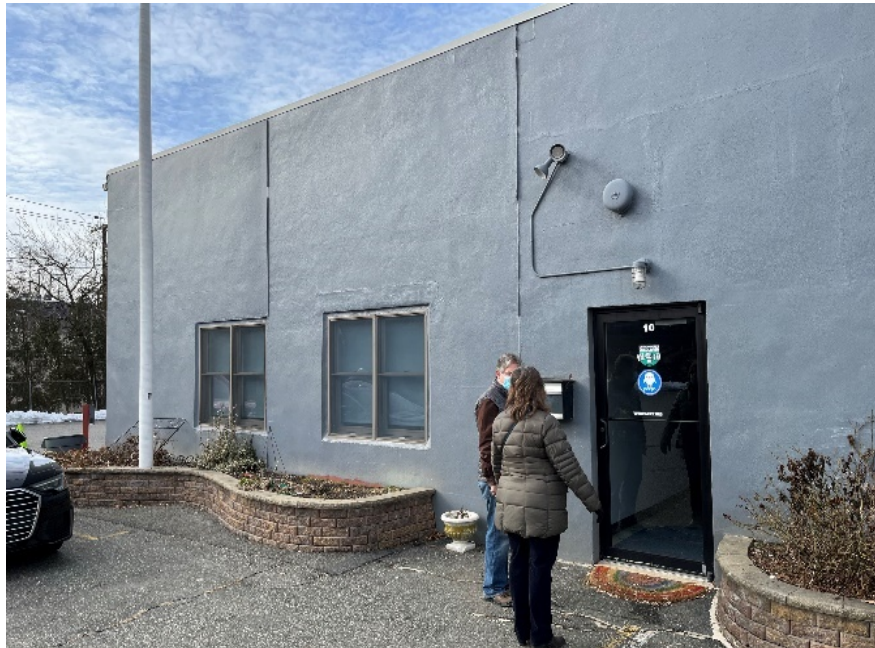
Figure 27: Exterior of 10 Erie Street

10 Erie Street, shown in Figures 27 and 28, is in the addition to the original industrial portion of the building and houses offices and learning spaces for the Montclair Foundation for Educational Excellence (MFEE), which is a local nonprofit that focuses on ESL education. Many of the indoor spaces here lack windows and natural light.

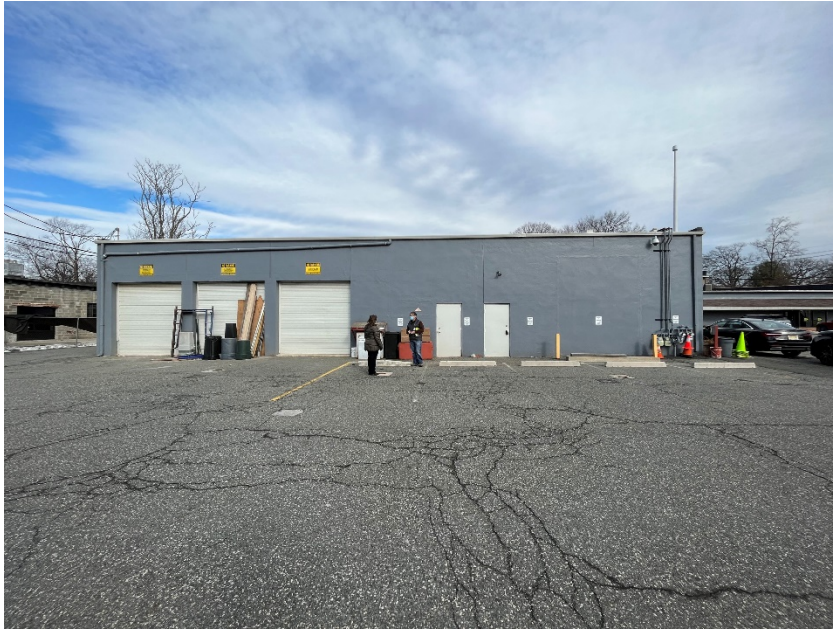
Figure 29: Southern elevation of addition

There are several large garage spaces located on the south side of the addition to the original industrial portion of the building as shown in Figures 29 through 32. These are used as storage spaces for the various tenants. On the west side are additional garage spaces, as well as spaces used by local millwork and carpentry businesses for light manufacturing and storage. The spaces on the west side are those facing toward the tributary and toward the vehicular pinch point discussed above.

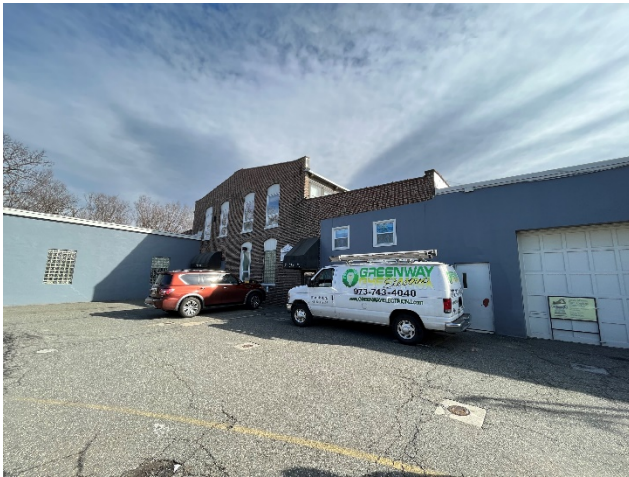
Figure 33: Exterior of 7 Oak Place

7 Oak Place is shown in Figures 33 through 36 and is located partially within the addition to the original industrial portion of the building, and partially on the second floor of the original building. This space is utilized by a variety of tenants as office space. Not all office spaces are currently leased. Some of the vacant office spaces are being used as temporary storage for other tenants. Emergency egress for the second-floor office tenants is via a collapsible stairway in the hallway leading to the roof and a collapsible fire escape to Oak Place.

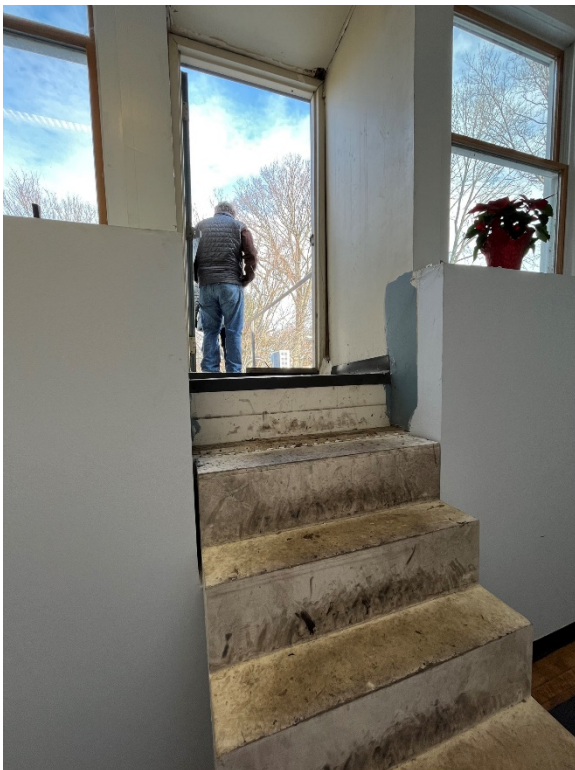
Figure 35: Egress stair to roof

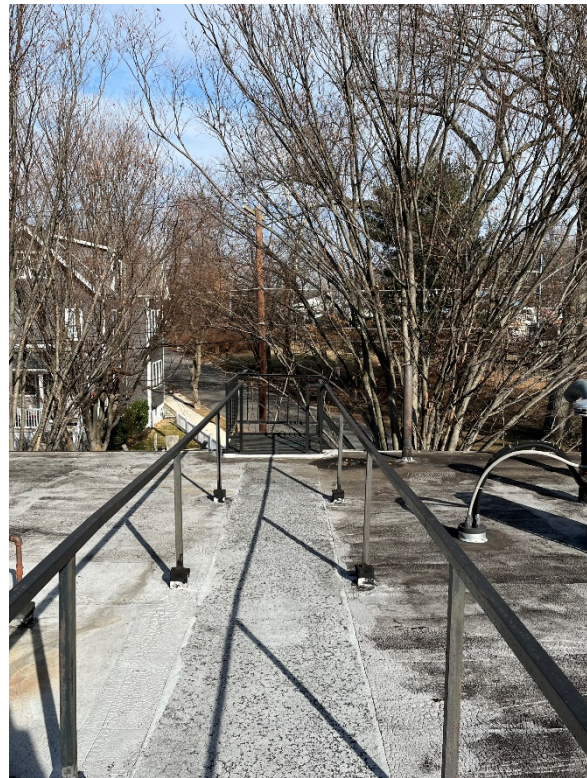
Figure 36: Roof access to fire escape

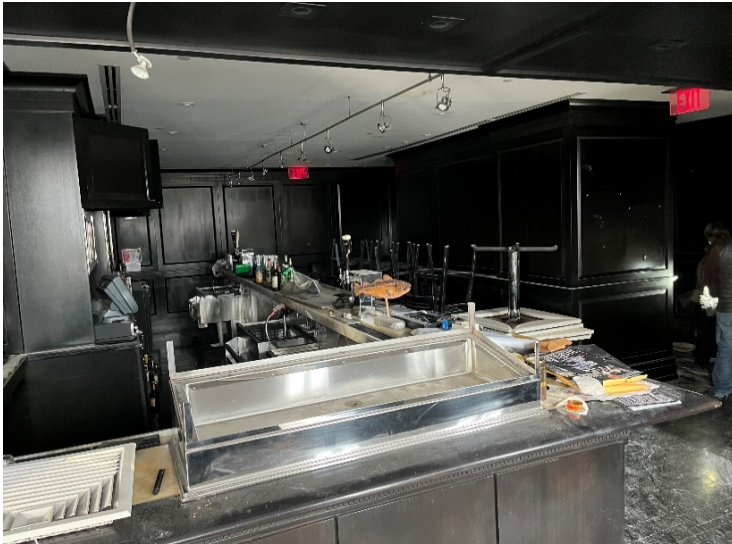
Figure 37: Interior of 2 Erie Street.

The former owner of the building at 2 Erie Street, Richard Cecere, held a 99-year ground lease on the property, which was abandoned in 2015 after a subdivision application was denied by the Planning Board. Reasons for denial centered around the lack of onsite parking for 2 Erie Street. In 2015 the building was regained by the property owner, 34 Label Street Associates, who has kept climate control and utility connections to the building active so that the structure would not deteriorate more than it already had. Much of the restaurant equipment and furnishings have been left behind in the building, as can be seen in Figure 37.

Building 2 has been vacant for many years, and its abandoned interior is in substandard and unsanitary condition. The location of its entrance away from prominent pedestrian areas, uneven and obstructed sidewalks limiting accessibility, a poorly-designed loading dock, and the odd and inefficient layout of the interior structure are all examples of how this building is obsolescent.

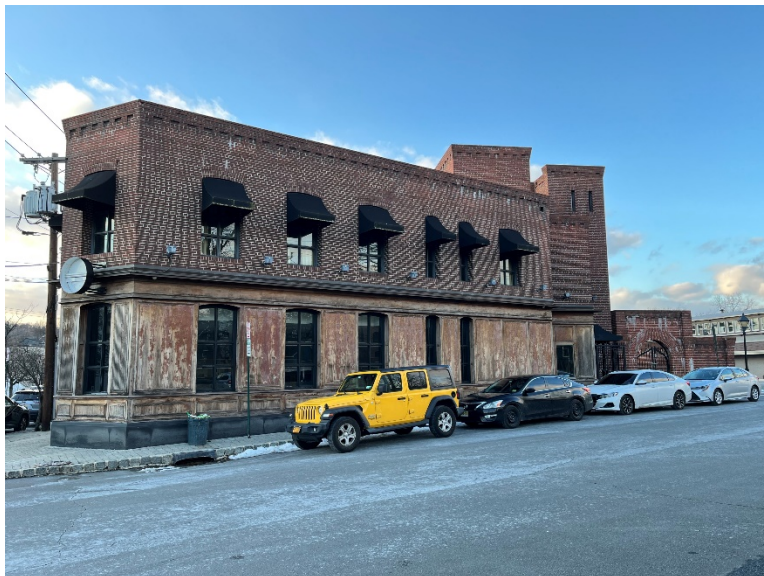
Figure 39: Wood paneling applied to first floor exterior

The original portion of 2 Erie Street is an approximately 1800-square-foot wedge-shaped section located at the corner of Label Street and Erie Street. A large rear addition was approved as part of a site plan application heard by the Board of Adjustment in 1996, subsequently amended in 2002 to account for unauthorized departures from the approval, including a walled-in courtyard. The exterior of 2 Erie remains in good repair overall as shown in Figure 38. Wooden paneling attached to the exterior of the ground floor by Richard Cecere as part of the 2002 site plan has begun to deteriorate, however, pictured in Figure 39.

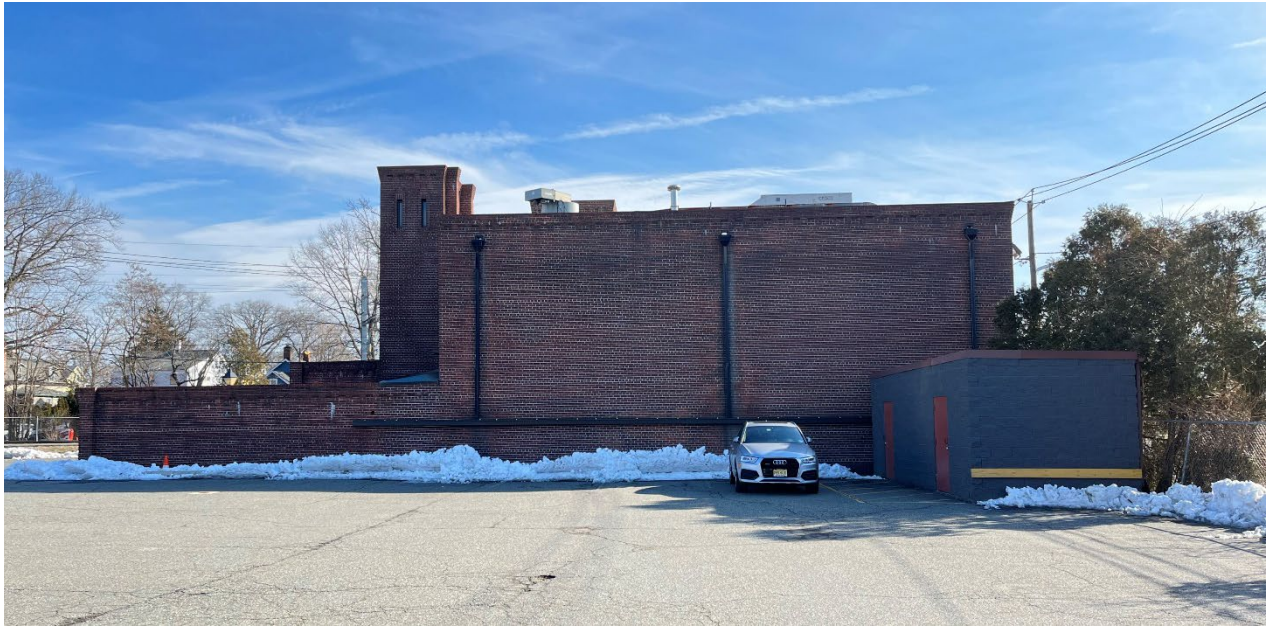
Figure 40: Large rear additions to 2 Erie Street, and the rear storage outbuilding (Building 3)

A small outbuilding, Building 3, was added to the site to add storage space, which can be seen in Figure 40. Figures 41 and 42 show the loading area on Label Street for 2 Erie Street. This loading area leads to a small interior storage space, not consistent with typical loading bays. Vehicular access to such a loading area would result in large transport vehicles blocking a portion of Label Street, as there is no interior space for vehicles.

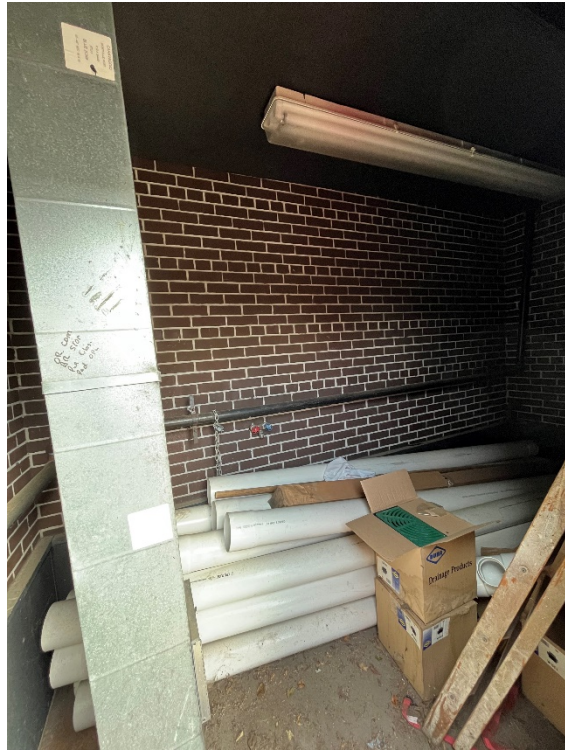
Figure 42: Interior storage area off of loading dock42

Despite repeated attempts by the owner to lease Building 2, it has remained vacant. Restauranters have not been interested in renting the building because of the inefficient layout of the interior spaces. Photos of the interior are provided in Figures 43 and 44. The interior was constructed contrary to what was approved in 1996 when the addition was approved. Oddities and inefficiencies of the interior layout include but are not limited to:

- Three levels with different dining spaces on all levels
- Separate kitchen spaces on each level
- Limited amount of seating for diners due to layout choices
- Windowless rooms on each level
- Dining areas that can only be accessed from staff areas or kitchen spaces
- Windowless basement dining area containing a hatch to the outdoor patio

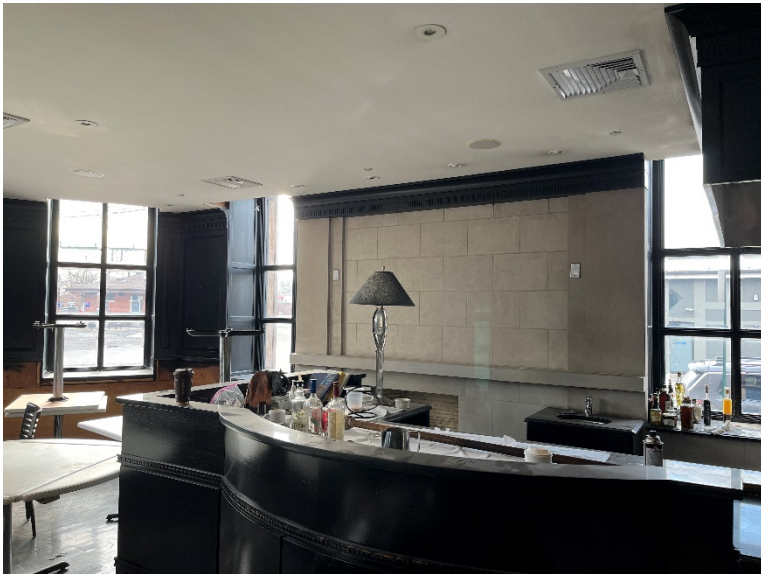
Figure 43: Abandoned interior ground floor

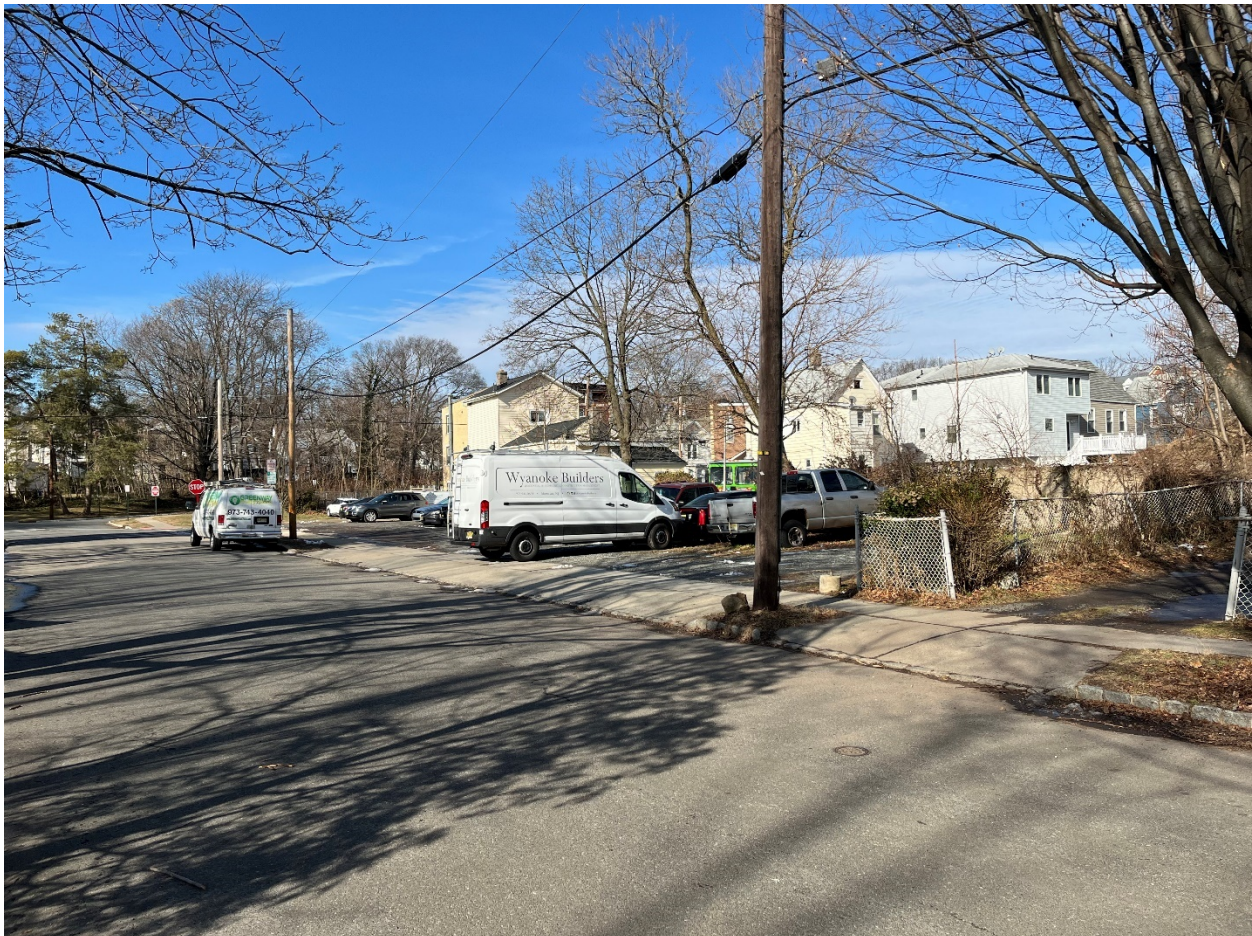
Parcel 2 comprises a rectangular lot at the northeast corner of Oak Place and Forest Street. It is currently used exclusively for open air parking as shown in Figures 46 and 47. There are four-foot concrete sidewalks along both street frontages in the right of way. Most of the linear length of the Oak Place frontage is an open concrete apron to allow vehicles to pull into the parking area. The lot is covered in gravel, and contains no markings for parking spaces, no screening, and no barriers between the parking area and sidewalks. It was observed that tenants of Parcel 1 utilize this parking area for parking of vans and other vehicles, and that there are instances of double parking and vehicles obstructing the sidewalk along Oak Place.

Figure 46: View toward Parcel 2 from Oak Place. Visible are tenant vehicles of Parcel 1, double parking, and vehicles partially blocking sidewalks.

The use of Parcel 2 for open air parking has become the default use of the space, as the location of the underground culvert precludes meaningful development of structures in this location. Parcel 2 is stagnant and unproductive as a parking area, as it is not properly marked or screened, resulting in unorganized and unsightly parking conditions in a chiefly residential area. The lack of barriers or markings create an unsafe pedestrian condition along the north side of Oak Place.

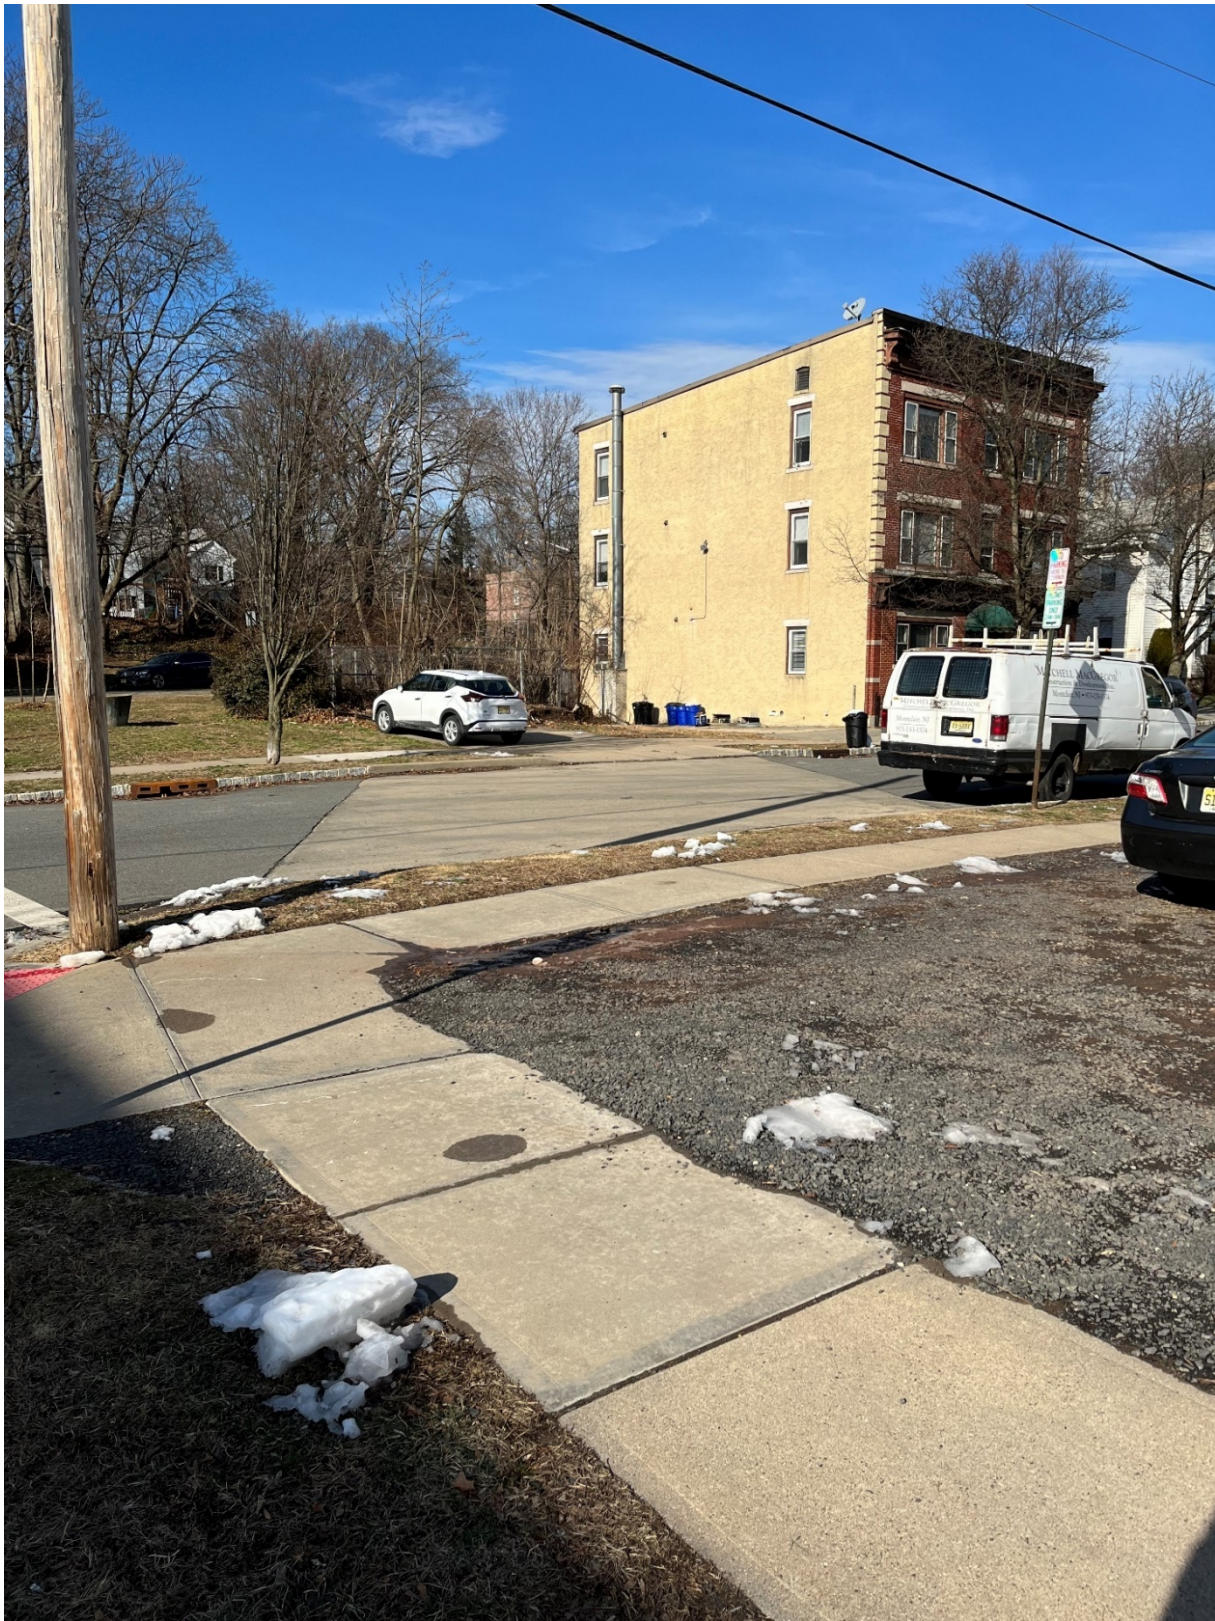
A portion of the Second River tributary enters an underground culvert to the northwest of Parcel 2, passes underneath Forest Street, Parcel 2, and Oak Place before daylighting on the south side of Oak Place near the northwest corner of Parcel 1. It is noted that no structures would be permitted to be constructed on top of a culverted stream. Figure 48 includes an aerial photo that illustrates the extent of the underground culvert.

Figure 47: View across Forest Street from Oak Place sidewalk, toward undergrounded portion of tributary.
