INTENSIVE-LEVEL ARCHITECTURAL SURVEY

WHEELER STREET AND OAKCROFT RESIDENTIAL AREAS
Township of Montclair, Essex County, New Jersey

OAKCROFT RESIDENTIAL AREA SUPPLEMENT

Project No. 1915C

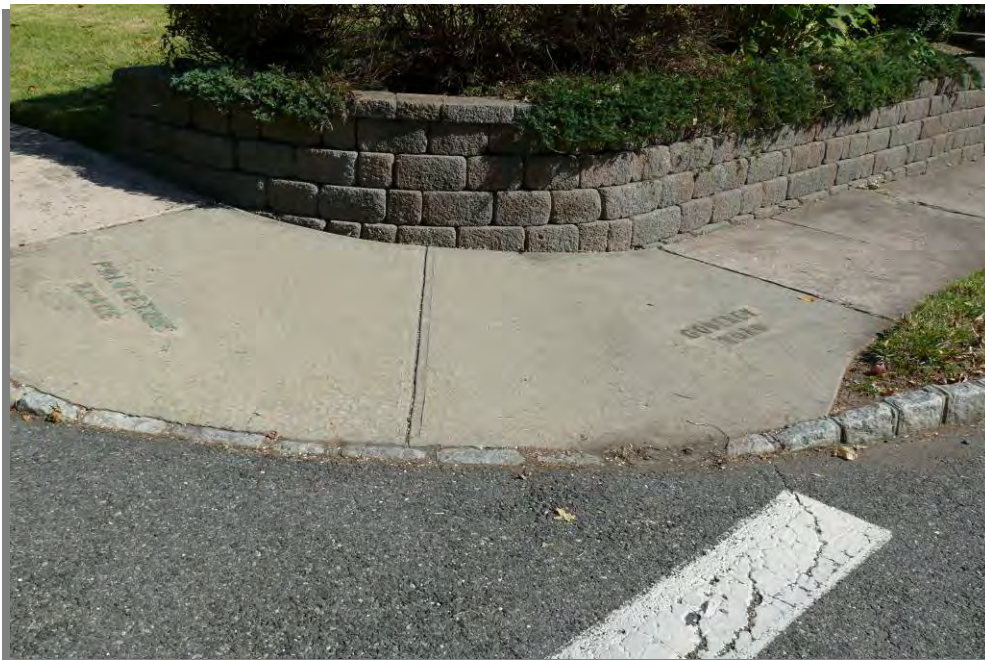
Figure 8

Image of the brass plates inset in the concrete showing the road names.
(Image taken by: Margaret M. Hickey, AIA)

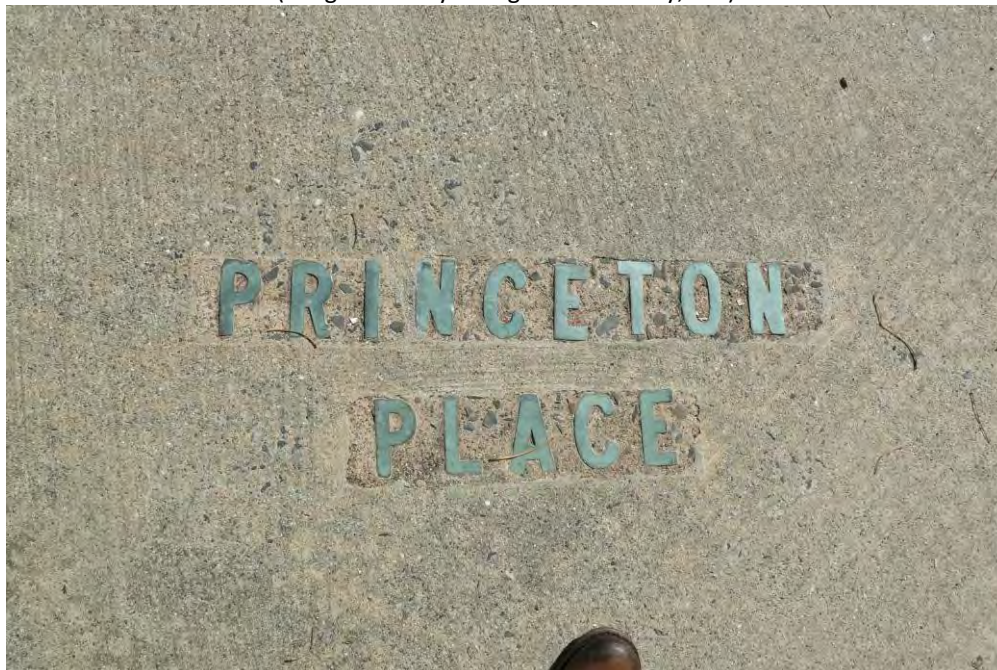
Figure 9

Detail view of the brass plates set in concrete: "Princeton Place". (Image taken by: Margaret M. Hickey, AIA)

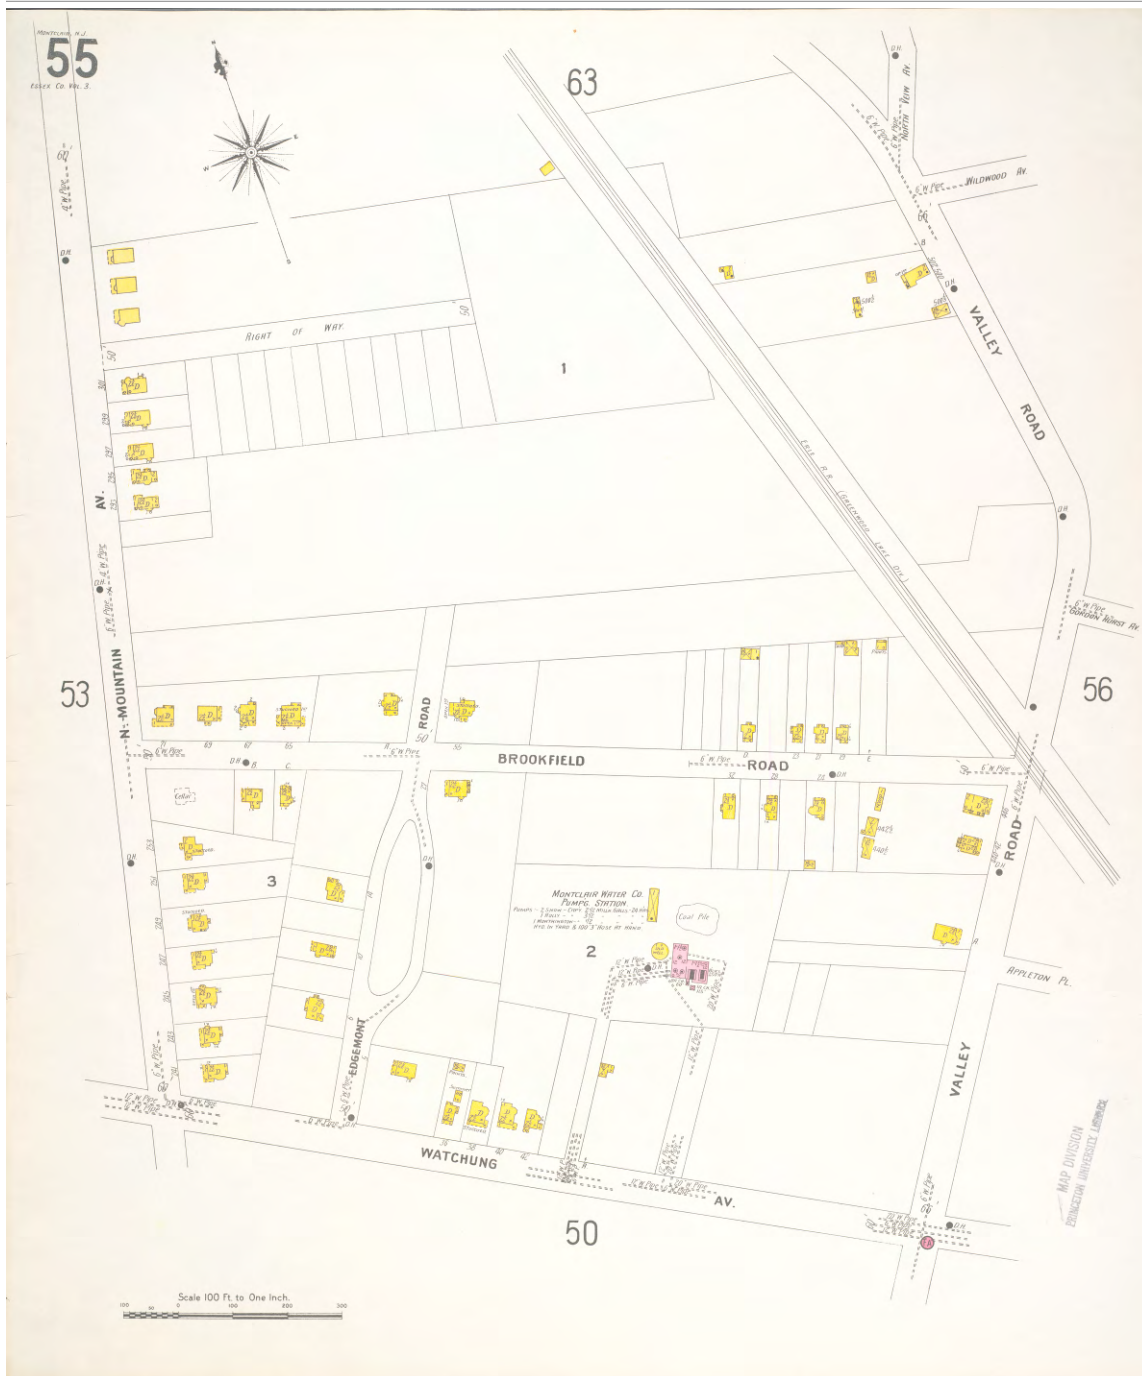
Figure 11

1907 Sanborn Fire Insurance Maps (Sheet 53) showing the Oakcroft Residential area just prior to development. (Credit Sanborn Map Company. *Sanborn Fire Insurance Maps, Essex County, Vol. 3.* New York, NY: Sanborn Map Company, 1907. Sheets 53. (Available from the Internet: Library.Princeton.Edu)

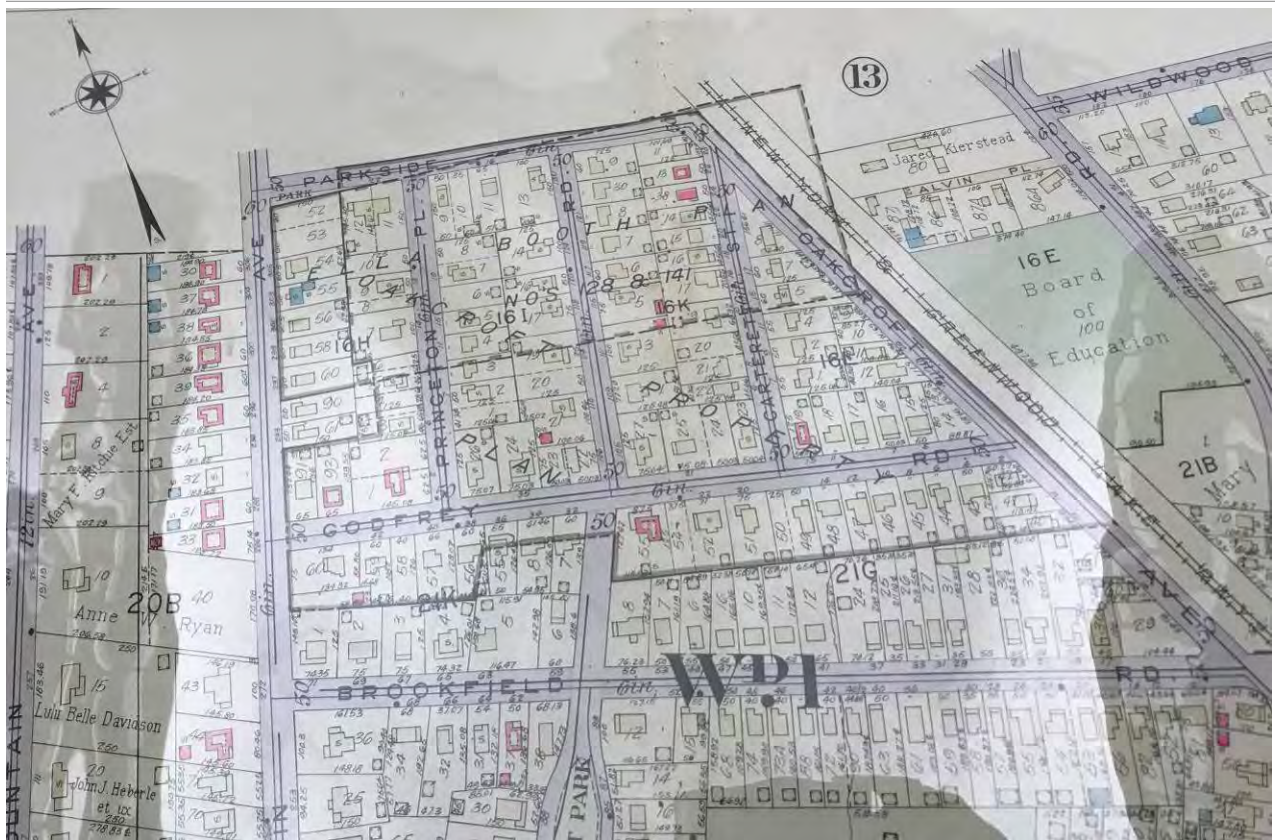
Figure 12

1933 Real Estate Atlas of Montclair showing the Oakcroft Residential area just after approximately twenty-five years of consistent development. (Credit: Franklin Publishing Co. *Real Estate Atlas of Montclair, Glen Ridge, Cedar Grove & Verona, NJ*. Philadelphia, PA: Franklin Survey Co., 1933. (Montclair Public Library, Main Branch)

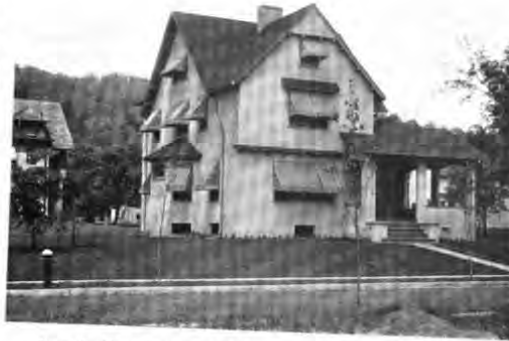
Figure 2—Mr. Lemkau's house is built of stucco, tinted a natural silver gray color

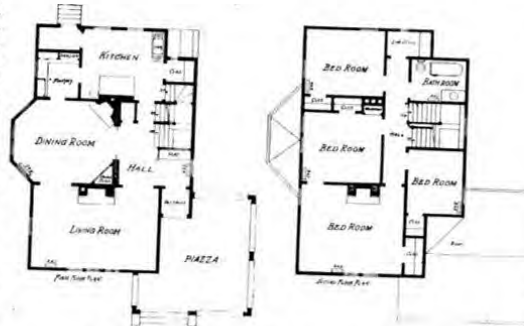
Figure 3—The first and second floor plans of Mr. Lemkau's house

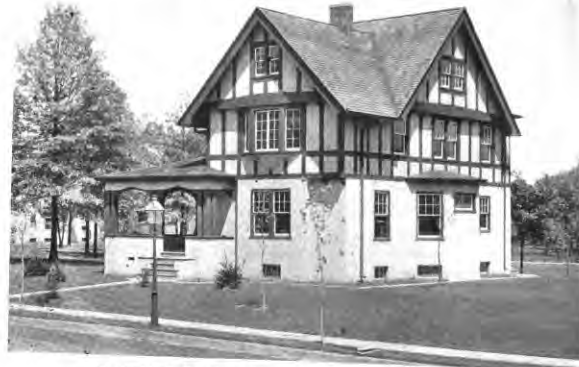
Fig. 5—Mr. Godfrey's house is designed in the English half timber style

The house illustrated in Figures 5, 6 and 7, is another Oakcroft house built for Aaron Godfrey, Esq., and is of the English half-timber style, with stucco for the first story and half-timber work for the second and third stories. The half-timber work is stained a soft brown tone, harmonizing nicely with the gray stucco and the moss-green stain of its shingled roof. The hall, living-room and dining-room are trimmed with oak, finished with a Flemish brown. The hall has a two-toned brown wall-paper and the living-room a two-toned green striped wall-paper, and also an open fireplace, with brick facings and hearth. The dining-room has a plain green paper to the height of six feet, at which point a

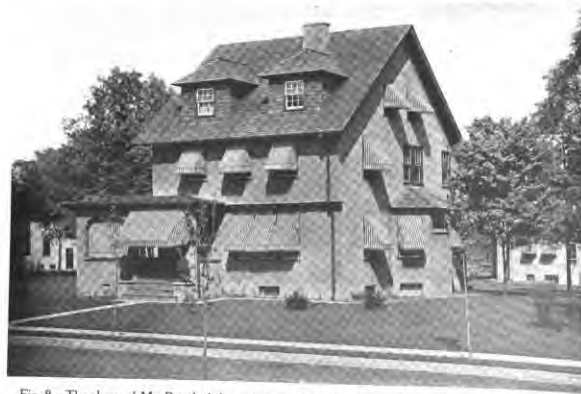
Fig. 8—The charm of Mr. Brandon's house is its massive wall surface and numerous small lighted windows

The house built for John R. Brandon, shown in Figures 8, 12 and 13, is of another type and with more formal lines in its design. The charm resides in its massive wall surfaces of stucco, which are well broken by the numer-

ous small lighted windows, with which the exterior walls are pierced. The house is of frame construction covered with metal lath and finished with a triple coat of cement stucco, tinted a light yellow. The trimmings are painted brown and the roof is covered with shingles, stained a reddish-brown. The interior arrangement of the house is similar to the plans shown in Figures 6 and 7, belonging to the house shown in Figure 9, with the exception that there are no bay windows at either the first or second stories of this house. The versatility of the architect is again very well expressed, for he has been able to design a distinctive exterior for a similar plan. The halls and living-rooms are trimmed with oak, stained and finished in a forest-green. The fireplace in the living-room is built of buff Roman brick with the facings rising to the height of four feet, at which line it is finished with a mantel shelf. The walls are covered with a two-toned brown wall-paper, with a large

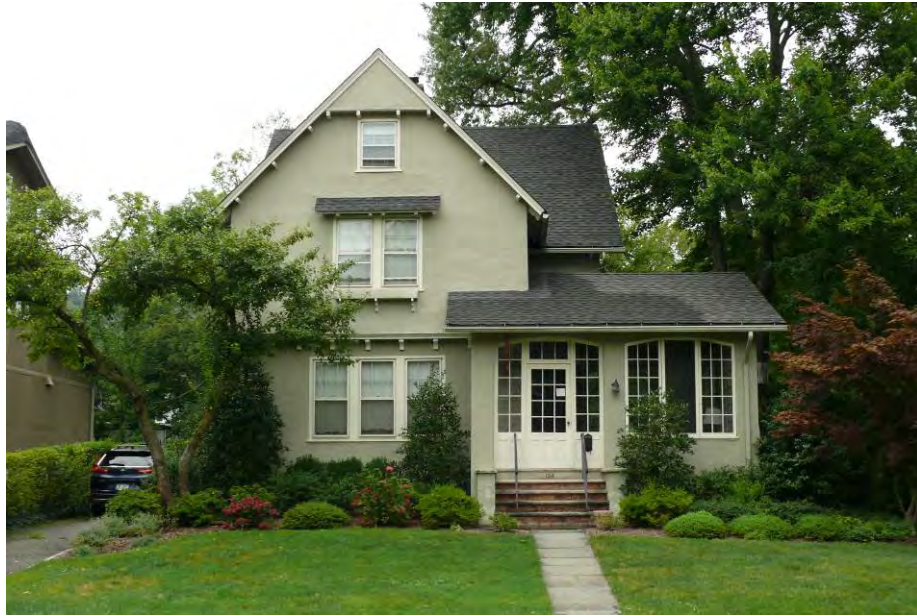
Figure 15

Current image of 124 Edgemont Road, Montclair, which was one of the properties designed by the architectural firm, Freeman and Hasselman of New York. The most visible change since original construction is the enclosing of the front porch. (Image taken by: Thomas B. Connolly, AIA)

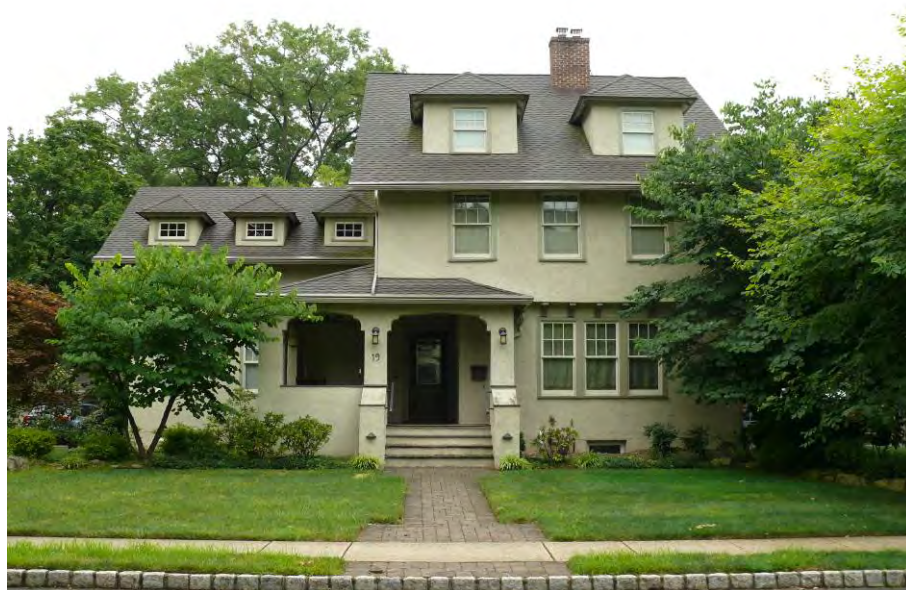
Figure 16

Current image of 19 Princeton Place, Montclair, which was one of the properties designed by the architectural firm, Freeman and Hasselman of New York. Although the building has been expanded, the addition was designed to fit with the original architecture. (Image taken by: Thomas B. Connolly, AIA)

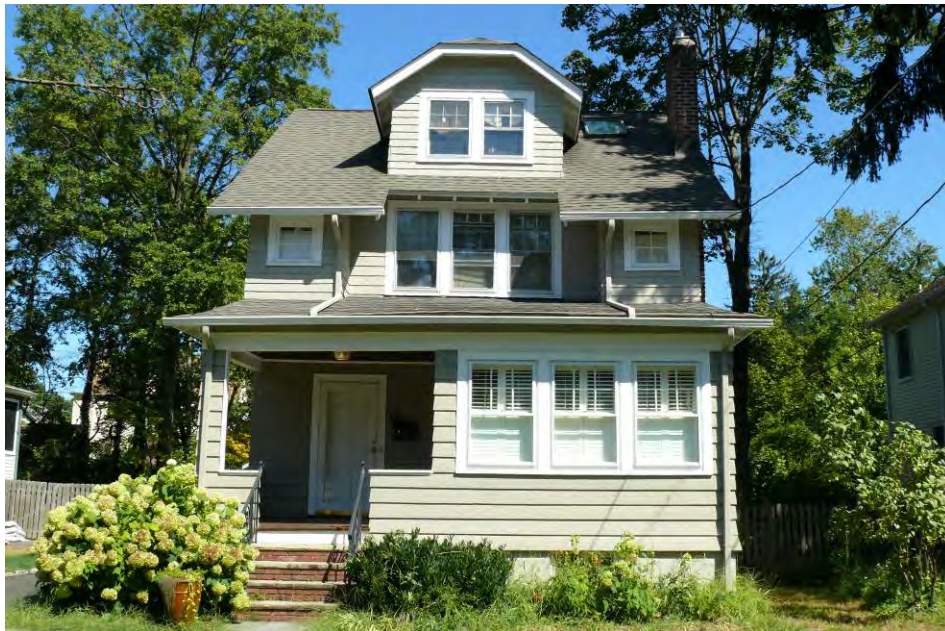
Figure 17

Current image of 49 Brookfield Road, Montclair, which was one of two residences constructed by the builder/contractor Paul Gowan in 1913. It is a sister to 53 Brookfield Road seen in Figure 18. (Image taken by: Thomas B. Connolly, AIA)

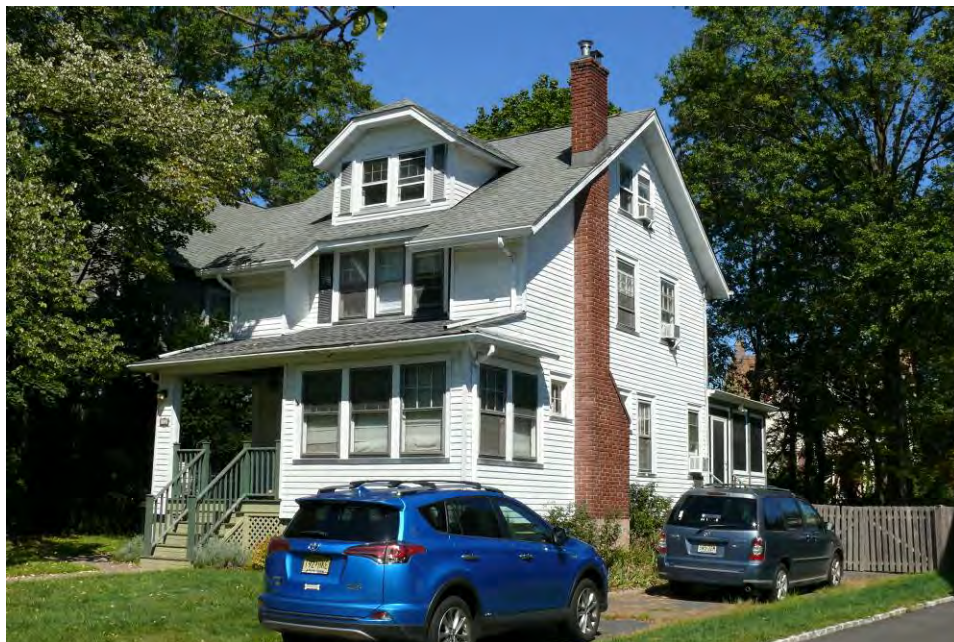
Figure 18

Current image of 53 Brookfield Road, Montclair, the sister of 49 Brookfield Road seen in Figure 17. (Image taken by: Thomas B. Connolly, AIA)

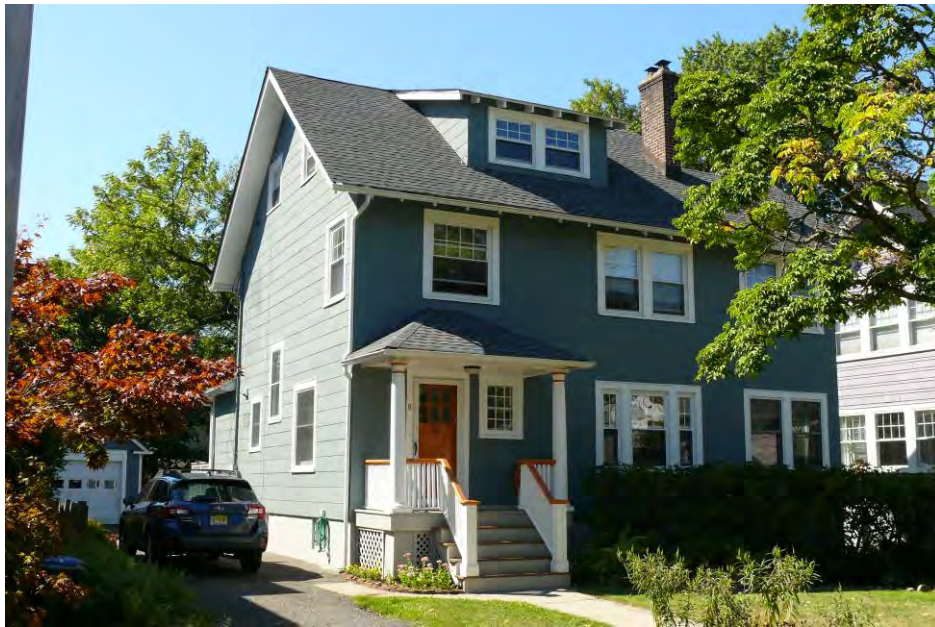
Figure 19

Current image of 8 Godfrey Road, Montclair, which was one of several residences constructed by the builder/contractor Thomas Curtis starting in 1915. This one is a sister to 10 Godfrey Road, its immediate neighbor seen in Figure 20. (Image taken by: Thomas B. Connolly, AIA)

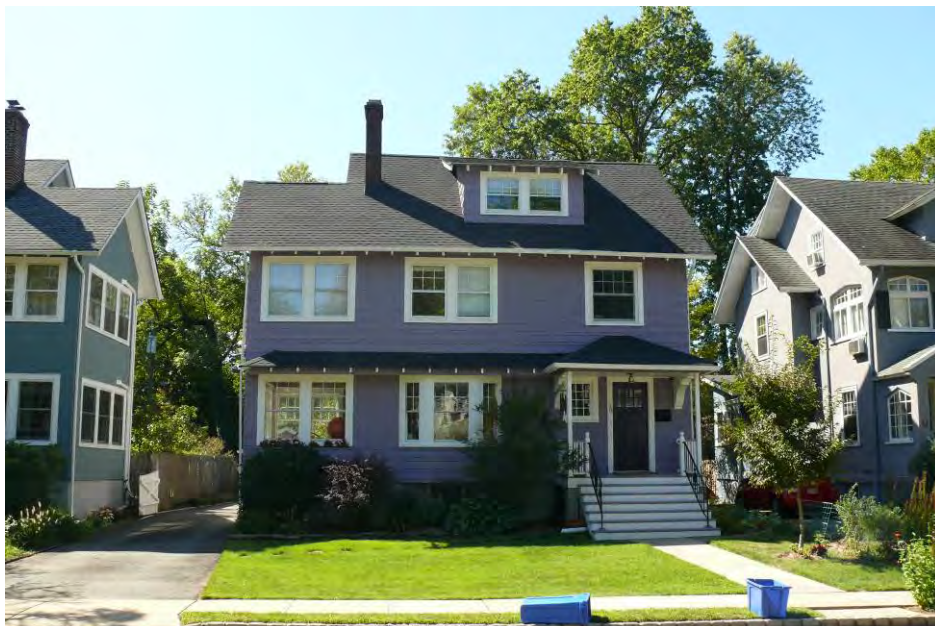
Figure 20

Current image of 10 Godfrey Road, Montclair, the sister of 8 Godfrey Road seen in Figure 19. (Image taken by: Thomas B. Connolly, AIA)

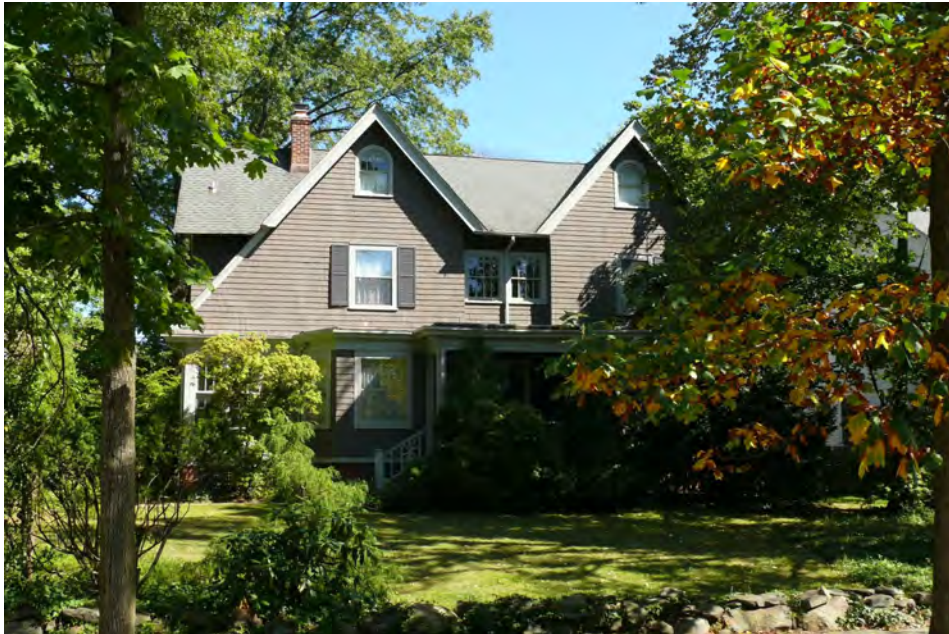
County:	Municipality:	Local Place Name:	USGS Quad:	Block:	Lot:
ESSEX	Montclair township			1705	1

This is a three-unequal bay wide by three-bay deep, two-and-one-half story single-family residence in the Shingle style. The building faces southwest toward Brookfield Road and the first floor is set several steps above grade. The property has a low stone retaining wall the perimeter and the driveway is accessed from Edgemont Road with a garage located in the southeast corner of the property. The foundation is red brick and the building is sided with wood shingles with mitered corners; a flat-stock wood water table is set just above the foundation. The window types and sizes vary but the openings are typically trimmed with flat-stock wood with narrow projecting sills and a drip cap at the square-shouldered openings. The main roof, clad with asphalt shingles, is a side gable with cross gables at the front and rear creating an intricate roof plan. The roof overhangs with exposed rafter tails at the downward slopes and deep recesses at the gable ends set behind flush rake boards with narrow molded trim at the transition with the roof. A one-story porch occupies with center and east bay; it has a shallow hip roof supported by three square columns with molded capitals and plinth. The porch columns are supported by brick piers with lattice between. The wood stairs lead from the west side of the porch. The railing has a wood top and bottom rail with a series of straight balusters and crossed balusters. A substantial newel is set at the first step. The first bay is defined by a front gable that projects slightly from the narrower center bay. The upper section of eave overhangs and transitions to a flush rake board at the head of the second floor windows. The roof extends to the first floor over a one-story enclosed porch. The second floor is supported by the same wood post as the entrance porch including brick pier and lattice below. Set between the post and a one-story bay window projection are a pair of six-over-six wood-hung sashes over one-panel each sash. Each side of the bay window projection has a one-over-one hung sash

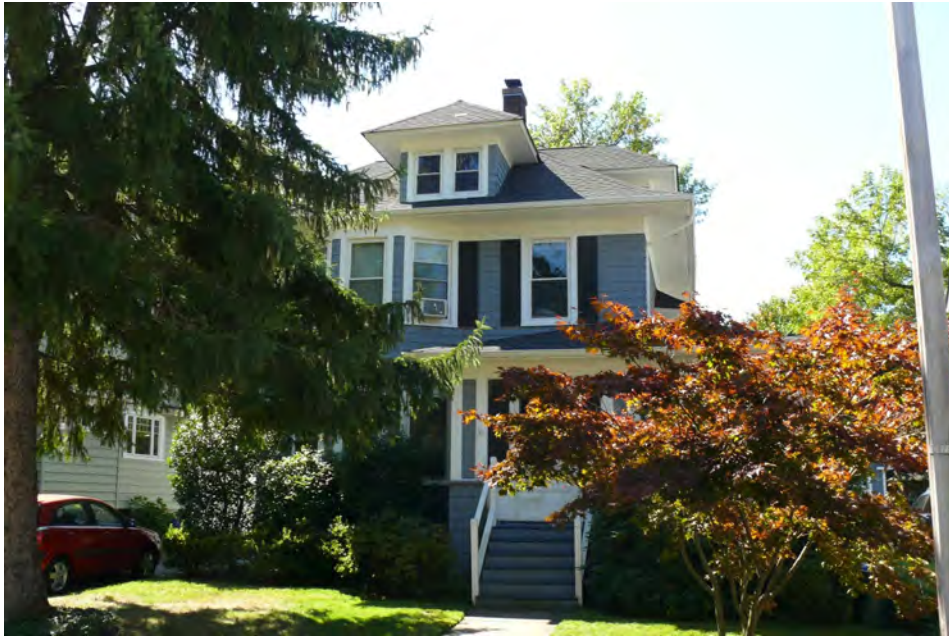
County:	Municipality:	Local Place Name:	USGS Quad:	Block:	Lot:
ESSEX	Montclair township			1705	10

This is a two-bay wide by two-bay deep, two-and-one-half story single-family American Foursquare with Craftsman style influences. The front of the building faces northwest toward Godfrey Road and the first floor is set several steps above grade. The building is set back from the road with a lawn in front and a drive set on the east side leading to a garage. The foundation is parged masonry. The building is clad with wood shingles with mitered corners. The windows are one-over-one hung sash typically; they appear to be replacement material. The trim is flat-stock wood with a narrow projecting sill. The roof is a hip with a deep overhang and boxed soffits set above a deep flat-stock entablature that also serves as the head of the second floor windows. Centered in each side of the roof are gabled dormers also with deep boxed soffits and narrow entablatures. All of the roofs are clad with asphalt shingles. The dormers are also clad with shingles; the fenestration varies. The front has a pair of small hung sash with wood mullion. The two sides dormers have single hung sash centered. A brick chimney is set about center of the roof. The east bay of the front elevation is dominated by a two-story bay window projection that is set under the deep overhang of the main roof. The shingles flare slightly between the first and second floor. There is a typical window opening in each side of the bay. A wood frame porch enclosed by wood shingle siding from sill height to grade occupies the west bay and extend beyond the main building one bay to the west. It has a shallow hip roof clad with asphalt shingles. The roof is supported at each corner and center bay by paneled wood piers that stop at sill height; the piers step out slightly below the sills and to the floor level where they are clad with wood shingles. The door is centered in the east bay of the porch and is accessed by wood stairs with simple wood railings on set on each side of the stair. The door has an upper screen and two lower panels and is flanked by sidelight

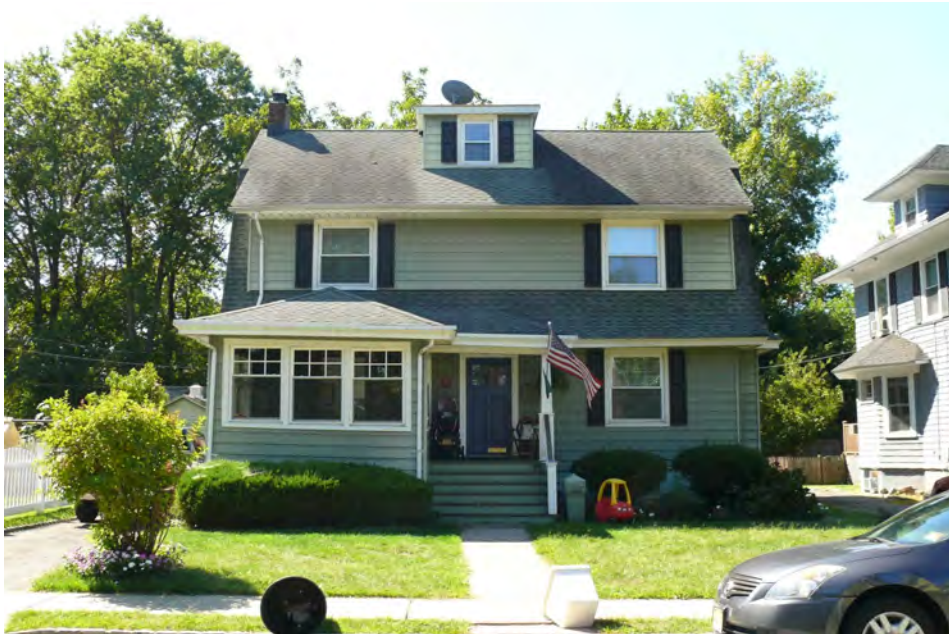
County:	Municipality:	Local Place Name:	USGS Quad:	Block:	Lot:
ESSEX	Montclair township			1705	11

This is a three-bay wide by two-bay deep, two-and-one-half story single-family residence in the Colonial Revival style. The building is set back from the sidewalk and the drive is set on the east side of the property leading to a garage at the rear of the property. The front elevation faces northwest toward Godfrey Road and the first floor is set several steps above grade. The foundation is parged masonry. The building is clad with vinyl siding with a narrow corner piece. The windows are typically one-over-one sash with some exceptions. The trim is flat stock with a vinyl trim piece and a clad sill. The roof is a side gambrel with a flared eave with a deep overhang and cornice return. An almost full-width shed dormer is set to the front and rear with a second narrow shed dormer center at the gable ridge at the front. All of the roofs are clad with asphalt shingles. A brick fireplace with chimney is set on the east side at the gable end. A one-story extension is set in the east bay at the front. It has a hip roof clad with asphalt shingles and a built-in gutter aligned with the sweeping eave of the main roof. The extension has unequal one-over-one sash, three grouped on the north elevation and two grouped on each of the side elevations. The roof of the hip and the main roof continues over a shallow entrance porch in the center bay. The porch is wood with wood stairs and a traditional wood railing with paneled new and top and bottom rails and square balusters lining the west open side. The roof extension, continuous with the hip including the built-in gutter is supported by an angled post set on a square paneled base which is further supported by a parged masonry pier. The door eight-light over two-panel wood with molded trim. Center in the west bay at the first floor is a typical window opening. A single typical window opening is set at each end of the lower shed dormer. A single small window opening is set center of the upper shed dormer. On the east side, there are typical window openings on either side of the fireplace and

The Essex County tax records indicate a construction date of 1916 and this is confirmed by the city directories. The main changes to the building are the application of synthetic siding and the replacement of the windows.

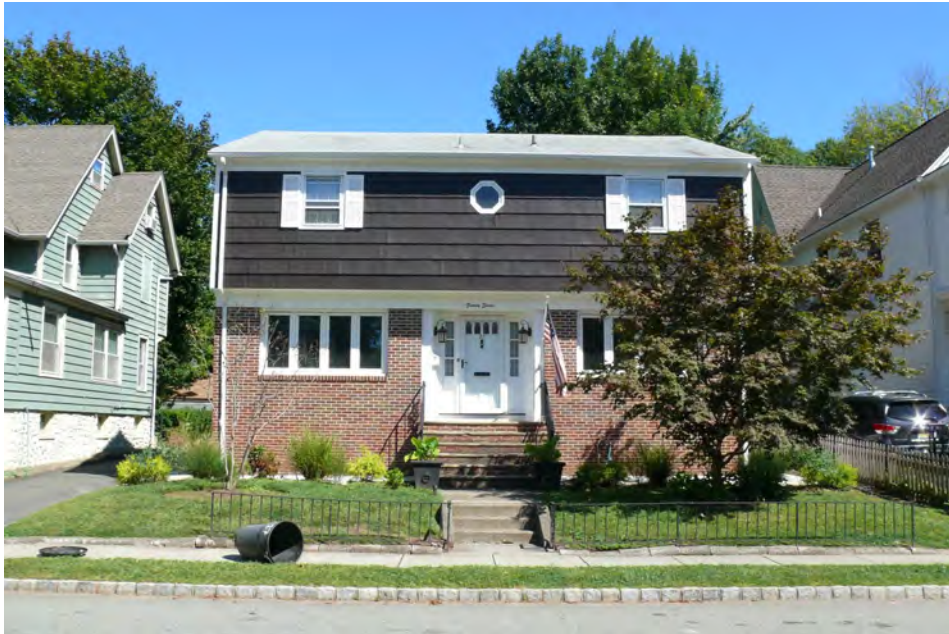
Property Photo:

This is a three-bay wide by two-bay deep two-story residence with a one-bay rear shed extension. The front of the building faces southwest toward Brookfield Road and the first floor is set several steps above grade. The building is set back from the street for a moderate front lawn that is slightly raised above the sidewalk via a few steps. A shared driveway runs along the west side. The foundation is parged masonry, visible at the side elevation, and wood shingles above (with a wide exposure). At the front, the foundation and first floor are clad with red brick and the second floor overhangs slightly. The windows are one-over-one vinyl sashes with flat-stock wood trim and projecting sill except where noted. The roof is a shallow side gable clad with asphalt shingles with a slight overhang at the downward slope and a flush rake at the gable end. The entrance is recessed and set at the center bay. The jambs are splayed on both sides; the door is four-light over four-panel wood in a flat stock surround with three-light-over-one-light sidelights (both sides). The door is accessed by brick stairs with limestone treads at a landing. Metal railings are set to either side of the steps. In each of the outer two bays are four grouped casement sashes with narrow mullions. The trim is flat stock. There is a typical window in each of the outer bays. At the center, high on the wall is a small octagonal window. The fenestration on both side elevations is minimal. At the west, there is a pair of small casements at the first floor, one in the north bay, and one in the addition as well as two at the second floor, spaced together at the center. Similar at the east elevation, there is the same at the first floor except one is a small typical sash, the other is a pair of typical sashes, and there are three windows spaced apart at the second floor. Constructed in 1968, the building is a vernacular residential building of the mid-20th century with some Colonial Revival detailing that was

The building would be considered a non-contributing resource in a proposed district due to its lack of architectural distinction for residences of its type and period, and for a construction period outside of the recommended period of significance.

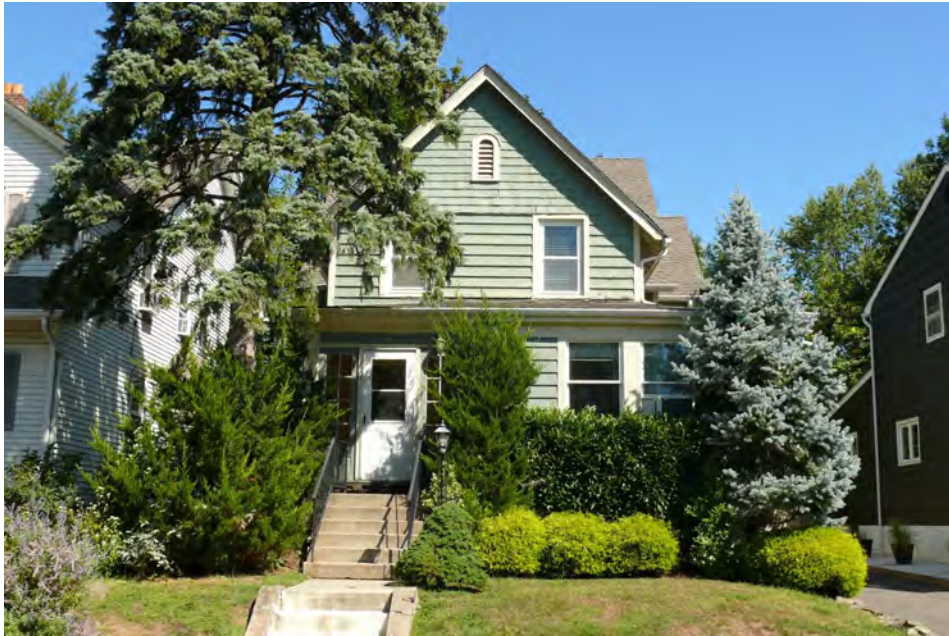
Property Photo:

This is a two-bay wide by three-bay deep, two-and-one-half story residence in the Craftsman style. The front of the building faces southwest toward Brookfield Road and the first floor is set several steps above grade. The building is set back from the street and on a shallow rise so there are concrete steps located off the sidewalk. A shared drive runs on the east side to a garage. The foundation is a painted rubble stone. The lower levels of the building are clad with wood clapboard siding with corner boards, and the gable ends are clad with wood shingles. The windows are one-over-one vinyl with flat-stock wood trim and a projecting wood sill. The roof is a cross gable with the front gable set lower than the side gable. There is a small gabled extension in the north bay on the east side that is inset from the larger gable. All the roofs are clad with asphalt shingles. The roof overhangs on all sides with the rafter tails exposed on the downward slopes. There is a slight detail molding at each point on the gable. The porch, which wraps almost fully to the east, abuts the gabled projection and is enclosed on all sides. It has a hip roof clad with asphalt shingles. The foundation is parged masonry. The body is clad similar to the main building. At the west bay is a storm door with two eight-light over one-panel sidelights with a full paneled transom. At the east end are a pair of typical sashes with a wide mullion. At the second floor there are two typical window openings in each bay of the gable end. A vent with a half-round head penetrates the gable peak. The fenestration on the west elevation is regular beginning at the second bay. The east elevation has more interest with the bump-out of the cross gable and the smaller second gable extension creating layers. There are single and paired windows across the entire façade including three masonry openings with sashes at the basement level. The garage is two bays wide with a side-gable roof clad with asphalt shingles. Only one bay is visible, and that section is concrete

Constructed in 1899, the building retains a high degree of architectural integrity. The most significant change is the enclosing of the front porch, but the detailing remains in keeping with the original building. A minor change is the painting of the masonry foundation. (The property was first mentioned in the 1910 city directory but this does not mean the property did not exist prior to 1910 because the earlier directories mentioned a limited number of street addresses and property owners.)

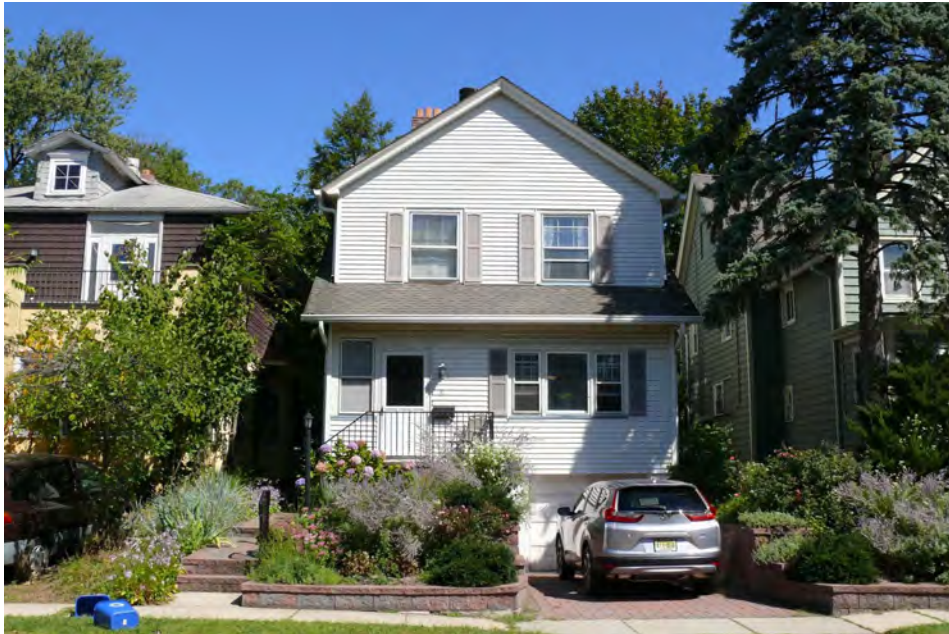
Property Photo:

This is a two-bay wide by three-bay deep, two-and-one-half-story single-family residence. The front of the building faces southwest and the first floor is set several steps above grade. The garage is under the east bay so the grade slopes down from the street here but steps up where a path leads to the front entrance. The foundation is parged masonry. The building is clad with vinyl siding with corner treatment. The windows vary. The trim is typically flat stock vinyl with an edge mold. The roof is a cross gable clad with asphalt shingles and a shallow boxed overhang. The entry at the first floor is located in the west bay. It consists of a wood door with storm and a one-over-one vinyl sash immediately adjacent to its west. In the east bay are three grouped openings with a center picture window and two narrow six-over-six sashes. A pent roof, clad with asphalt shingles that extends at least two feet beyond the face of the building, is set between the first and second floor levels. At the second floor there is a six-over-six wood-hung sash in each bay. The fenestration at the west elevation is not readily visible due to vegetation. The east elevation has regular fenestration with a boxed bay about center of the first floor.

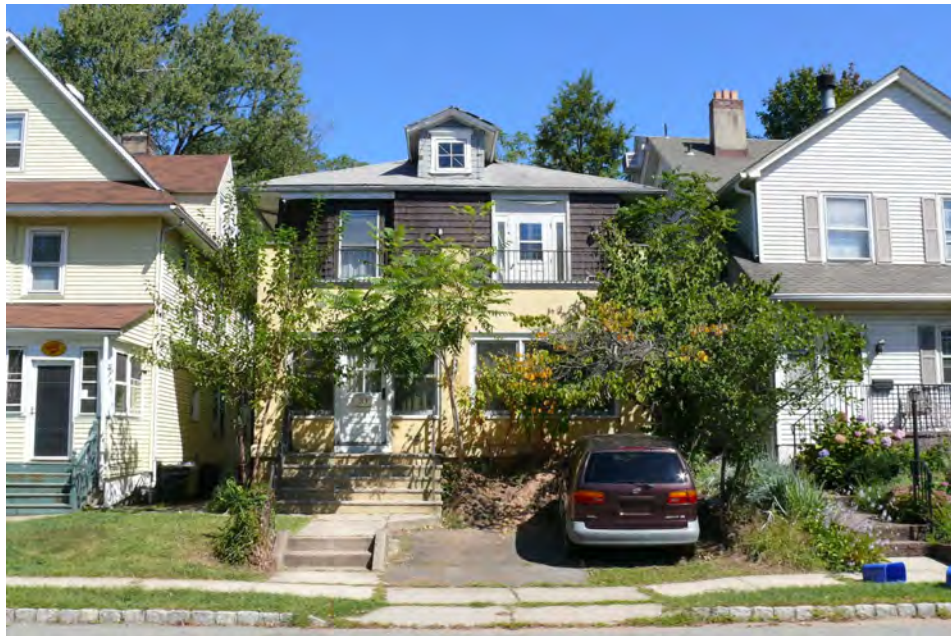
Property Photo:

This is a two-bay wide by three-bay deep, two-story single-family residence in the Craftsman Style. The front elevation faces southwest toward Brookfield Road and the first floor is set several steps up from grade. The building is set very close to its neighbors and has a shallow front that steps up, so that two steps are set off from the sidewalk. There is a drive that sits in front of the house on the east side. The foundation is parged masonry. The first floor is finished with stucco. The second floor is finished with shingles. The windows are typically one-over-one wood-hung sashes with exterior storms, with some exceptions. The trim is typically flat-stock wood. The roof is a low-slung hip clad with asphalt that overhangs about one foot with flush soffits. A small gabled dormer is set at the center that is clad with shingles and has a four-light casement with molded architrave. The first floor at the front is dominated by a one-story porch whose flat roof also serves as an open porch at the second floor. The porch is enclosed but historically the stucco has dominated the façade with three wide piers that extend to the second floor to frame the metal railing at the second floor porch. In the west opening is a low wall with a stone sill and a single one-over-one sash set to either side of the door. The door is four-light over three-panel wood. The stair leading to it is concrete with limestone treads with metal railings to either side. The east bay holds three grouped typical sashes. At the second floor, the west bay is partially recessed and there is a typical window centered in the recess. Centered at the east bay is a recessed door of two-lights over two panels with two one-light sidelights and a one-light transom. The west elevation carries the windows of the first floor at the porch. There is regular fenestration with the center bay bumped out.

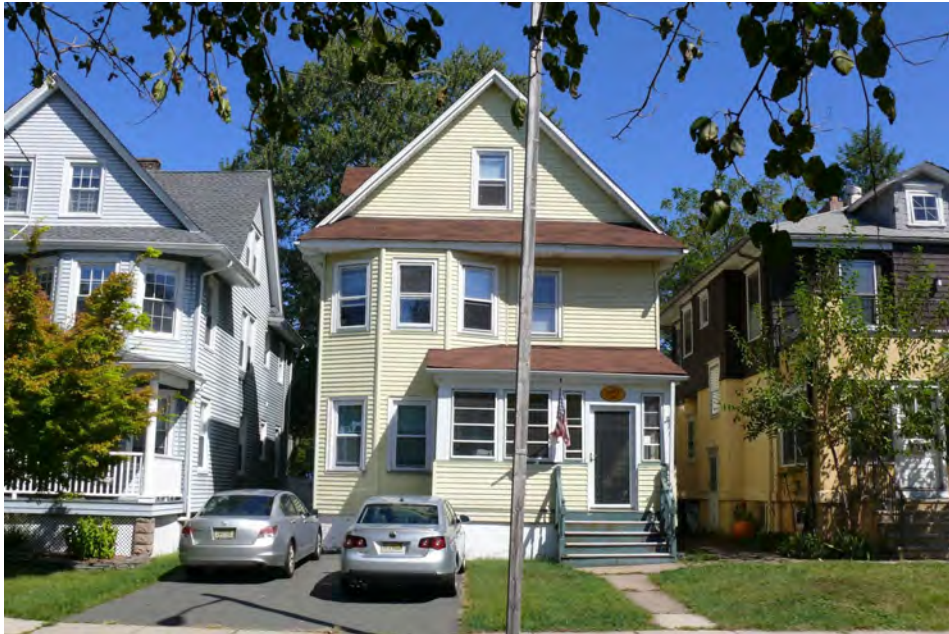
Property Photo:

This is a two-unequal-bay wide by three-bay wide, two-and-one-half story two-family residence. The front elevation faces southwest toward Brookfield Road and the first floor is set a few steps above grade. The front of the building is set slightly back from the sidewalk and there is a narrow drive set in front of the house. The foundation is parged masonry. The building is clad with vinyl siding with corner treatments. The windows are one-over-one vinyl sashes with narrow flat-stock vinyl trim. The roof is a front-gable clad with asphalt shingles and also extends beyond the gable end at the front to create a pent roof across the attic level. The roof overhangs on all side and the soffits are clad with vinyl. There are two gabled dormers on the west side and one on the east side. The west dormers each have a small typical sash and the east dormer has a pair of typical windows. The dormer sides and fronts are finished with vinyl siding. A two-story bay window projection occupies the wider west bay at the front elevation. There is a typical window in each exposed bay at the first and second floors as well as a three-light wood awning sash at the basement level centered at the bay projection. An enclosed porch occupies the narrower east bay at the first floor. It engages a third of the bay projection and has a shed roof clad with asphalt shingles. The roof is supported by three unequally-spaced clad posts set on a low wall, which is also clad with vinyl siding. The door is set in the narrower east bay and is simply a screen door. On either side of the door is a narrow, hung sash. Wood stairs lead to the door, and a wood railing with turned newels at the bottom stair, square newels at the top stair with a top and bottom rail and turned balusters between is set to either side. To the west of the door is a pair of hung sashes with narrow mullion. On the side of the porch, a pair of narrow sashes with mullion is set between the building face and corner post. Off-center at the second floor is a single typical window opening.

The Essex County tax records indicate a construction date of 1907 and this is confirmed by the city directories. The changes to the building, as evidenced by the architecture and similar neighboring properties, include the enclosing of the front porch, the application of synthetic siding, and the replacement of the windows.

This building is a "sister" to its neighbor, 37 Brookfield Road. The changes to the exterior cladding, replacement windows, and enclosing the porch are typical for the area and do not diminish the overall massing of the building. Additionally, its fenestration patterns have been retained and its position in the streetscape has been maintained; therefore, the building would be a contributing resource in the historic district.

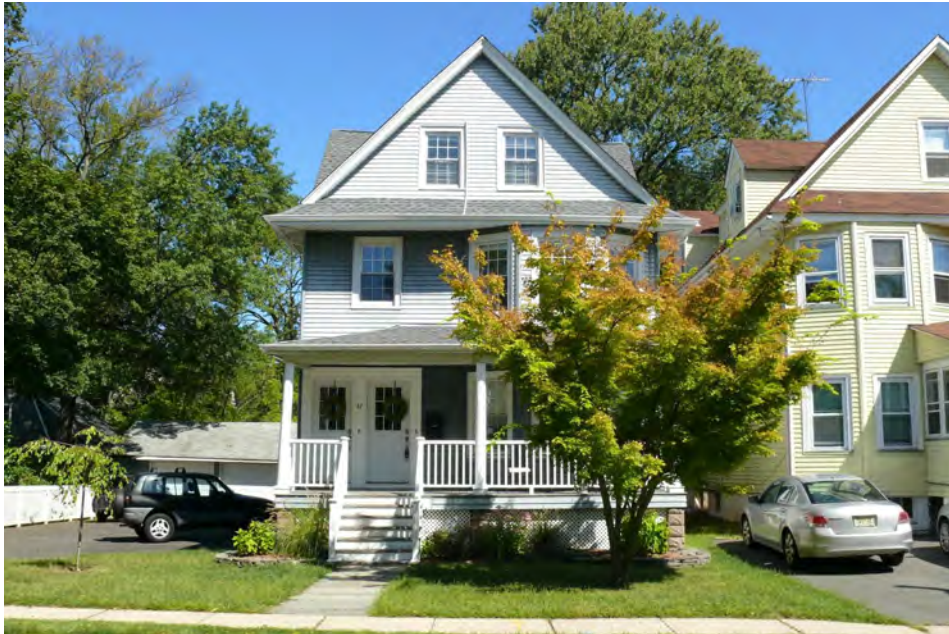
Property Photo:

This is a two-unequal-bay wide by three-bay deep, two-and-one-half-story, two-family residence. The front of the building faces southwest toward Brookfield Road and the first floor is set several steps above grade. There is a shallow lawn at the front and a wide paved area of property to the west with a two-car garage set to the rear property line. The foundation is rock-faced brownstone. The building is clad with vinyl siding with narrow trim pieces. The windows are one-over-one vinyl sashes with false muntins and flat stock vinyl with edge mold and narrow clad sills. The roof is a front gable clad with asphalt shingles, has a deep projection that creates a pent roof below the gable, and wide soffits clad with vinyl. There are two cross gables, set slightly catty-corner from each other and with gable returns on the west and east sides of the roof. The front gable has two typical sashes set apart. The west gable has the same fenestration and the east gable has a pair of typical sashes separated by a mullion. A one-story porch spans the entire front of the building. It has a hip roof clad with asphalt shingles supported by three equally-spaced round columns with no capitals and a plain rounded base with square pedestal that rest on rock-face brownstone piers. The stairs are set center of the west bay and are wood with railings that appear to be composite materials; the railings have square newels and top and bottom rails with square balusters. The railing is continuous with the balustrade that spans the open ends of the porch. The porch deck appears to be wood with a wood skirt board. The two main entrance doors are set in the west bay. Each is a nine-light over two-panel door with exterior storm set in a wide wood surrounded with outer beaded mold. A two-story bay projection occupies the east bay and is set under the porch at the first floor, and is roofed by the overhang of the main roof. Each bay projection has a typical window opening. Centered in the west bay at the second floor is a single typical window opening. The

The Essex County tax records indicate a construction date of 1907 and this is confirmed by the city directories. Based on recent images of the building, the front porch railings were recently installed. The application of the vinyl siding, and the replacement of the porch columns, windows and doors appear to be older, late-20th century changes.

This building appears to be a "sister" to its neighbor, 35 Brookfield Road. The changes to the building including the exterior cladding, replacement windows, and modification to the porch elements are typical for the area and do not diminish the overall massing of the building. Its fenestration patterns and its position in the streetscape have been retained; as such, the building would be a contributing resource in the historic district.

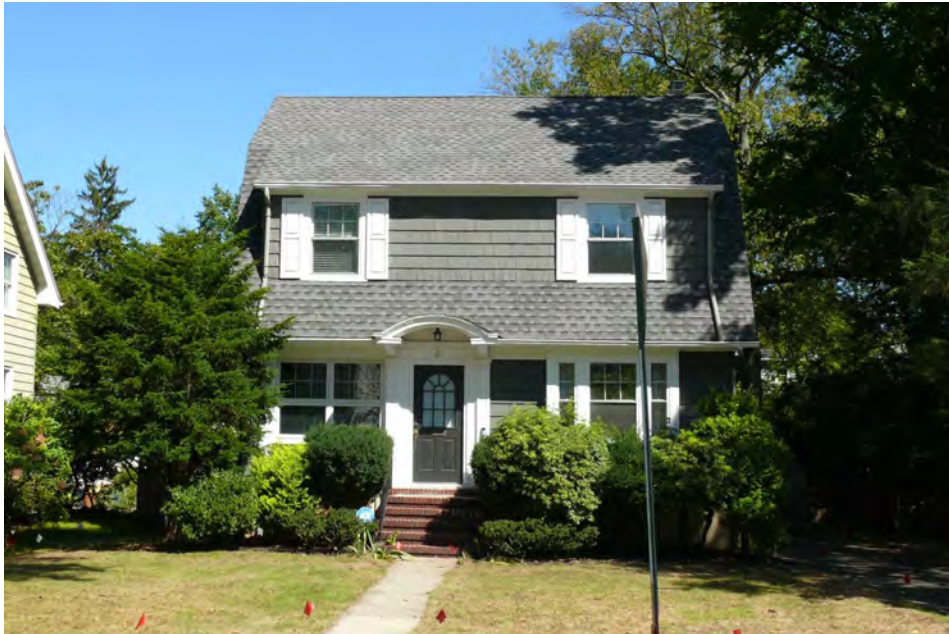
Property Photo:

This is a three irregular-bay wide by two-bay deep, two-and-one-half-story single-family residence in the Colonial Revival style. The front of the building faces southwest toward Brookfield Road and the first floor is set a few steps above grade. There is a stretch of lawn between the sidewalk and the front of the building and a narrow drive on the east side that leads to a garage located at the rear of the property. The foundation is parged masonry. The building is clad with shingles. The windows are typically six-over-one wood-hung sashes with flat-stock wood trim with a drip cap and a narrow, molded projecting wood sill. The roof is a side gambrel clad with asphalt shingles with an almost full shed roof on the front sloping side. The front entrance, distinguished by a half-round hood with molded cornice and slight return that is supported by wood brackets, is set off-center to the west on the front elevation. The entrance is a six-light wood door and a five-light fanlight above and two panels below. The surround is detailed with two paneled pilasters set with molded capitals and plinths that align with the brackets. Set in line with the molded cornice is the top of the architrave, which is detailed with a molded cornice and narrow dentils. Access to the door is via a brick stair with shallow stoop and a metal railing on one side. Set immediately adjacent to the door surround on the west is a pair of typical sashes separated by a narrow wood mullion. Centered in the east bay are three grouped sashes with a wide center hung sash flanked by two, narrow, two-over-one hung sashes separated by wide wood mullions. Centered in each of the outer bays is a typical hung sash. The west elevation has a regular fenestration pattern with a typical window in each bay at the first and second floors and a half-round window with six panes, and the same trim as the typical windows with the added feature of a keystone. The fenestration at the east elevation is slightly more irregular with a grouped basement window opening in the north bay and a

The Essex County tax records indicate a construction date of 1914 and a permit is pulled in 1915; the builder is F.B. Herman Fayen. The building overall appears little changed since original construction. The front door may be newer material fabric and there are noticeable repairs to the front stairs.
