INTENSIVE-LEVEL ARCHITECTURAL SURVEY

WHEELER STREET AND OAKCROFT RESIDENTIAL AREAS
Township of Montclair, Essex County, New Jersey

OAKCROFT RESIDENTIAL AREA SUPPLEMENT

Project No. 1915C

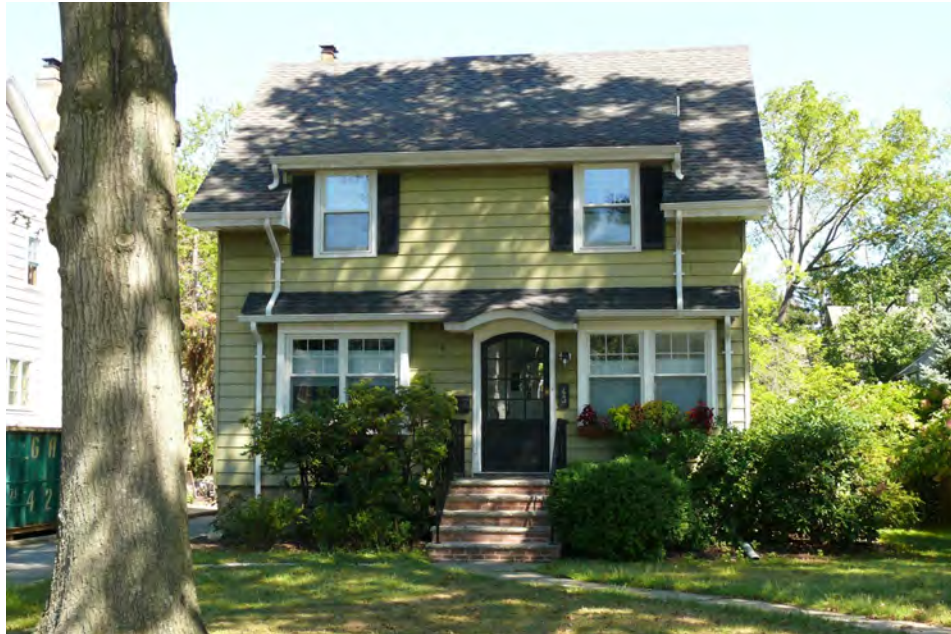
Property Photo:

This is a three irregular-bay wide by three-bay deep, two-and-one-half-story single-family residence in the Colonial Revival style. The front of the building faces southwest toward Brookfield Road and the first floor is set a few steps above grade. There is a stretch of lawn between the sidewalk and the front of the building and a narrow drive on the west side that leads to a garage located at the rear of the property. The foundation is parged masonry. The building is clad with aluminum siding with a corner treatment. The windows are typically one-over-one hung sashes with false muntins in a six-over-one pattern. The trim is aluminum with an edge piece and a narrow sill. The roof is a side-gable clad with asphalt shingles and has an overhang on all sides with plain boxed cornice and aluminum clad soffits. An almost full shed dormer is set at the center of the front of the roof. Set between the first and second floors, almost full width, is a shallow pent roof clad with asphalt shingles and an aluminum-clad soffit. The front entrance, distinguished by a segmental-arched hood with flare and molded cornice set just below the cornice of the pent roof, is set off-center to the east on the front elevation. The door has a segmental arched head with a wide surround with inner and outer bead. The door is a 12-light over three-panel wood door and is accessed by brick stairs with limestone treads and metal railings set to each side. Set immediately to the east at the first floor is a pair of typical sashes separated by a narrow mullion. About center of the west bay at the first floor is the same paired sashes. At each end of the dormer at the second floor are typical single windows. A stucco-clad chimney is set toward the north on the west elevation. There is a series of typical sashes at each floor of varying sizes: three grouped basement sashes, and a fan at the gable end. There is a one-story extension with a shed roof set on the north elevation. The east elevation is similarly detailed with paired and single windows in each bay

The Essex County tax records indicate a construction date of 1914 and a permit is pulled in 1915; the builder is F.B. Herman Fayen. The changes to the building include the application of aluminum siding and trim, the replacement of the windows, and a small one-story addition at the rear of the building. The stairs to the front door have been rebuilt over time.

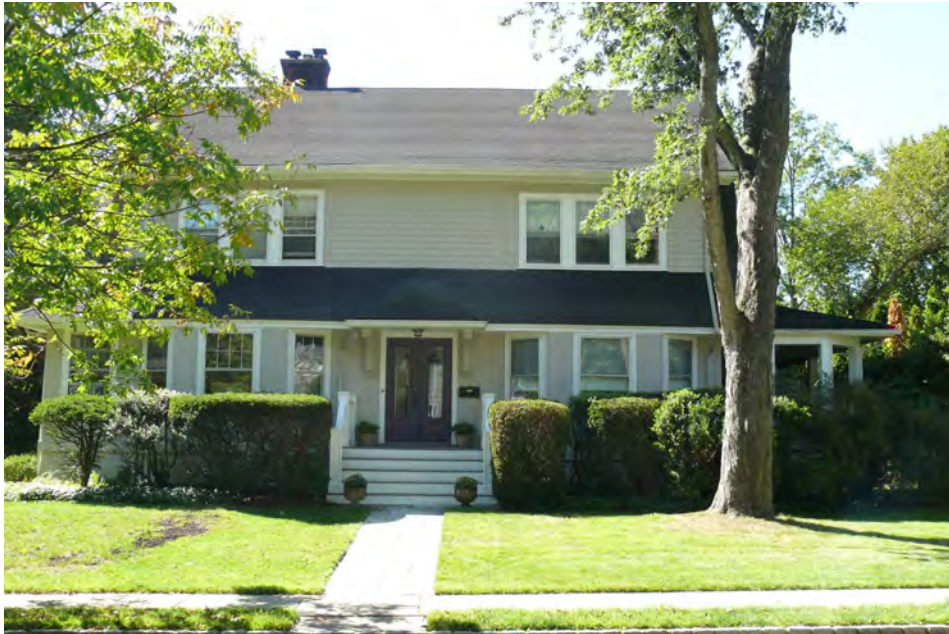
Property Photo:

The building is four-bays wide by two-bays deep, two-and-one-half story single-family residence with Colonial Revival style detailing. The front of the building faces northwest toward Godfrey Road and the first floor is set several steps above grade. The foundation is parged masonry. The first floor is clad with stucco with a stucco-clad water table. The upper part of the building is finished with wood shingles. The windows are typically multiple-light over one wood-hung sash. The trim is flat stock with an outer molded edge and narrow projecting wood sill. The roof is an expansive side gambrel with a shed dormer set from the break at the roof on both the front and back sides. The main roof and dormer roof overhangs on all side with a molded cornice and rake. Both roofs are clad with asphalt shingles. The dormer side walls are wood shingle and there are three grouped six-over-one wood-hung sash set at each end bay. A brick chimney is set in the east bay on the back side of the roof. The door is set center of the main block. It has a tall hip roof that aligns with the eave of the main roof and it is supported by two stucco-clad brackets to either side of the double wood doors of one-light over one-panel each. A wide wood stoop with stairs leads to the front door. Substantial railings are set to either side; they are composed of paneled newels with a top and bottom rail and square balusters. To either side of the door are bay window projections. The center bays have eight-over-one hung sash and the sides have six-over-one hung sash. A one-story extension is set on the east side. It has a hip roof that aligns with the eave of the main roof. An eight-over-one wood-hung sash is set center and three of the same are set on the east side separated by wide wood mullions. A box projection is set at the south end at the second floor, it has a gable roof with its south downward slope aligned with that of the main roof. It is clad with wood shingles. It is supported by a stucco clad extension to the front and it has three small four-over-one

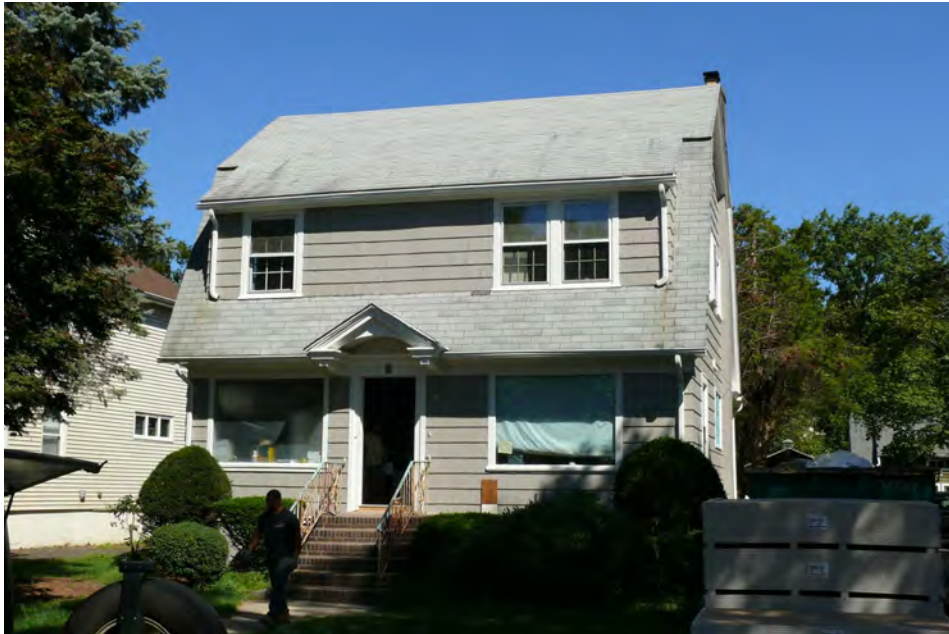
Property Photo:

This is a two-unequal-bay wide by three-bay deep, two-and-one-half-story single-family residence in the Colonial Revival style. The front of the building faces southwest toward Brookfield Road and the first floor is set several steps above grade. There is a section of lawn at the front and a drive set to the east of the house leading to a garage at the rear of the property. The foundation is parged masonry. The building is clad with wood shingles. The windows are typically six-over-six wood-hung sashes with some exceptions. The trim is typically flat-stock with a drip cap and a narrow projecting wood sill. The roof is a side gambrel with a shed roof extending almost the full width at the front of the building. The roofs are clad with asphalt shingles and the roof overhangs slightly with cornice returns at both gambrel ends. The front door is set off-center to the west and is delineated by a gabled hood with molded cornice including a return and an arched inner molding that is supported by a shallow wood bracket. The brackets are set to either side of the door surround, which has deep molded architrave and molded trim at the jambs. A brick stair with metal railings leads to the front door. Set near to the door assembly on the west side is a large opening of a single pane of glass. Set center of the east bay at the first floor is the same, a single pane of glass in a large frame opening. At the second floor, a single typical sash is set at the west edge of the dormer and a pair of windows with wide wood mullion is set at the edge at the east end of the dormer. There is a single typical sash in each of the outer bays at the first and second floor with one anomaly: a clerestory window in the south bay at the first floor. There is also a wood fanlight window with a keystone at the gable end. At the east side, the first floor window in the south bay was in the process of being changed. Three three-light casement sashes are located in the rear bay at the first floor; this is an older window. There are three typical sashes, one large and two

This building is a "sister" to its neighbors, 41 and 43 Brookfield Road. As of the preparation of this survey, the building would be considered a contributing resource in the historic district. It should be noted that the building was undergoing major renovations and this designation may change depending on the changes made to the building. This building has experienced more changes to its fenestration than its two "sister" neighbors especially at the front elevation.

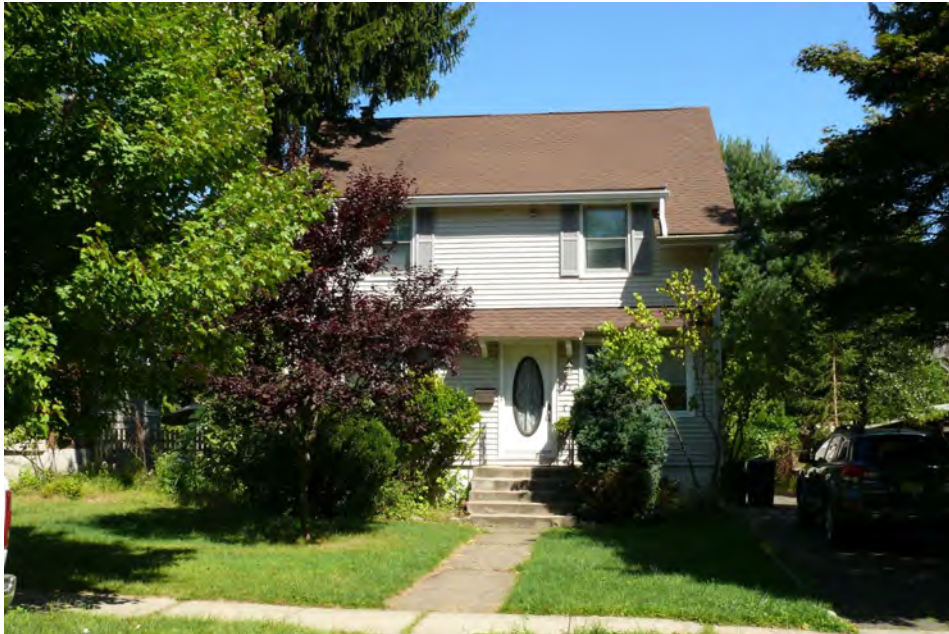
Property Photo:

This is a three-irregular-bay wide by three-bay deep, two-and-one-half-story single-family residence in the Colonial Revival style. The front of the building faces southwest toward Brookfield Road and the first floor is set a few steps above grade. There is a stretch of lawn between the sidewalk and the front of the building, and there is a narrow drive on the east side of the property. The foundation is parged masonry. The building is clad with vinyl siding with a corner treatment. The windows vary but are typically trimmed with narrow vinyl with a slightly projecting clad sill. The roof is a side gable clad with asphalt shingles and with an overhang on all sides with a sloping soffit at the front and rear and clad soffits at the gable end. An almost full shed dormer, similarly treated as the main roof, is set at the center of the front of the roof. Set between the first and second floor levels, almost full width, is a shallow pent roof clad with asphalt shingles and sloped soffit. The front entrance, distinguished by an extension of the shed pent roof supported by angled wood brackets, is set off-center to the east on the front elevation. The door is a modern metal with oval glass at the center and flat stock trim. The entrance is accessed by parged masonry stairs, and there are metal railings set only at both sides of the landing. Set immediately to the east at the first floor is a large sliding sash window. Set about center of the west bay at the first floor is a slight bow window with three vinyl casement sashes. At each end of the dormer at the second floor are typical one-over-one hung sashes with false muntins. A stucco-clad chimney is set toward the north on the west elevation. There is a series of hung sashes of varying sizes at each floor level: three grouped basement sashes and a small three-light casement sash at the gable end. There is a two-story extension with gable roof set on the north elevation. The east elevation is similarly detailed with the same sliding sashes in the south bay at the first floor, a single sash at each of the remaining bays at

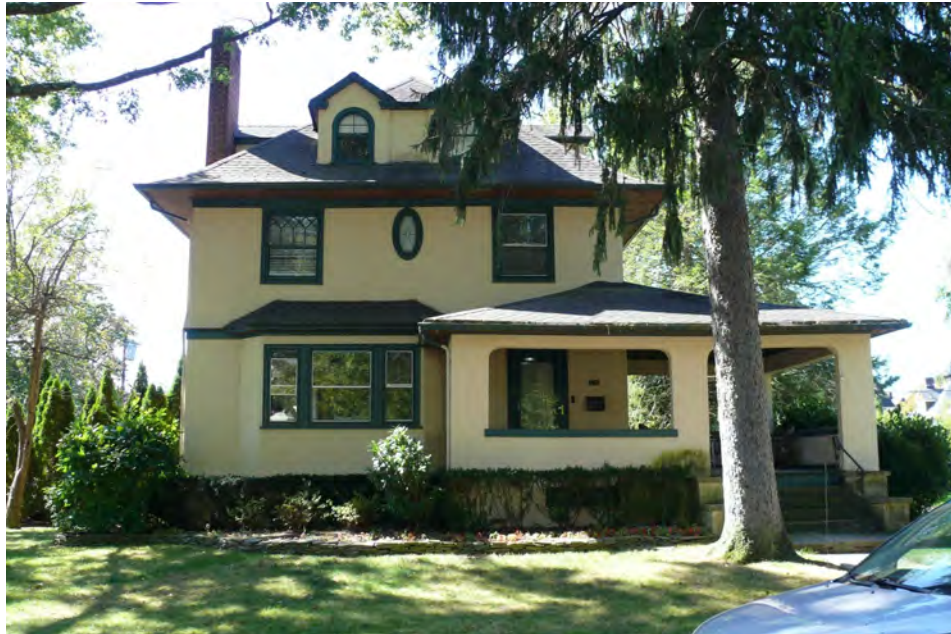
Property Photo:

The Montclair Times noted building permits were issued for this house in June 1909 and the cost of construction was to be \$7,000. The changes to the building include replacement of the sashes and the one west side extension; the present rear extensions appear original to the building.

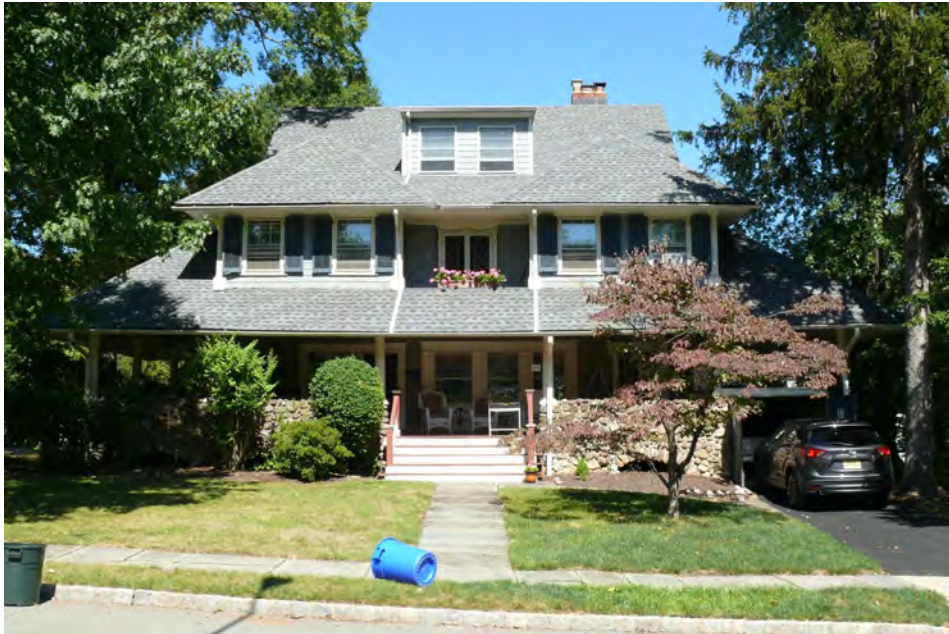
Property Photo:

This is a three-bay wide by two-bay deep, two-and-one-half story single-family residence in the Shingle style. The front elevation faces southwest toward Brookfield Road and the first floor is set several steps above grade. The building has a fieldstone foundation in a random ashlar pattern. The body of the building is clad with wood shingles with noted exceptions. The windows are typically six-over-one wood-hung sash with noted exceptions. The roof over the main block is a side gable with two projections in each of the outer bays that have hip roofs set perpendicular to it; the ridges of the hips are set lower than the main roof but the wide overhanging eaves align. There is a shed dormer set center of the roof above and between the two hips. It is clad with vinyl shingles and have two one-over-one wood-hung sash set apart. A large expansive porch extends beyond the body of the building at the first floor. To the west, the added bay is a continuation of the porch. To the east, the added bay is a porte-cochere, which has been infilled for a wood-frame garage. All elements are set under a hip roof that is supported by Doric columns set on a stone wall of fieldstone that is un-coursed. The same wall and column configuration is carried to the east side of the porte-cochere supporting the roof over it. Centered on the porch are wood stairs with a substantial wood railing with newel posts at the top and bottom of the stair both sides. The railing has a top and bottom rail with turned balusters between. Set under the porch, off center in the west bay, is a typical window that is set next to the front entrance door. The assembly is trimmed with flat stock wood and a shallow architrave with molded top. Set off-center of the center bay are three grouped typical sash, the west sash is slightly wider than the center and east sash. There is a fluted pilaster at the jambs and serving as the mullions; these support a deep architrave with a molded top. Off-center of the east bay is a pair of 15-light doors with a similar surround to

the main entrance. Under each of the hip roofs, the second floor projects from the center bay. Two typical windows are set center of each of these projections; each is trimmed with flat stock wood with a narrow projecting wood sill and the trim is set directly under the eave. The recess at the center creates a small porch set behind the roof of the porch below. Centered on this bay is a pair of inswing doors with diamond panes and the same surround as found at the main entrance door. Both sides are masked by the sweeping overhangs of the porch roof limiting visibility to the gable ends, each have a pair of typical sash with narrow molded architrave set apart at the center. Constructed in 1902, the property is first mentioned in city directories in 1910; this means the property was at least constructed by 1910 but could well have been earlier as the directories prior to 1910 were more limited in their references to street addresses and property owners. The house probably, given its style, originally had a wood-shingle roof; the roof is a prominent feature and the current shingles are visually distracting but reversible. The treatment of the dormer windows and side walls with vinyl shingle and trim are a prominent change on the front elevation. The wood railing, as detailed, are incongruous with the Shingle style and appear to be newer material fabric. The added garage is older and almost unnoticeable from the street. The 1981 Historic Sites Inventory noted that the house is interesting architecturally, one of the earliest buildings on the street, and unique to the neighborhood. The building has been little changed since original construction other than the noted changes above and a possible rear deck noted in the inventory but not readily visible from the street. 65 Brookfield Road, given its construction date and level of architectural integrity, would be a contributing resource in the historic district.

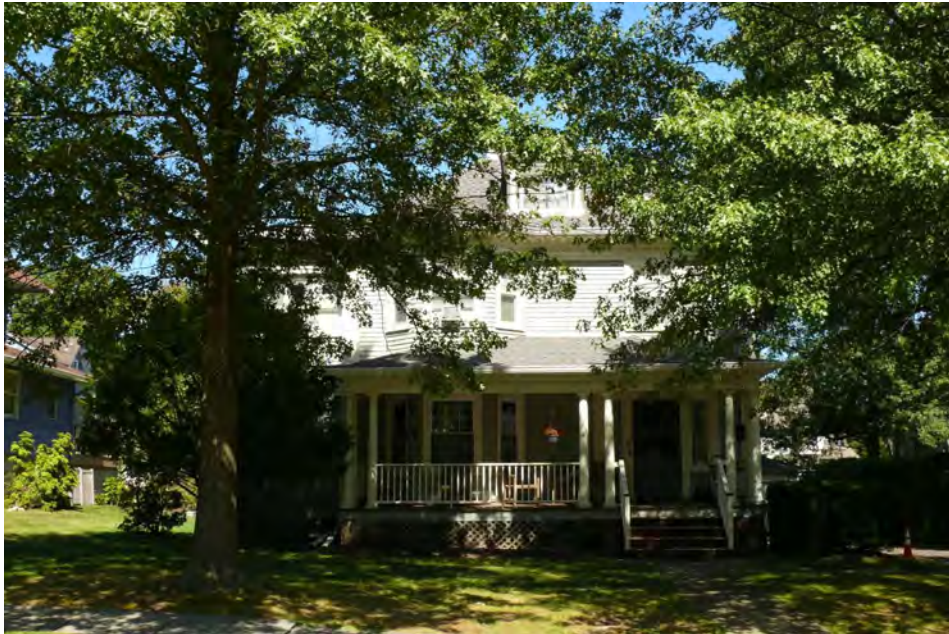
Property Photo:

This is a three-bay wide by three-bay deep, two-and-one-half story single-family residence with Neo-Classical detailing. The front of the building faces southeast toward Brookfield Road and the building is set a few steps above grade. The foundation is red brick masonry. The building is clad with wood clapboards and there is wood ornament that will be described in the body of the description. The windows are six-over-one wood-hung sashes. The trim is flat-stock wood with a molded outer edge and a narrow wood sill. The roof at the main block is a truncated hip with a substantial overhang detailed with an elaborate wood cornice. The cornice is supported by narrowly spaced molded corbels set on a deep entablature that is detailed with dentils about upper-mid span. Centered on each side of the hip is a hip-roofed dormer. The side walls are wood clapboard. The fronts are treated with flat boards with a slender fluted pilaster set to each side of the window opening; the windows are six-over-one hung sashes. The main roof and those of the dormers are clad with asphalt shingles. There is a brick chimney set to the rear of the hip roof. On the west side there is a two-story extension set on brick piers. The roof appears to be a low slope set behind the same cornice as the main roof but there is an added upper piece that is difficult to discern its purpose. As a result, this extension has an awkward transition with the main roof despite sharing a cornice entablature. A one-story porch extends across the front façade of the main core. It has a hip roof with similar cornice entablature as the main roof and is supported by tripled slender Doric columns at the two outside corners, and a pair of columns at a third span of the roof in line with the east bay of the entrance at the main block. The deck is wood supported by brick piers. The wood stairs are set at the narrower east bay. The stairs and porch are enclosed by wood railings with square newels, top and bottom rail, and square balusters. Set under the deck is wood lattice. In

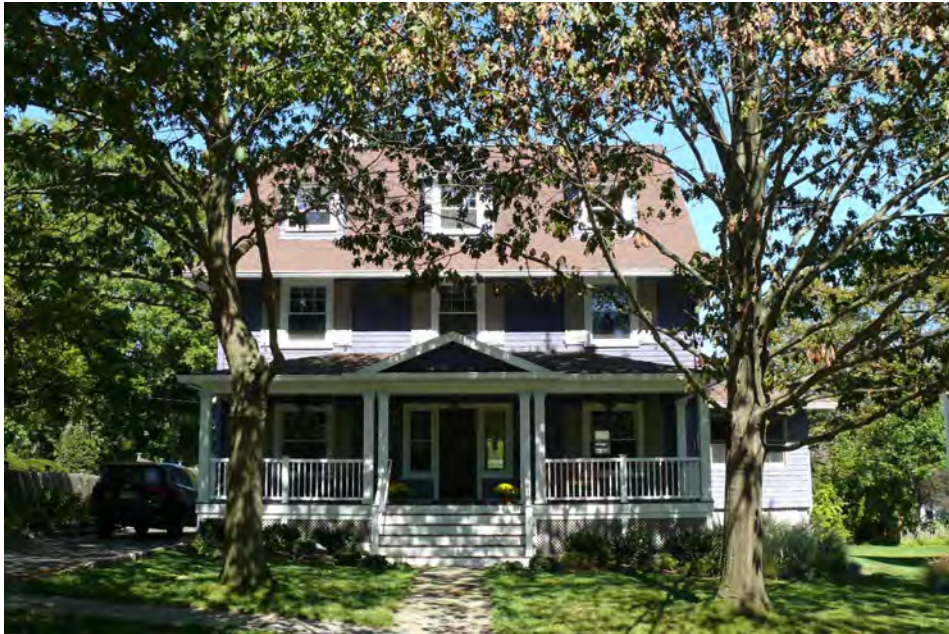
Property Photo:

This is a three-bay wide by two-bay deep, two-and-one-half story single-family residence with Colonial Revival influences. The front of the building faces southeast toward Brookfield Road and the first floor is set several steps above grade. The foundation is fieldstone masonry in a random ashlar pattern. The building is clad with wood shingles with mitered corners. The windows are one-over-one hung replacement sash with false muntins. The trim is flat-stock wood with a drip cap and narrow wood sill. The roof is a side gable with overhang and boxed soffit that is carried to the sides to create shallow pent roofs at each gable end. There are three dormers equally spaced apart on the main roof. The end dormers have shed roofs with a sweep from their roof overhang to where it meets the main roof. The center dormer has a gable roof with simple rake. The gable dormer stands taller than the shed dormers but each has a hung sash proportional to the height of the dormer. All roofs are clad with asphalt shingles. A one-story porch spans across the first floor. It has a hip roof with a center gable with full return and recessed tympanum. The roof is supported by single square columns with molded top and plinths at each corner and paired to align with the ends of the gable. Wood stairs are set at the center of the porch. The stairs and porch have railings with square newels, top and bottom rails, and square balusters. The underside of the porch is enclosed by wood lattice. The main entrance is set center of the main house. It is composed of a wood paneled door with partial-height, leaded-glass sidelights in a plain wood surround. In each of the outer bays is a hung sash window opening. The same fenestration pattern is applied to the second floor with one window opening of a single hung sash in each bay. To the east is a one-story, one-bay-wide by three-bay-deep extension. It is set on painted brick piers with a wood enclosure underneath. It has a hip roof clad with asphalt shingles that has a slight overhang. There

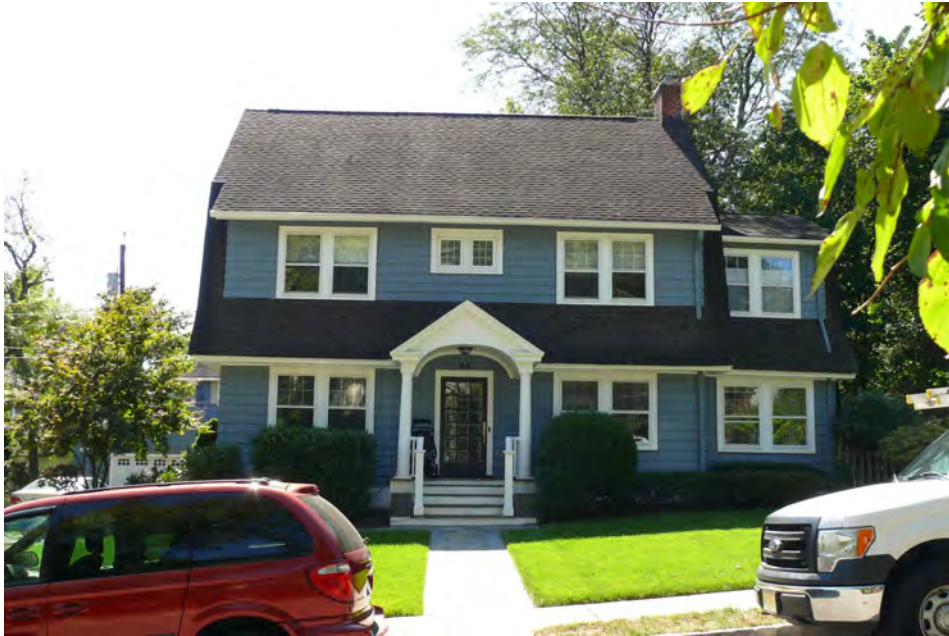
Property Photo:

This is a three-bay wide by two-bay deep, two-and-one-half story, single-family residence in the Colonial Revival style. The building occupies the corner of Godfrey Road and No. Mountain Avenue and the grade rises slightly to the west to align with the higher elevation of No. Mountain Avenue. The front of the building faces northwest toward Godfrey Road and there is a drive set on its east side with a slight retaining wall. A garage is set to the rear of the property. The first floor is set several steps above grade. The foundation is parged masonry. The building is clad with wood clapboards with mitered corners. The windows are typically six-over-one wood-hung sashes with some exceptions. The trim is flat-stock wood with a molded outer edge and inner bead and a narrow wood sill. The roof is a side gambrel with a full return at each end supporting a pent roof. A shed dormer spans much of the front elevation and it is also clad with wood clapboards. The main entrance is set center of the main block at the first floor and consists of a fifteen-light wood door. The entrance is delineated with a gabled roof hood with molded cornice and return to frame a curved ceiling with flush tympanum above. This roof is supported by two Doric columns with molded capitals and bases set at each side that rest on a wood deck supported by parged masonry piers. A wood stair is set center between the columns and a railing is set to either side of the stair and landing. The railing is detailed with square newels, has a top and bottom rail, and square wood balusters. To either side of the entrance in each outer bay is a pair of typical windows with wood mullions. The same fenestration pattern is carried to the dormer with paired sashes in the outer bays and a pair of nine-light casements with narrow mullion centered above the door. To the west is a two-story extension set slightly to the rear of the front façade. The roof over it is a side gambrel inset of the main gambrel with a shed dormer matching that of the main dormer. At the first and

Constructed in 1918, the most significant change is the rear addition, which was at least partially constructed prior to 1986, but based on the map evidence expanded further west since that time. As noted above, it does not diminish the architectural detailing and massing of the original building.

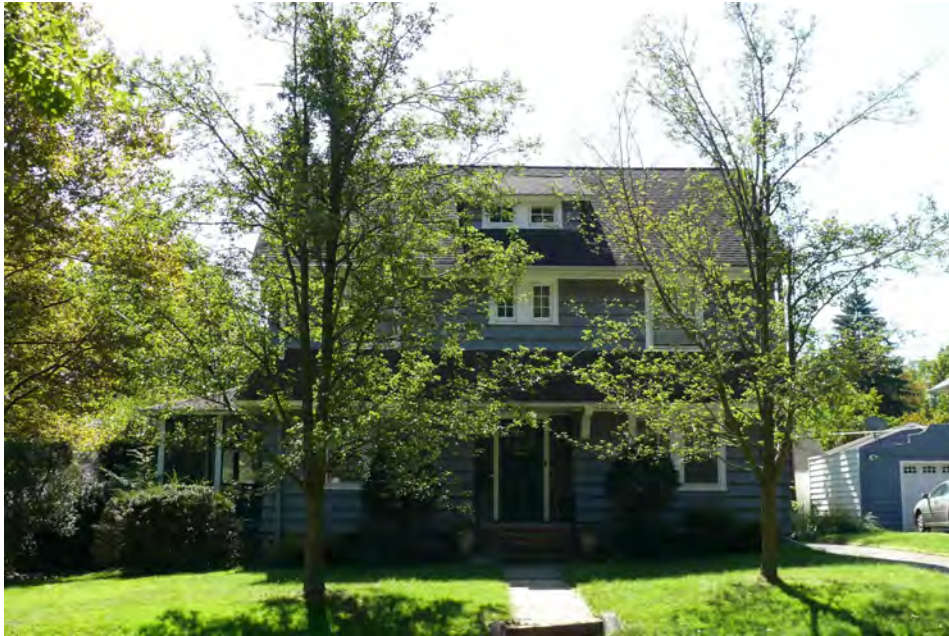
Property Photo:

This is a three-bay wide by two-bay deep, two-and-one-half story single-family residence with Colonial Revival influences. The front of the building faces northwest toward Godfrey Road and the first floor is set a few steps above grade. The foundation is parged masonry and the building is clad with wood clapboard with mitered corners. The windows are six-over-one wood-hung sashes with flat-stock trim with a beaded outer edge and narrow wood sill. The roof is a side gable with a slight overhang on all sides and boxed soffits. There is a shed roof dormer set center of the main roof. Its sidewalls are clad with shingles and there are two four-light wood casements set center with a mullion. A brick chimney is set abreast of the east side wall. A pent roof is set on each side of the building between the first and second floors and has a deep soffit. All roofs are clad with asphalt shingles. The front entrance is centered at the first floor. The eight-light over panel wood door is set in a wide recess. Over the entrance, a shallow hip roof projects beyond the pent roof and is supported by molded wood brackets set to either side of the recessed opening. The landing for the door is set within the recess, and brick stairs with limestone treads are set between two low walls aligned with the brackets above. To either side of the door in the two outer bays are pairs of typical sashes. At the second floor there is a single typical sash in each outer bay and at the center above the door are two small six-light casements with a wide wood mullion. To the east is a one-story screened-in porch with a hip roof that aligns with the pent roof. The hip roof is supported at each corner by square posts with an intermediate mullion to support the frames of the screens that go from floor to underside of roof. Forward of this porch in the first bay is a typical sash. At both the second floor and attic are single windows set to either side of the chimney. There appears to be a rear extension but it is not readily visible from the street. The west elevation has more varied

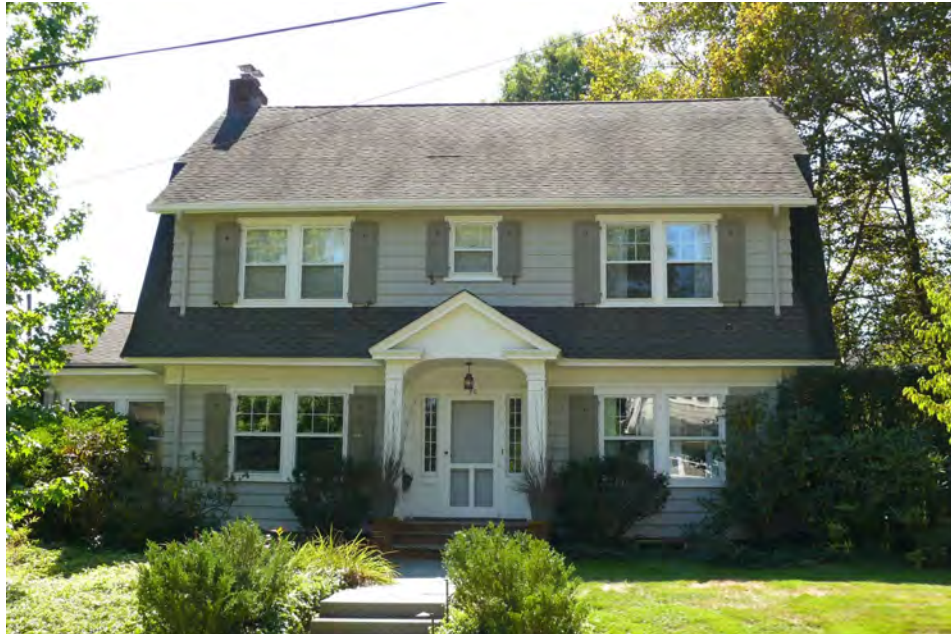
Property Photo:

This is a three-bay wide by three-bay deep, two-and-one-half story, single-family residence in the Colonial Revival style. The front faces northwest toward Godfrey Road. The lawn is set a few steps above the sidewalk and the first floor a few steps above grade. A drive is set on the east side of the property leading to a garage. The foundation is parged masonry. The building is clad with wood clapboard siding with mitered corners. The windows are six-over-one wood-hung sashes with flat-stock trim with beaded outer and inner edges and narrow wood sill. The roof is a side gambrel with an almost full shed dormer at its front. The main roof returns to create a pent roof at each gambrel end between the first and second floors. Set under the deep board soffits is a narrow entablature with a beaded detail along its lower third. A brick chimney is set abreast of the east wall centered at the ridge. The front entrance is centered on the main block and is composed of a paneled door with 12-light-over-one-panel sidelights and a fanlight at the transom that is detailed in wood (no glass). Over the door is a gabled hood with cornice return and a relieved arched ceiling set below a flush tympanum. The hood is supported by two square posts with inset panels, molded cornice, and plinth, and the cornice is aligned with that of the main roof. There are corresponding pilasters flanking the entrance door. The posts rest on a brick stoop and stair with bluestone treads and low sidewalls. To either side of the door in each of the outer bays at the first floor is a pair of typical sashes. The same pattern is repeated at the second floor with two pair of sashes in the outer bays and a single small window centered over the door. On the east elevation is a one-story extension with a gable roof with matching cornice and entablature. There is a pair of typical sashes on the front and what looks like three windows at the east side of the extension. There is fenestration in each bay at the upper floors, with smaller sash at the attic to either side of the

chimney. The west elevation has a window in each bay at the second floor and a pair of sashes at the attic; the first floor is covered with vegetation. The garage is two bays wide with a hip roof and has a single door of multiple panels with the upper panels being lights. Constructed in 1917, there are no obvious changes to the building. 40 Godfrey Road is a fine example of a Colonial Revival residence. The most interesting aspects or finely tuned details can be found at the front entrance in terms of the detailing of the cornice, tympanum, ceiling, columns with corresponding pilaster, and door surround with molded fanlight transom. This building would be a contributing resource in the historic district.

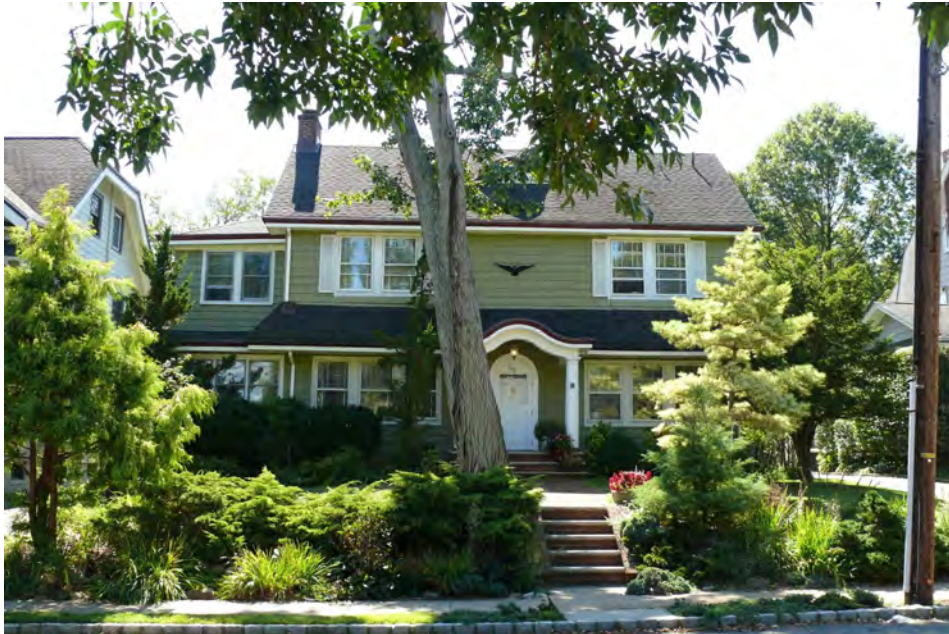
Property Photo:

This is a three-bay wide by two-bay deep, two-and-one-half story single-family residence with Colonial Revival style influences. The property sits on a slight rise with brick stair leading from the sidewalk along the front. A driveway is set to the west side and leads to a garage at the rear. The front elevation faces northwest toward Godfrey Road and the first floor is set a few steps above grade. The foundation is red brick. The building is finished with vinyl siding with a corner treatment. The windows are six-over-one wood-hung sashes with exterior storms. The trim is narrow flat stock with molded edge and narrow wood sill. The roof is a side gable with a built-in gutter and cornice return. There is an eyebrow dormer with fanlight at the center of the roof and a brick chimney centered on the gable at the east side. A deep projecting pent roof is set the perimeter of the building between the first and second floors. It has a similar simple cornice with flush board soffits. All roofs are clad with asphalt shingles. Centered at the main block is the front entrance. It is set under a curved roof with the cornice aligned with the pent roof and supported by two Doric columns with molded capitals and bases. The entrance stoop and stairs are brick with limestone treads. The door, which is wood paneled, is set in a half-round arched opening with flat-stock trim with a molded outer edge. In each of the outer bays at the first floor are three grouped typical sashes separated by wide wood mullions. There is a two-story extension on the east side that is set slightly back from the front, has a shallower pent roof at the second floor level and a hip roof. The cornices of the pent roofs align but not that of the hip roof with the main roof. At the first floor there are three, one-over-one hung sashes set center with narrow mullions. In each of the two outer bays at the second floor of the main block are paired typical sashes with wide mullions. In the center of the east extension are paired one-over-one hung sashes with narrow mullion.

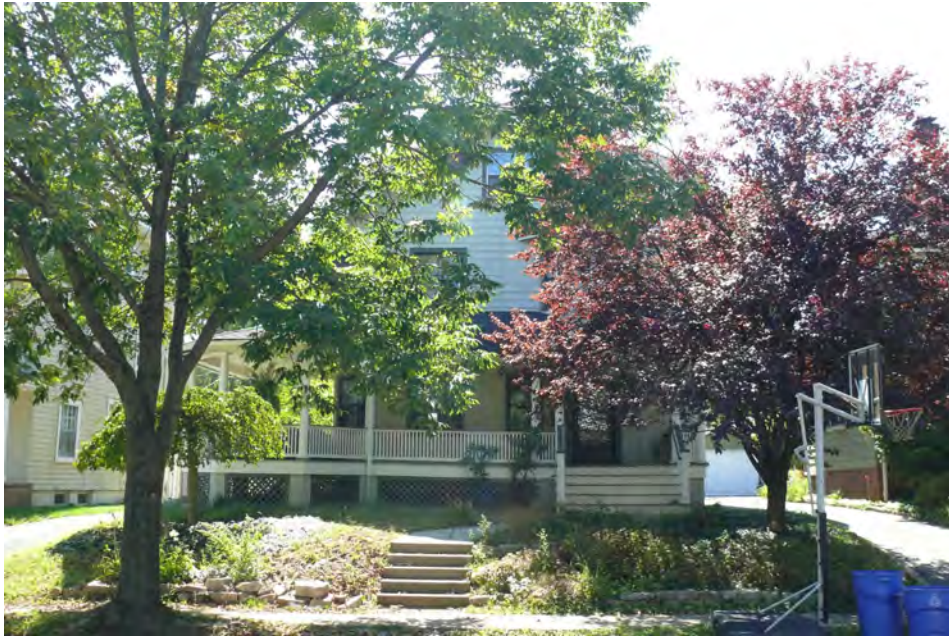
Property Photo:

This is an irregular two-bay wide by two-bay deep, two-and-one-half story single-family residence in the Craftsman style. The property is set on a low rise with stone steps leading to the front from the sidewalk. The driveway is set on the west side of the property. The front elevation faces northwest toward Godfrey Road and the first floor is set several steps above grade. The foundation and first floor are finished with stucco with a stucco-clad water table set above the foundation. The upper floors are finished with wood clapboard with narrow corner board. The siding has a slight flare where it sits over the stucco finishes. The windows are typically multiple-light over one-light wood sashes with exterior storms. The trim is flat stock with a molded outer edge and narrow sill. The main roof is a side gable with jerkinhead treatments at each end. At the front there is a large cross gable also with a jerkinhead. Both roofs, clad with asphalt shingles, have a deep overhang with a deep rake and dentils at the edge with the shingles. The soffits are flush boards. A brick chimney is set about center of the main roof. At the first floor there is an all-encompassing porch that extends one bay east of the main block. The east bay has a three-sided angled front, a deeper east bay, and connects with the straight section along the front of the main block. This projecting bay section has a hip roof. In the west bay the roof transitions to a jerkinhead with stucco and half-timbering in the gable end. Between these two roofs is a shed roof. The entire assembly is supported by slender Doric columns with molded capitals and bases set on the wood deck and supported by parged masonry piers with lattice set between each pier. There is one column at each bend or corner of the bay projection. There is a pair framing the entrance in the west bay with a triple at the outside west corner. Between the columns is a wood railing with top and bottom rail with square wood balusters. The stairs leading to the porch are wood with a similar railing on both

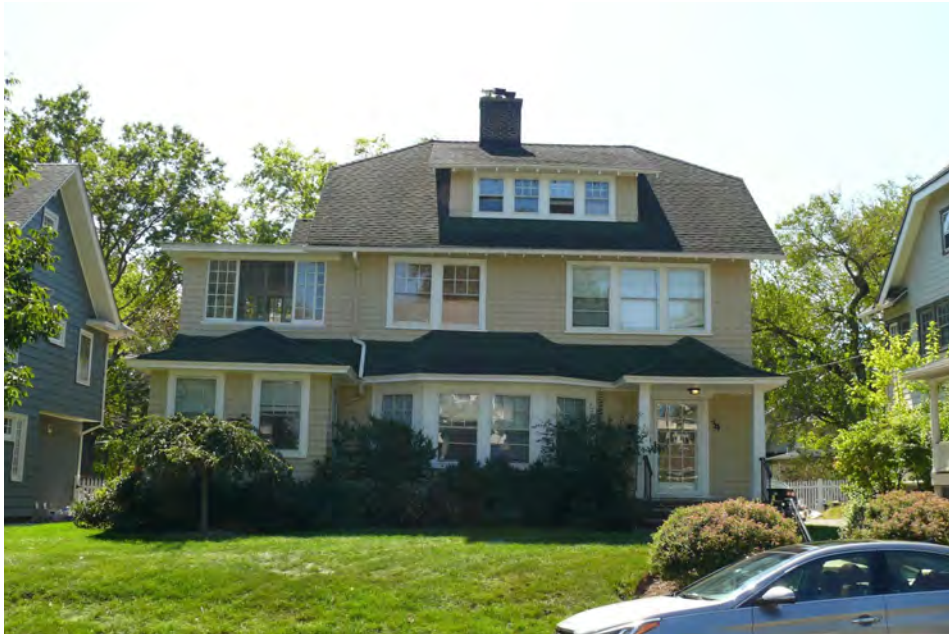
Property Photo:

This is a two-unequal-bay wide by two-bay deep, two-and-one-half story single-family residence with Craftsman style influences. The front of the building faces northwest toward Godfrey Road. The lawn is set on a slight rise along the street with brick stairs with limestone treads set at the sidewalk. The first floor is set a few steps above the lawn. A drive is set on the west side of the property. The foundation is parged masonry. The body of the building including the additions is finished with wood shingles. The windows are typically six-over-one wood-hung sashes with flat-stock trim with edge molding, inner bead, and a narrow wood sill. The main roof is a side gable with jerkinhead treatment at the gable ends. The roof overhangs on all sides, and the rafter tails are exposed at the downward slope and purlins at the overhanging eaves at the jerkinhead. There is a shed-roof dormer at the center of the roof also clad with shingles and with exposed rafter tails. Set behind the dormer to the east is a brick chimney. The front entrance is set in the west bay at the first floor of the main block. The entrance is a 15-light wood door with storm set in a molded surround with shallow architrave. A steeply-pitched hip roof supported by square posts with molded capitals and plinths support the roof that connects with a pent roof set across the façade at the first floor level. The stoop is brick with limestone treads with similarly detailed stairs with metal railings at each side. In the east bay of the main block is a large bay window projection with the center bay double the width of the side bays. The roof is a steep hip that sits under the sill of the second floor windows. The cornice aligns with that of the hood at the door and the pent roof. Centered on the bay are a pair of typical sashes with center mullion with two flanking typical sashes in the outer bay sides. There is a two-story extension to the east. The first floor has a room projection with a hip roof similar to the porch with a connecting cornice line and the continuation of the pent

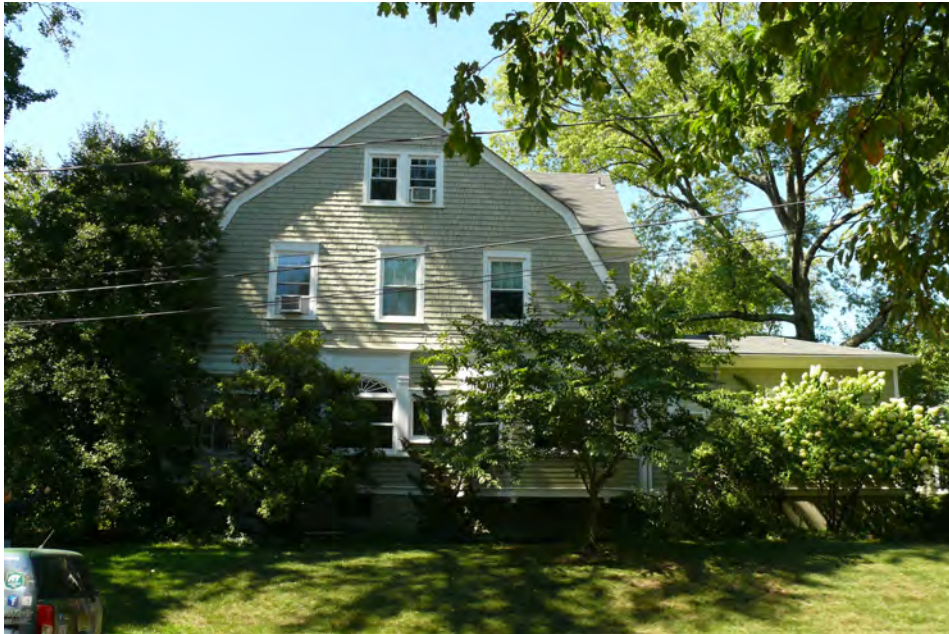
Property Photo:

This is a two-and-one-half story single-family residence executed in the Shingle style with Colonial Revival influences. The building occupies the corner of Brookfield and Edgemont Roads and the front elevation faces southwest toward Brookfield Road. There are varied rooflines and materials so the description will be broken into component pieces. The main roof is an expansive gambrel with its ridge running parallel with Brookfield Road. From this gambrel are centered gabled extensions at the front and back. The upper level of the gambrel and these gabled extensions are clad with wood shingles, while the main body of the building is clad with wood clapboards with corner boards and other trim elements. The entire building rests on a stone foundation. A wood skirt board runs the perimeter of the building. At the south (front) elevation, there is a one-story enclosed porch with a shed roof that extends from the main roof and has a molded cornice with wood entablature. Its base and corner piers are stone matching the foundation. The entrance to the porch is set center and is a fifteen-light wood door with a four-light transom accessed by masonry steps with limestone treads and metal railings set to each side. To either side of the door is a pair of 16-light sliding sashes, each with a four-light transom, and the whole assembly is set on a low wall with two inset panels. This same fenestration is carried to the sides of the enclosure one bay deep. The second story gabled extension is set center of this porch but also back from so it sits about two feet from the roof edge below. The gable has a full return with wood entablature below. Centered at the second floor are three grouped windows: a center wider eight-over-one sash and two narrower six-over-one sashes. The trim is flat stock wood with molded drip cap set below the entablature board, a wood sill, and wood mullion set between each sash. Centered at the attic is a single eight-over-one sash with a similar surround as at the second floor. The west

elevation is completely obscured by vegetation. The east elevation is visible from Edgemont Road, but it too has a lot of vegetation so some of the detail may not be noted. The main block within the gambrel is three bays wide but the fenestration at the first floor tends to ignore the bay rhythm, whereas the second floor is distinct with one six-over-one wood-hung sash in each bay with the same surrounds as found at front gable. At the attic is also a pair of six-over-one hung sash in a similar surround. At the first floor, the first bay, as noted and occupying the expanse of the gable extension is the sliding sash with transoms. Next to this is a wood surround set slightly off the façade and containing a wide, one-over-one hung sash with a fanlight above. The surround consists of two fluted pilasters with capitals and plinths supporting an architrave with a molded top and dentils. Immediately next to this is a pair of small casements of one-light each in a wood surround similar to the upper levels. At the north end, still under the gambrel, is a bay window projection that is cantilevered and supported by wood brackets. It has a low-slope copper hip roof with projecting molded cornice and entablature with dentils that serves as the head of each window. Each window has a transom of intersecting ovals. The center window is wider than the sides and is fixed. The side windows are one-over-one wood-hung sashes. The bay window projection is clad with wood clapboards and the skirt is carried over from the main façade. There is also a one-story extension to the rear. It is similarly detailed as the first floor of the main building. The roof is a low-slope hip. There is a single hung sash in the south bay of six-over-one lights, and paired sashes, also six-over-one, but taller. At the north or rear elevation, the one-story extension has a single six-over-one wood-hung sash; this addition obscures the first floor of the rear of the main building. The upper level, the cross gable, is similarly treated as the front but with cornice returns only at the corners. There is a pair of hung sashes in the east bay, a single in the west bay, and one at the attic level. The driveway is to the north side of the property from Edgemont Road and leads to a garage that is one bay wide, clad with clapboard, treated with flat-stock trim, and has a hip roof with slight overhang. The door is wood, paneled, with lights in the upper center panel, and of overhead operation. Constructed in 1916, 59 Brookfield Road takes a commanding presence at the corner and uses its position architecturally by orienting the expansive roof to the cross street. The one-story extension appears to be at least early and possibly original as it is indicated on the maps and the detailing between the component parts is fairly seamless. The building is a fine example of a Shingle style building that retains a high level of architectural integrity. The building would be a contributing resource in the historic district.

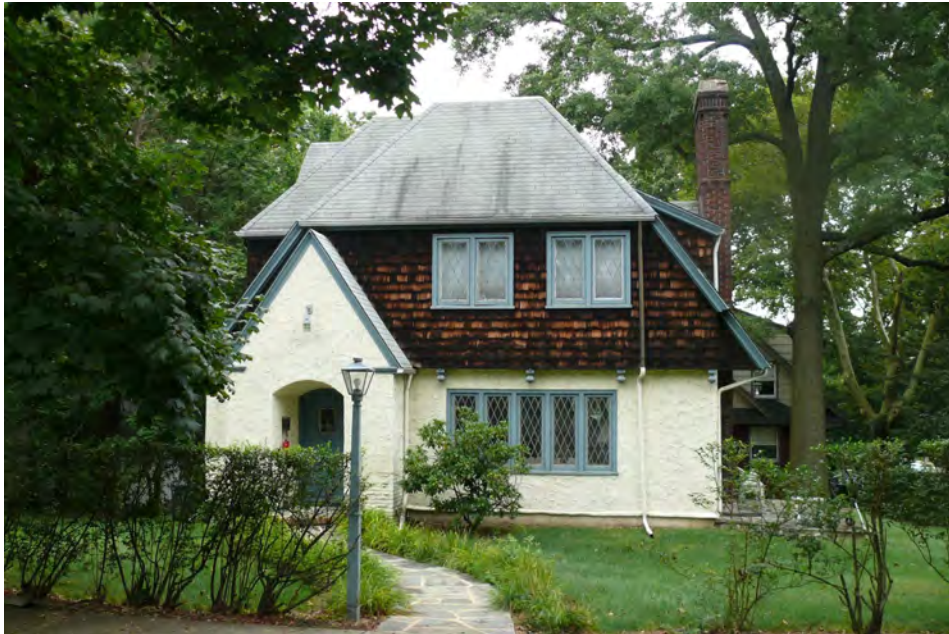
Property Photo:

This is a three-bay wide by two-bay deep, two-story single-family residence with Tudor Revival influences. The property sits somewhat in a bowl at the corner of No. Mountain Avenue and Godfrey Road as it is set slightly lower than the sidewalk and street along No. Mountain Avenue. The front elevation faces southwest toward No. Mountain Avenue and the first floor is set at about grade at the front but the grade drops at the east end of the property. The foundation is parged masonry. The upper body of the building is clad mostly with wood shingles with rough stucco detailing as indicated. The windows are a mix of diamond panes with leaded-glass casements as well as hung sashes. The trim is flat-stock with a molded outer edge and narrow wood sill. The roof is essentially two intersecting hips that are truncated with a cross gable at the north side, and an extension of the hip on both ends of the building at the front. The roof is clad with asphalt shingles. There is a large brick fireplace back with chimney set in the west bay on the south elevation. Set adjacent to this chimney on both sides of the south roofline are shed dormers clad with wood shingles at their sides and a hung sash at their center. To the east on the same side is a wall dormer with a shed roof and a six-over-six hung sash. The front entrance is set in the north bay and it is delineated by a stucco massing with a steeply-pitched gable roof. The door is recessed in a segmental-arched opening; it is a board door with one light and molded trim also with a segmental-arched head. The second floor overhangs the first slightly and there are four wood drops detailing the overhang. The first floor is finished with rough stucco and the upper level is wood singles. Spanning the two bays at the first floor are five grouped casement sashes with narrow wood mullions. In each of the two bays at the second floor are paired casement sashes with narrow mullions. The molded rake follows the extension of the roof framing the roof on this side. The north

elevation has a small side porch with shed roof supported by square posts and lattice set between the posts. This sits on a concrete foundation with a few steps leading to the side door. Above this at the second floor is a six-over-six hung sash. To the west are two sashes, one at each floor, which are short diamond-paned casements. At the attic is a single hung sash and in the far east corner at the second floor is another hung sash. The south elevation is dominated by the brick chimney which is beautifully articulated above the roofline with steps, projections, and recesses. The fenestration is limited to a door with exterior screen set next to the fireplace, which leads to a small slate patio. Centered in the east bay are three grouped eight-light casement sashes with narrow mullions. The east elevation has a fairly regular fenestration pattern. A garage is set on the north side of the property. It is one bay wide, clad with stucco, has a hip roof, and the trim is flat stock wood. The door is a flush panel metal overhead-type and there is a six-over-one sash centered on the south elevation.

Constructed in 1924, there are obvious changes to the building other than that the shingles have been replaced on the entire east side of the building recently; this appeared to be a maintenance condition rather than an effort to change the architecture.

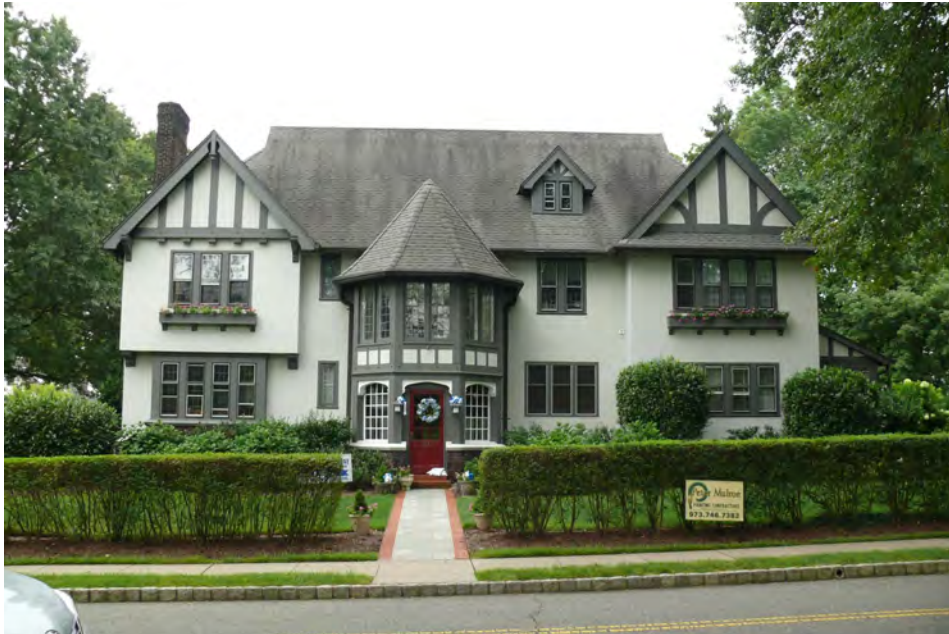
Property Photo:

This is a three-unequal bay wide by two-bay deep, two-and-one-half story single-family residence in the Tudor Revival style. The building faces northeast toward Parkside Street and the entrance is set only a few steps up from grade level but the first floor of the main building is a few steps up from there. The property is deep along the west side of Princeton Place and narrower along Parkside Street yet has a stretch of lawn at its front. The driveway is located off Princeton Place and leads to a garage located along the west property line. The foundation is red brick and the building is finished with stucco from the masonry water table to the underside of the roof and includes half-timbering detailing, particularly at its numerous gables. The window types and sizes vary but the openings are typically trimmed with narrow flat-stock wood with narrow projecting sills. The main roof, clad with asphalt shingles, is a side gable with jerkin heads; however, there are so many roofs that either abut it or die into on all four sides, it may be a hip roof under all the (original) accretions. The plan format helps to inform the elevations. The main block is rectangular with two rectangular blocks at each side creating an H-shape. The east block has a front gable roof with its ridge set lower than the main roof but also runs the full depth, so the roofs look spliced together where they join. The west block, which is wider than the east block, also has a front gable roof that joins the main roof and returns on the rear rather than creating a two full gables front and back. Visible from Princeton Place, there is a third block about center of the main block that creates a cross gable with the main roof. Finally, at the front there is a truncated octagonal entry enclosure that is set off-center to the east on the main block. It is two stories (the first floor and second floor are set lower than the main level), has a conical roof that is partially engaged with the main roof. There are other accretions, but these are the five main building blocks. All the roofs have sweeping
