INTENSIVE-LEVEL ARCHITECTURAL SURVEY

WHEELER STREET AND OAKCROFT RESIDENTIAL AREAS
Township of Montclair, Essex County, New Jersey

OAKCROFT RESIDENTIAL AREA SUPPLEMENT

Project No. 1915C

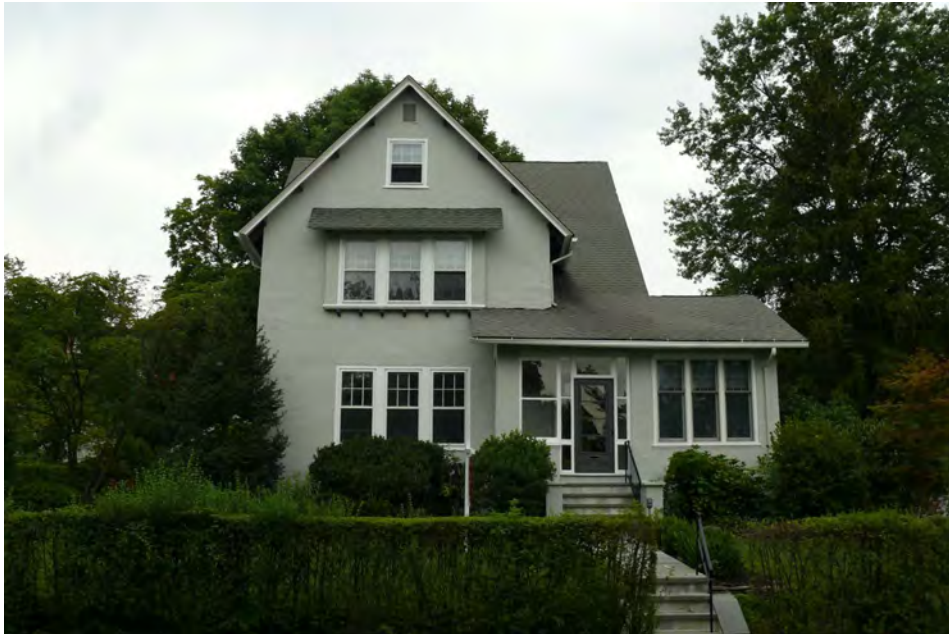
Property Photo:

is finished with stucco similar to the body of the building. The north bay contains the entrance which is a one-light wood door with three-light sidelights and one-light transom set to the underside of the eave. To the north of this is a two-light casement set on a low wall. Stucco-clad stairs with limestone treads and a low stucco-clad wall with limestone caps is set to either side of the stair with a metal railing to one side. In the south bay of the porch are replacement vinyl sash of six-light over a taller one-light sash, three together with narrow mullion set in typical trim with a sill. The south elevation of the main block has a fairly regular fenestration pattern at all levels with a one-story bay window projection about center of the first floor and a small enclosed gabled porch to the rear. The south side of the front porch has a similar casement to the front. The north elevation of the porch has two bays of the same three grouped sashes with two triangular fixed sashes set under the roof and separated by mullions. The garage is two bays wide and one-story with a front gable roof. Each bay is framed with wood trim; the doors are either not existent or were in the open position at the time of the survey. Constructed prior to 1910 for John L. Parrish, Esq., an attorney, the home was featured in the January 1910 edition of American Homes and Gardens. The building was designed by the architectural firm of Freeman and Hasselman of New York. Comparing the historic images with the current conditions, the only significant change is the enclosing of the front porch including adding the triangular windows on the gable end wall. (Note: The Essex County tax records indicate a construction date of 1912; however, the building was featured in the 1910 edition of American Homes and Gardens.) The building is a well-executed single-family residence of the Craftsman style. The changes to the original porch are sympathetic and the building and site retain a high degree of architectural integrity making it a contributing resource in the district.

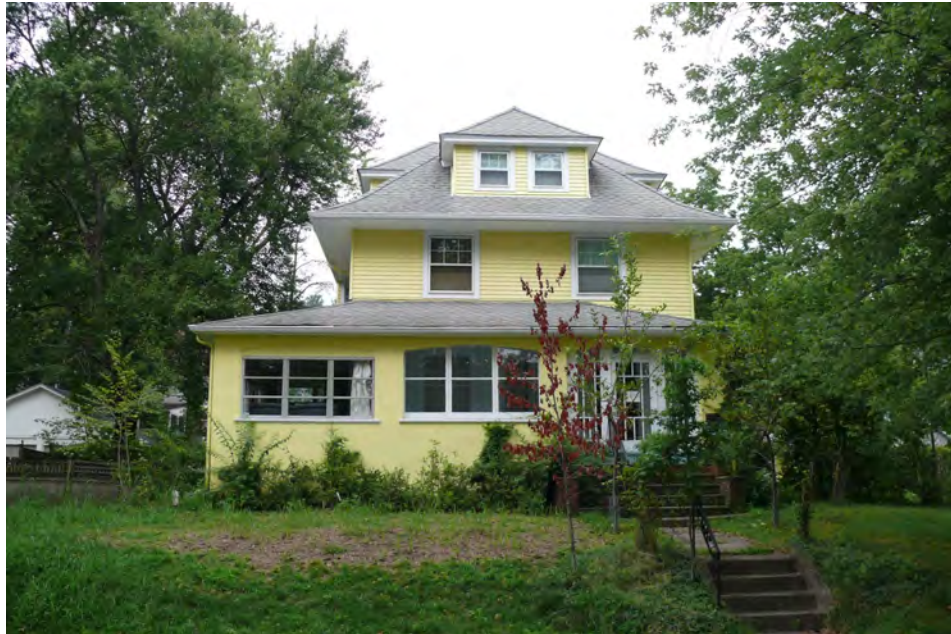
Property Photo:

This is a two-bay wide by three-bay deep, two-and-one-half story single-family residence, an American Foursquare. The front elevation faces northeast toward Princeton Place. The building is set a distance from the street with a shallow lawn that has a slight rise to it from the sidewalk overcome by concrete stairs. The first floor is set several steps above grade. The foundation is parged masonry and the building is primarily clad with narrow vinyl siding with corner treatments. The windows are typically six-over-one wood-hung sash with flat-stock trim with a square edge molding and wood sill. The main roof, clad with asphalt shingles, is a steeply pitched hip with ridge running perpendicular to the street and with a very deep overhang (about two feet); the soffits are clad with vinyl. Each of the three visible sides of the roof have dormers that are treated the same as the body of the building and with steeply pitched hip roofs with deep overhangs (proportional to the dormers). Each dormer has two small typical sashes set apart. The first floor is dominated by a wrap around porch that has been fully enclosed. The porch, which extends to the south one bay beyond the main building footprint, has a hip roof clad with asphalt shingles. It is three equal bays wide by one bay deep and each bay is distinguished by a pointed segmental arched opening set between stucco-clad piers with a low stucco-clad wall. The stucco finish is from grade to underside of roof. The south side bay and the south bay on the front have an infill at the head and three-light aluminum sash in a group of three on the front elevation and a group of four on the south elevation. The operation of these windows is not clear. The center bay is also infilled but only with glass and frame of three two-light grouped wood casement sash. The north bay contains the door, which is a multi-light wood door with true muntins surrounded by multi-light sash and four-light narrow transom. The assembly is set behind the arched opening. Brick steps with limestone treads with low

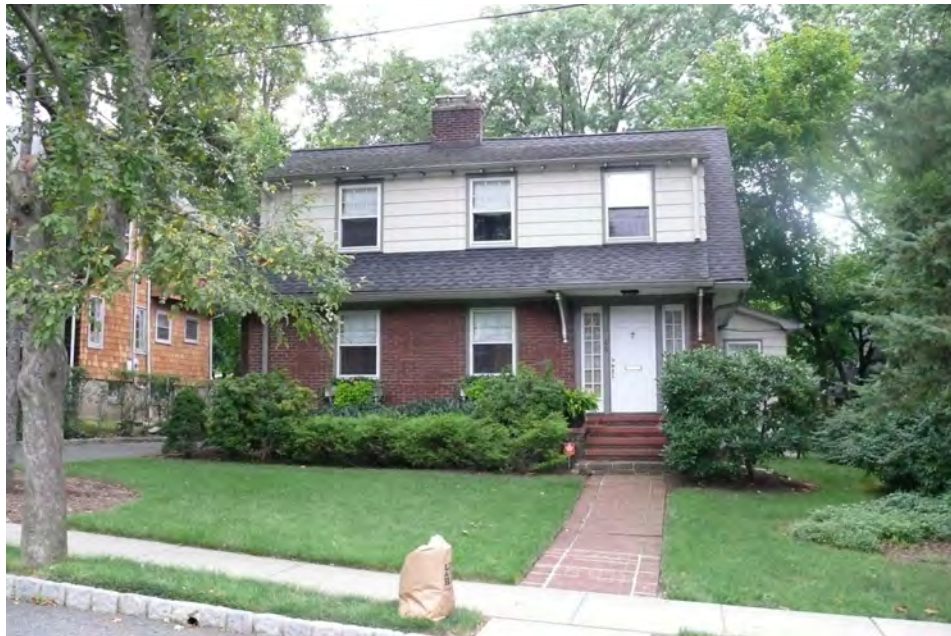
Property Photo:

This is a three-bay wide by two-bay deep, two-story single-family residence with Colonial Revival style influences. The front of the building faces southeast toward Godfrey Road and the first floor level is set a few steps above grade. A drive is set on the west side of the property and leads to a garage at the rear. The first floor and foundation are finished with red brick. The gable ends, dormer, and other appendages are clad with wood clapboards with mitered corners. The windows are six-over-one wood-hung sashes with narrow flat-stock wood trim and narrow wood sill at the frame openings, and flat stock wood with brick sills at the masonry. The roof is a side gable with deep projection on all sides that returns over the first floor at each end to create a shallow pent roof. There is a slight projection on the west side set back from the front elevation that has a gable inset of the main gable roof. A shed dormer spans almost the entire front of the gable roof. It has a slight overhang detailed with rafter tails. A brick chimney is located off-center to the west at the ridge of the main roof. All of the roofs are clad with asphalt shingles. The front entrance is set in the east bay. It is a paneled door with two 12-light sidelights covered by a shed roof that projects just slightly beyond the overhang of the main gable and is supported by two molded wood brackets. The entry is a brick landing with brick stairs and low brick sidewalls. In the center and west bay are single window openings. In each of the three bays at the dormer are single window openings. The west elevation has a single window at the first floor and next to it in the projection, are a small four-light casement and a door, which is set at grade level. There are two windows at the second floor, one each on the south end of the gables. On the east elevation, the first bay at the first floor is dominated by three grouped pairs of eight-light casement sashes with narrow mullions. There are two additional windows toward the rear spaced apart. At the gable end there are two

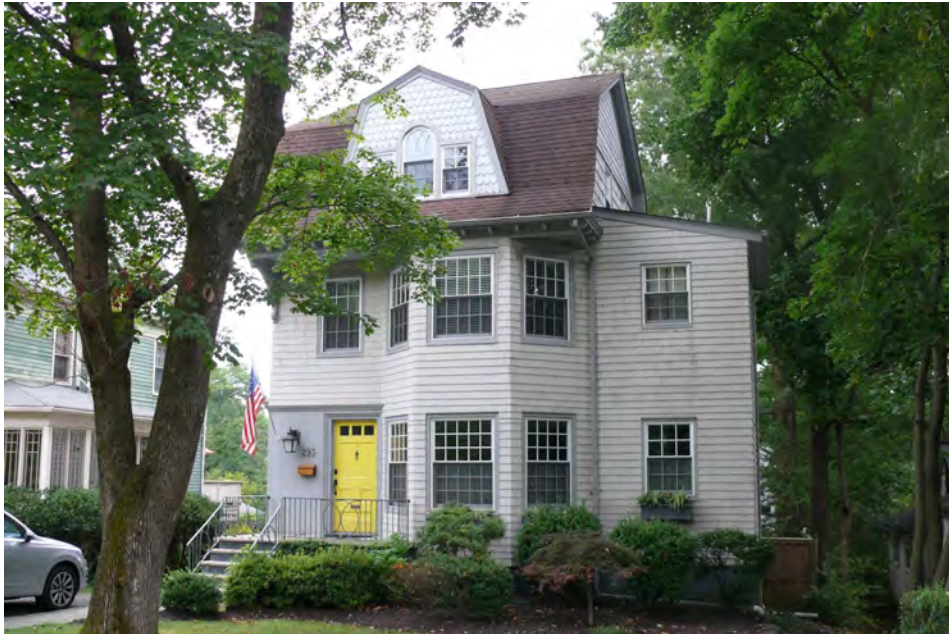
Property Photo:

This is a three-irregular-bay wide by three-bay deep, two-and-one-half story single-family residence. The property is set back from the sidewalk and there is a short driveway at the north side of the property. The property slopes down from west to east so the basement is more exposed at the rear. The front elevation faces southwest toward No. Mountain Avenue and the first floor is set several steps above grade. The foundation is random ashlar laid fieldstone. The building is clad with wood shingles. The windows are typically multi-light over multi-light hung sashes that appear to be replacement material with some exceptions. The trim is flat-stock wood with a drip cap and narrow wood sill. The roof is an anomaly. The roof over the core front section is a side gambrel, and to the east the building extends beyond the main gambrel and has a low-slope roof. At the front, the building extends to the north and over this there is a separate side gambrel, but the two roof slopes of the gambrel roofs align. Centered on the front gambrel is a dormer that is also a gambrel. Each of the gambrel roofs has different cut shingle cladding at their face. The entirety of the roof is detailed with a molded cornice entablature with supporting rounded corbels. The gambrel located to the north is also supported by massive wood brackets set to the front and back of the north extension. In addition, there is a two-story extension to the south near the front that has a shed roof that slopes south and has a plain rake board and slight overhang, which is unadorned. The front is broken into three almost disparate bays. The north and center bays are set under the front side gambrel. At the north end, the front stoop set on a painted stone base, stone stairs and metal railings sits in front of the main entrance, which consists of a half-false wall to the north and a three-light over four-panel wood door in a molded surround. Above this, the wall which from the front looks like a full wall, but really only projects at the second floor. There is a six-over-six

The building was constructed c. 1897. Based on the current conditions, there appears to have been a porch of some type at the front of the building as the current stoop is inconsistent with the architecture. The sashes have been changed at most of the square-shouldered hung window openings.

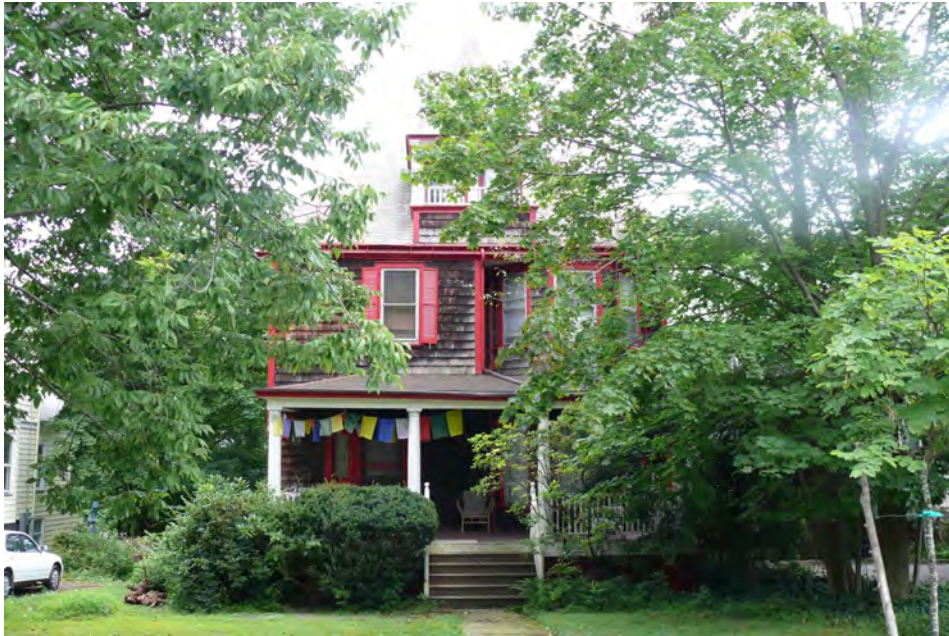
Property Photo:

This is a two-unequal-bay wide by three-bay deep, two-and-one-half story Queen Anne residence. The property is set back from the sidewalk and the drive is set along the north property line. The property slopes down from west to east so the basement is more exposed at the rear. The front elevation faces southwest toward No. Mountain Avenue and the first floor is set several steps above grade. The foundation is parged masonry. The building is clad with wood shingles with corner boards. The windows are typically one-over-one hung sashes with flat-stock wood trim with a drip cap and narrow wood sill. The roof is an irregular shaped truncated hip with the front slope of the hip extending further than the sides, so the sides have a shallow boxed cornice; on each side is a diverter gutter. A brick chimney is set toward the rear on the south side of the upper hip. There is a wide dormer with hip roof at the front that extends to a Juliet balcony and is topped by a peaked roof supported by tiny Doric columns at each side of the balcony, as if the whole assembly was scaled for a large dollhouse. Centered at the dormer are paired hung sashes with mullion. On the north side is a narrow dormer with hip roof and single casement window. On the south side there is a wide dormer with paired hung sashes. The side walls of the dormers are clad with wood shingles, and the fronts are clad with flat boards. All of the roofs are clad with asphalt shingles. The front elevation of the main block is articulated with a projecting two-story block in the north bay and a two-story bay window projection in the south bay. A one-story porch with hip roof encloses these two projections at the first floor. The porch roof is supported by four equally-spaced Doric columns with wood stairs set at the center bay. To either side of the stair is a wood railing with turned newels, top and bottom rails, and turned balusters. The same railing configuration is set between the columns at the porch. The porch columns are supported by masonry piers with lattice set in

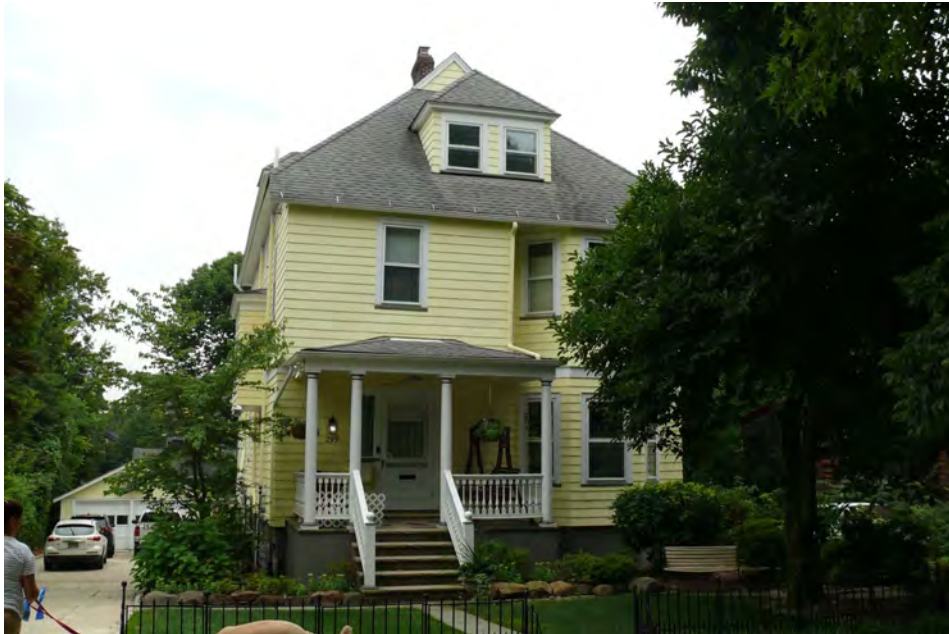
Property Photo:

This is a two-unequal-bay wide by three-bay deep, two-and-one-half story Queen Anne residence. The property is set back from the sidewalk and the drive is set along the north property line leading to a garage at the rear. The property slopes down from west to east so the basement is more exposed at the rear. The front elevation faces southwest toward No. Mountain Avenue and the first floor is set several steps above grade. The foundation is parged masonry. The building is clad with wood shingles with mitered corners. The windows are typically one-over-one hung sashes with flat-stock wood trim with a drip cap and narrow wood sill. The roof is an irregularly-shaped hip in that the eave at the front is set lower than the sides so it projects at an angle at the front and ends at a boxed soffit at the sides. The roof is clad with asphalt shingles. A brick chimney is set toward the rear on the south side of the ridge. There is a wide dormer with hip roof at the front and south sides of the main roof and a narrow dormer with hip roof at the north side. The dormer walls are clad with shingles. At the larger dormers there are two paired hung sashes with shingled muntin between and at the narrow dormer is a single hung sash. A porch is set in the north bay at the first floor; the bay projects slightly from its neighboring two-story bay projection, which occupies the south bay at the front. The roof is a hip clad with asphalt shingles and is supported by four irregularly-spaced, slender Doric columns with molded capitals and bases. A stair is set in the center bay of the columns; it is brick with limestone treads. A railing with square newels, top and bottom rails, and turned balusters is set at each side of the stair with a similar rail at the open sides of porch. The porch has a masonry landing and support wall. The porch covers a door set approximately center at the north bay. It is a one-light, multi-panel wood door set behind a storm door with a one-light over three-panel sidelight on its north side. Centered at the second floor is a

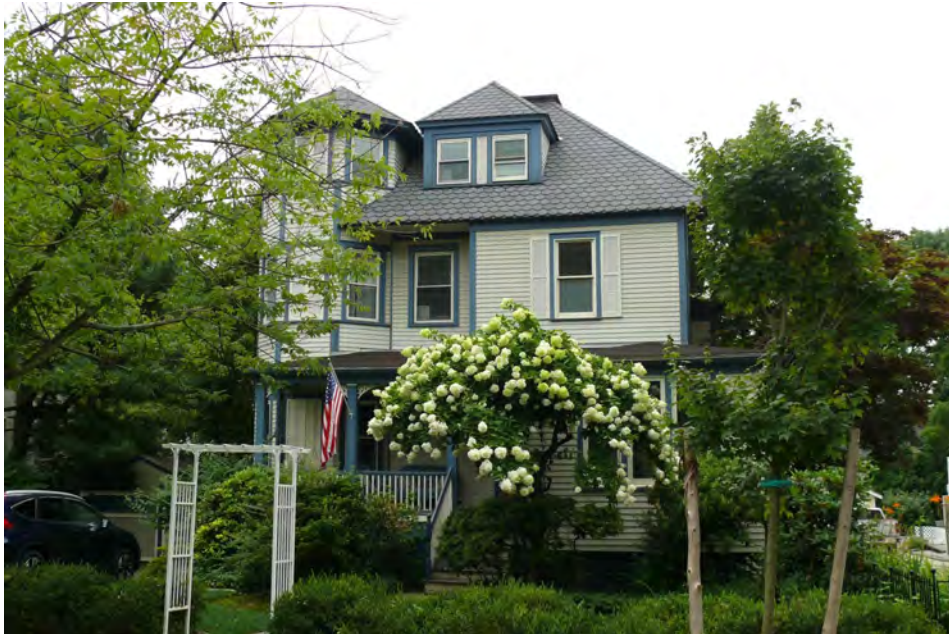
Property Photo:

This is a three-bay wide by two-bay deep, two-and-one-half story, single-family residence in the Queen Anne style. The front elevation faces northwest toward North Mountain Avenue and the building is set several steps above grade. The building is set back slightly from the sidewalk and a small drive is set to the north of the property. The foundation is brick. The building is clad with narrow clapboard siding with narrow corner boards. The windows are typically one-over-one replacement sashes with flat-stock wood trim with drip edge and narrow projecting wood sill. The roof is a truncated hip with a brick chimney set at the upper hip toward the rear. A turret engages the building and the roof in the north bay, and has a shallow octagonal roof. Both roofs are clad with asphalt shingles. The main roof extends further at the front than at the sides with a sloped board soffit with molded edge and a flat-stock entablature set along the top of the wall. The turret roof is similarly detailed. Centered on the front hip is a wide dormer with a hip roof. The dormer roof extends only to the molded cornice set proud of the dormer wall. The dormer is clad with siding at its side walls, and at the front is a flat-stock wood surround with two small typical sashes. The same dormers are centered on the north and south sides of the roof as well. A front porch is set within the center bay and partially engages the north turret and a one-story front extension in the south bay. The roof of the porch, which is a hip, and the roof of the extension are set level with each other. The porch is supported by four square posts with eased edges set somewhat equal-distant apart; the south bay aligns with the front door and is slightly narrower than the other two bays. The posts, supported by masonry piers set behind lattice, have a narrow beaded molding at the head and plinth. Scroll-sawn trim is set at the transition of the roof girder and posts. The stairs, set in the south bay, have wood treads and risers with turned newel, top and bottom rail, and square wood

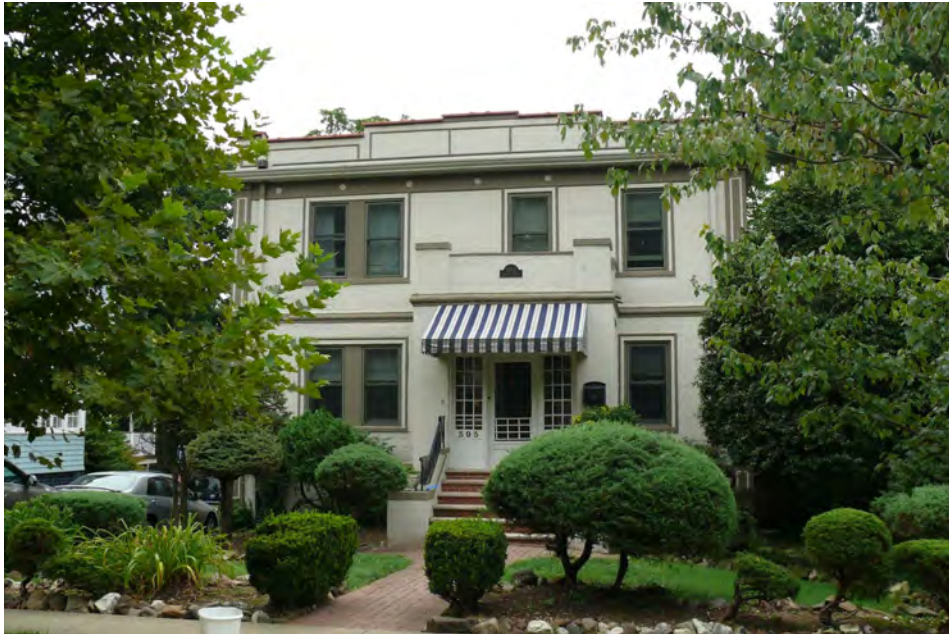
Property Photo:

A stucco-finished addition is located at the northeast corner of the building; it houses the garage at the lower level and a pair of one-over-one sashes with flat-stock trim and a narrow mullion centered above the garage door at the first floor. The roof is set behind a stepped parapet capped with metal copings. The north elevation is similar adorned at the first floor with three grouped hung sash. The addition was added in the early 1980s; the addition is noted on the 1986 Sanborn map.

Constructed in 1912 for F.D. Lambie, it is one of a handful of houses constructed using technology created by Thomas A. Edison. The building was constructed by the American Building Company (Lambie was president of the company) for a cost of \$9,250. (The Montclair Times, 3/25/1911) It remains as one of approximately 70 remaining homes built of this technology, most of which are located in either New Jersey or Indiana. Lambie was one of the early adopters of the technology. (The Montclair Times, 3/1/1913) Based on existing conditions and historic images and maps, the main changes to the core building are the stairs were originally concrete and the metal railings are an addition and the window sashes appear to be replacement material. The addition, which is set to the rear of the property, is respectful of the main building in both its placement and that it's much more simply detailed than the historic core.

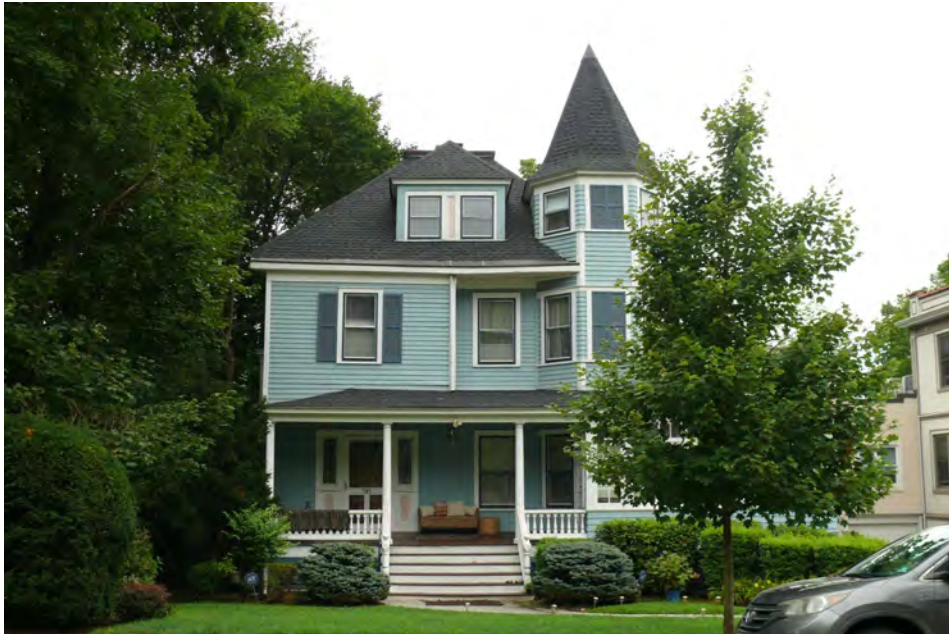
Property Photo:

This is a three-unequal-bay wide by two-bay deep, two-and-one-half story single-family residence in the Queen Anne style. The front of the building faces northwest toward North Mountain Avenue and the first floor is set several steps above grade. The property slopes down from west to east so the sides and rear of the property have greater exposure of the foundation than the front. A drive is set to the south side of the property. The foundation is stone masonry. The building is clad with narrow clapboard wood siding with narrow corner boards. The windows are one-over-one wood-hung sash with exterior storms trimmed with narrow flat-stock wood with drip cap and narrow projecting sill. The roof is a truncated hip clad with asphalt shingles. The eaves project slightly and incorporate a built-in gutter. The cornice is flat stock with flush eaves set above a narrow flat-stock entablature. A wide dormer with hip roof is set on both the front and south sides of the roof, about center on each side. A narrower dormer is set toward the rear of the north side of the roof. A turret engages the south corner; it has a conical roof with a slight flare at the eave, which is narrow with a flat cornice and plain narrow entablature above the attic-level windows. At the first floor, a wraparound porch dominated and projects beyond the building to the south dominates. It has a hip roof clad with asphalt shingles. The north end is open and the south end is enclosed by a low wall and a series of multi-pane wood sashes and transoms. The open end is supported by three unequal-spaced slender Doric columns set on a masonry piers set behind wood lattice. The porch stairs are centered of the building; they are wood with a wood railing composed of turned newels and a top and bottom rail with turned balusters. The same railing is carried to the open sides of the porch. The entrance door is set center of the wider north bay. It is a one-light over two-panel wood door with one-light over one-panel wood sidelights. Centered in the narrower center bay is

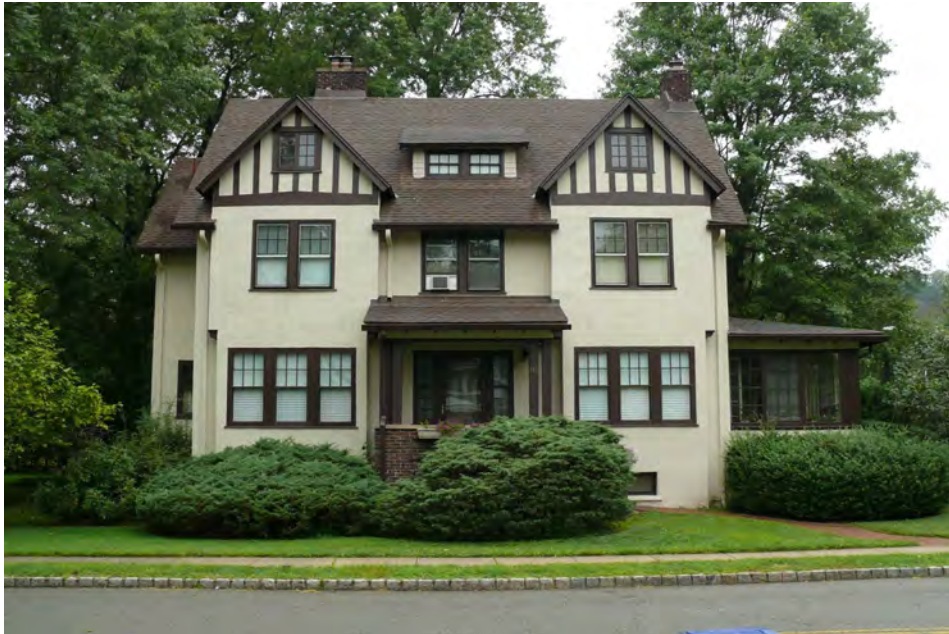
Property Photo:

This is a three-bay wide by two-bay deep, two-and-one-half story single-family residence in the Tudor Revival style. The property occupies the corner of Edgemont Road and Parkside Place. The front elevation faces southeast toward Edgemont Road and the first floor is set several steps above grade. The building is finished with stucco from grade to the underside of the roof with some half-timbering, as noted. The windows are typically six-over-one wood-hung sash with noted exceptions. The openings are finished with narrow flat-stock trim and narrow projecting wood sills. The roof over the main block is a side gable with two slightly projecting sections in the south and north bays that each have cross gables with their ridges set lower than the ridge of the main roof. A two-story wing on the south side is set center and to the west; it has a side gable set lower than the main roof so that the downward slope on the west side aligns with that of the main building. All of the roofs overhang slightly with recessed soffits behind flat-stock wood rakes and exposed rafter tails on the downward slopes. A shed dormer is center of the main roof. It is clad with wood shingles at its front and side walls and a pair of three-over-three wood-hung sash separated by a wood mullion are set center of the dormer. The south wing has a single typical window at the first floor. Both projecting gables, which frame the center main entrance, overhang the first floor slightly on both sides; the overhang is supported by small wood corbels. Centered at the first floor of each gable projection are three grouped typical sash separated by wood mullions. Above at the second floor are a pair of typical sash with mullions and at the attic level there are a pair of six-light wood casement sash. The gable ends are treated with vertical half-timbering resting on a timber canted beam; all of the half-timbering is set flush with the stucco. In the center bay at the first floor is the entrance porch with a shed roof, which is clad with asphalt shingles, is

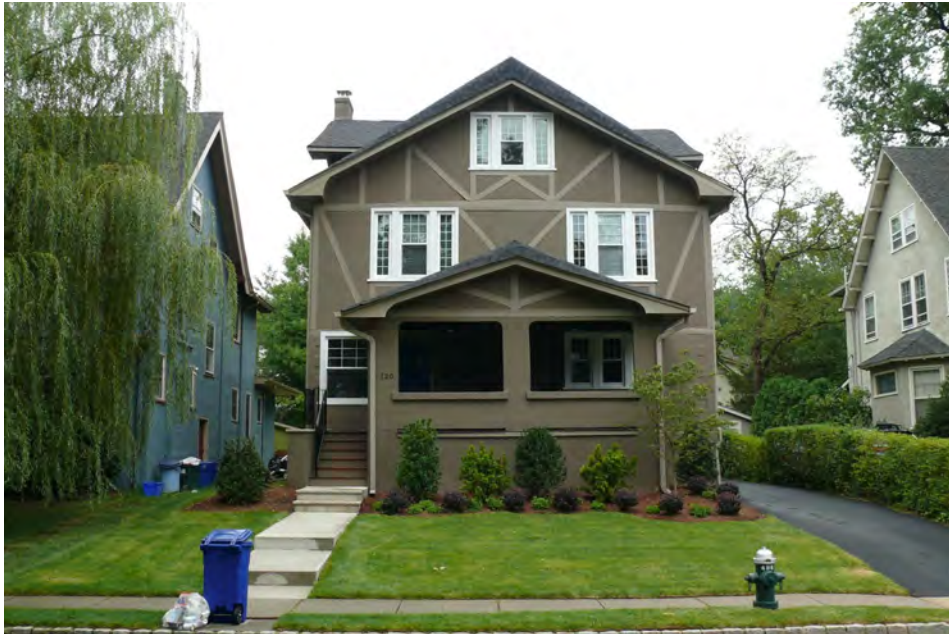
Property Photo:

This is a two-bay wide by three-bay deep, two-and-one-half story single-family residence in the Craftsman style with Tudor Revival influences. The front elevation faces northeast toward Edgemont Road and the first floor is set several steps above grade. A drive is set along the north side of the property. The building is clad with stucco from foundation to underside of roof with half-timbering detailed at the second floor and gable ends. The windows vary but are typically set in a flat stock trim with a projecting sill; based on an image from 2013, the trim and sills were added over or replaced the original and the windows are all replacement sashes. The roof over the main block is a front gable with a deep overhang and a rounded edge that rises to the peak; the asphalt shingles take the curve. The cornice return also takes an inverted rounded edge. The roof assembly gives the appearance of a thatched roof. Set on either side of the roof are gabled dormers with the same roof and cornice treatments. The dormer walls are finished with stucco and there is a single hung sash at its center. There is a stucco-clad chimney at the front of the south dormer. Centered at the first floor and inset a half bay on each side is an open, one-bay-deep porch. The roof is the same as the main roof and the ridges align. Two end piers and a center pier clad with stucco support the porch roof, and the gable end is treated with half-timbering. A low stucco wall surrounds the porch and the wall goes to grade. The wood stairs are set alongside the porch on its south side. It is enclosed by a low stucco wall and has a metal railing on one side. It leads to the porch where the door is set center of the south bay. To the south of the door and overlooking the stair is a large hung sash. Set just under the porch in the north bay are three grouped sashes with wide mullions. Centered at each bay at the second floor are two tall casements flanking a center hung sash with wide mullion. This same window configuration is set at the attic under the gable.

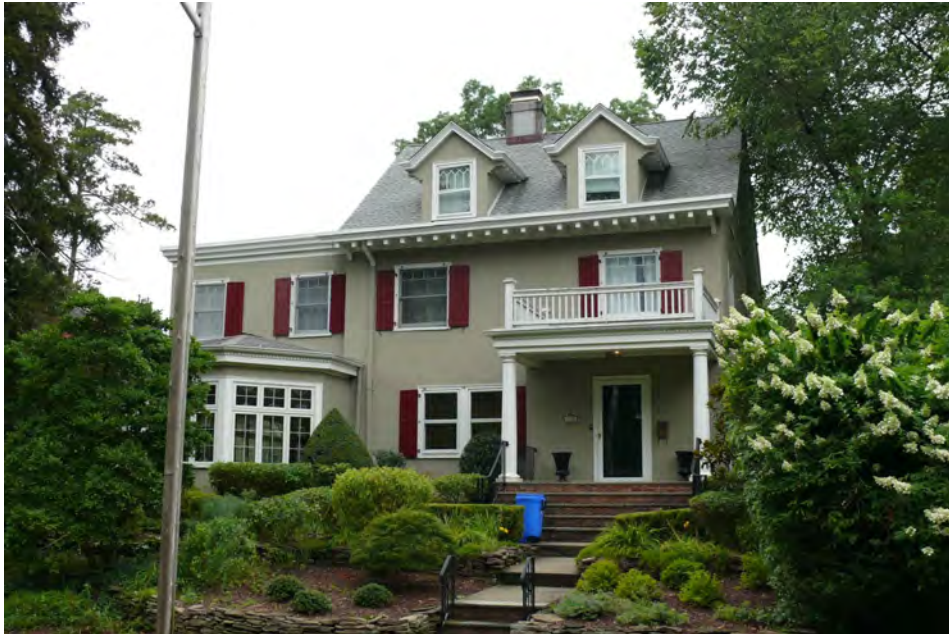
Property Photo:

This is a two-bay wide by two-bay deep, two-and one-half story single-family residence with a two-bay wide by two-bay deep, two-story addition on its south side set only slightly back from the main building at the front. The building is executed in the Colonial Revival style. The front elevation faces southeast toward Edgemont Road. The property is set on a slight bluff so that there are three steps up from the sidewalk to the front lawn that is heavily landscaped. The first floor level is set several steps up from the lawn. The building is clad with stucco from foundation to roofline. The windows are typically four-over-one wood-hung sash with molded trim and narrow projecting wood sill. The main roof is a side gable with a built-in gutter with a molded wood cornice supported by simple wood corbels; the end corbels have a slight curve and sit slightly onto the stucco below. Spaced apart on the main roof are gabled dormers with similar cornice details. The main roof and dormers are clad with asphalt shingles. A stucco-clad chimney is set off-center along the ridge. The wing has a low-slope roof set behind a molded wood cornice with dentil treatment at the upper edge. The type of roofing material is unknown. At the first floor in the south bay is a pair of one-over-one vinyl sash set off-center toward the center. Centered in the north bay is a nine-light over two-panel wood with aluminum storm. The entry is further detailed with a wide porch supported by Doric columns with molded capital and base. The roof is a low slope set behind a molded cornice with a wooden balustrade set along its edge. The balustrade is composed of corner square newels with a top and bottom rail between with square wood balusters. The columns are set on a brick stoop. The stairs leading to the stoop are brick with limestone treads and metal railings are set to each end. The railings are carried to each open side of the stoop. At the second floor of the main block are typical sash, one in each bay. The windows in the dormers are net tracery over one

The changes to the building are prominent and take away from the original building, as noted above. As such, 110 Edgemont Road would be a non-contributing resource in the historic district.

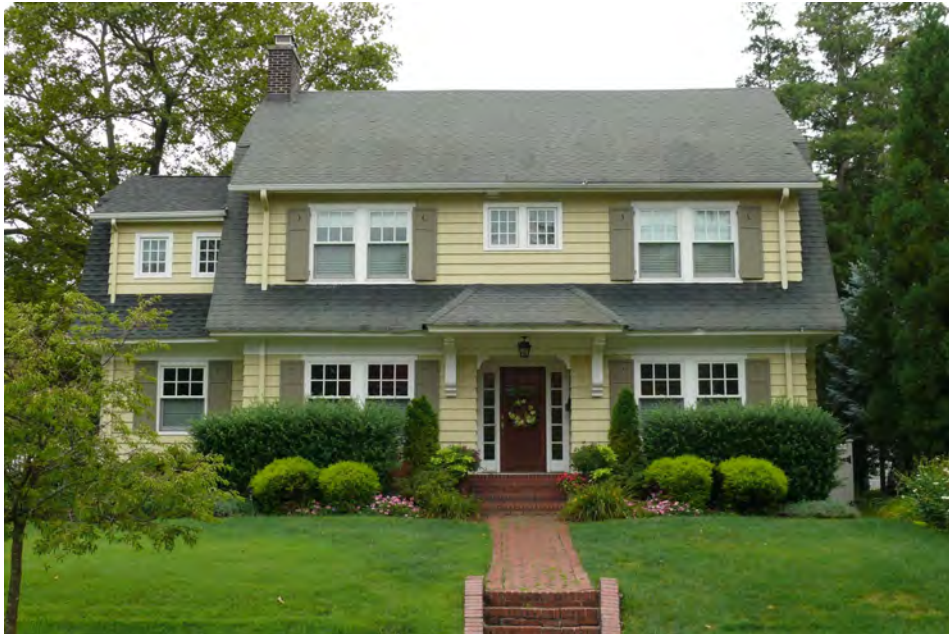
Property Photo:

This is a three-bay wide by two-bay deep, two-and-one-half story single-family residence executed in the Colonial Revival style. The building occupies the corner property at the intersection of Godfrey and Edgemont roads. A low stone retaining is set partially on the south side of the property and drive is accessed from Godfrey Road leading to a garage. The front elevation faces southeast toward Edgemont Road and the first floor is set only a few steps above grade. A two-story wing is set on the south elevation. The foundation is masonry finished with parging. The building is clad with wood clapboard with mitered corners. The windows are typically six-over-one hung sash with some exceptions. The trim is typically flat stock with a drip cap and narrow projecting sill. The main roof is a front gambrel with full shed dormers on both sloping sides. The main roofs encompass the second and attic levels and have a slight sweep at the overhanging eaves and a full cornice return at each gambrel end (when not interrupted by the wing). A wood fascia is set below the roof over the first floor windows. The wing also has a gambrel roof with shed dormer. All roofs are clad with asphalt shingles. A brick chimney is set about center of the roof on the south end. Centered on the front façade is a recessed entrance detailed with corner brackets at the opening and with a porch hood with hip roof in line with the edge of the main roof and supported by detailed wooden brackets. The door is six-light over two-panel wood with five-light sidelights. Brick steps lead up to the front porch with a slight landing in front and in line with a brick walk and brick stair at the sidewalk. To either side of the door area a pair of typical windows with wood mullion. At the second floor, a pair of nine-light casements are set center and these are also flanked by a pair of typical sashes. The wing has at its center a typical sash at the first floor and two nine-light casement sash set apart at the second floor. The north elevation is partially obscured by vegetation; the

Although there have been changes to the building, such as the addition and the replacement of the sashes, the residence retains its Colonial Revival features and reflects the architectural of the neighborhood. The addition is sympathetic to the main building in its placement and massing; the detailing is a very close match making it difficult to discern it is an addition. Given the building's high level of architectural integrity, it would be a contributing resource in the historic district.

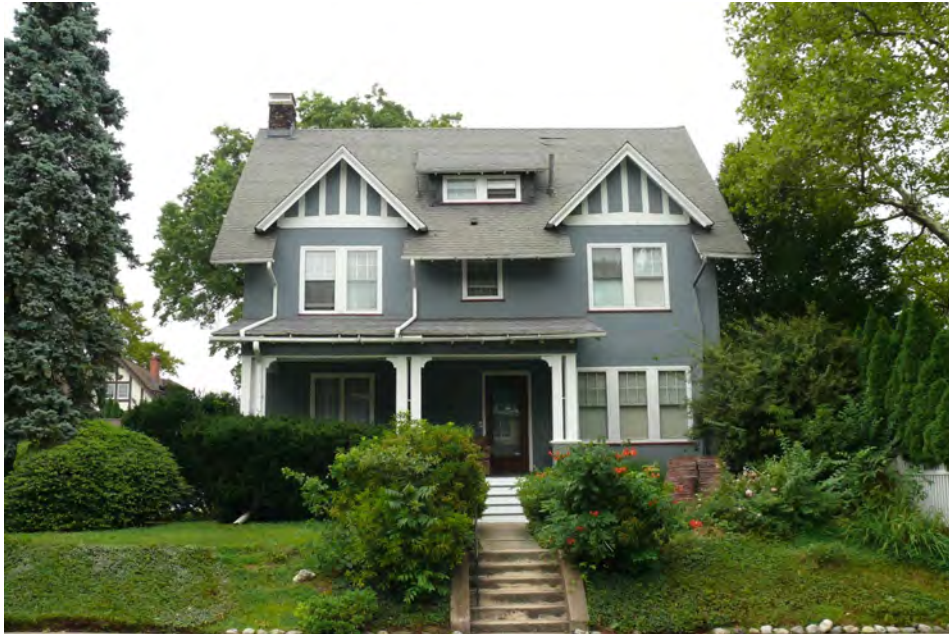
Property Photo:

The Montclair Times references a building permit for 43 Godfrey in 1909 but today there is no building of this number; however, this may be the property in question based on the street layout and its architecture. The cost of the building was noted as \$6,364 and the permit was held by Godfrey's development company. The property is referenced in the 1910 city directories. The exterior façades visible from the street appear intact with little changes noted.

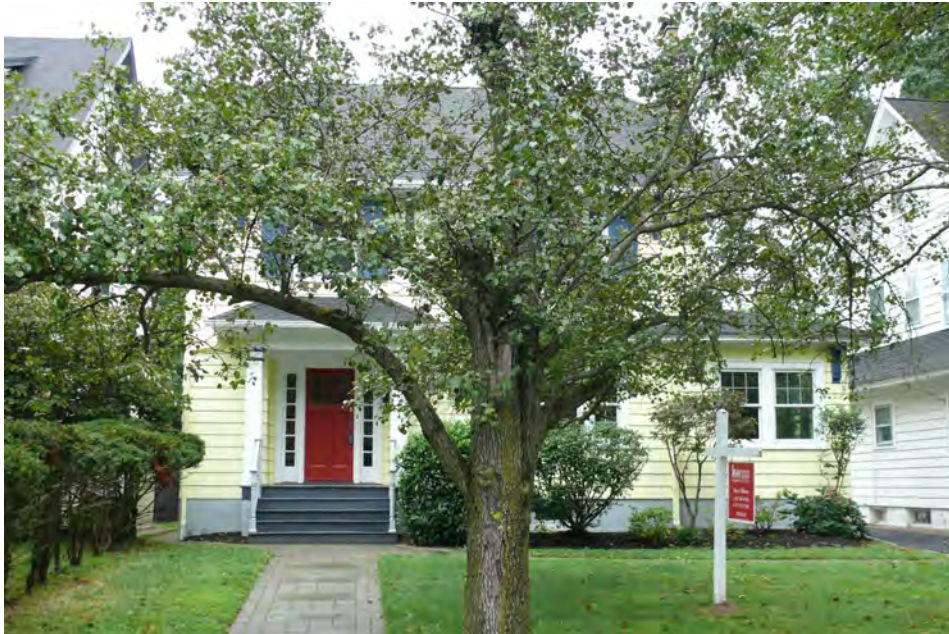
Property Photo:

This is two-bay wide by two-bay deep, two-and-one-half story single-family residence with Craftsman style influences. There is a one-story wing on the south side. The front faces northwest toward Princeton Place and the first floor is set several steps above grade. The building is set a distance from the sidewalk creating a shallow lawn at front. The driveway runs the south side of the property leading to a garage in the southwest corner. The foundation is parged with masonry. The body of the building is clad with clapboard siding with mitered edges. The first floor windows are replacement one-over-one sash of composite material with false muntins. The second floor windows are multi-light-over-one wood-hung sashes; the configuration varies based on the size and location and each also has a storm window. All openings are trimmed with flat-stock wood with a squared moulded edge and have a projecting wood sill. The roof, clad with asphalt shingles, is a side gable with a jerkin head at each gable end. The roof overhangs and has a box cornice that returns slightly on the gable ends. The main roof is supported by pairs of molded wood brackets at each end and single separated brackets center of the cornice line. The roof of the wing is a hip with deep overhang that aligns with a shallow pent roof separating the first and second floors. Both roofs are clad with asphalt shingles with a simple molded cornice and flat wood soffits. The roof of the wing is supported by wood brackets. The front door is set in a slightly recessed opening in the north bay with a shallow porch over it that extends from the pent roof to a shallow hip. This is supported by two square columns with molded caps, paneled shafts, and plinths. The columns are set on a wood frame and deck stoop with wood stairs at its center. Either side of the stairs and stoop has a wood railing with top and bottom rails and turned balusters. The stair railings have slender turned newels at each end of their run. The door is a wood six-light-over-two-panel wood

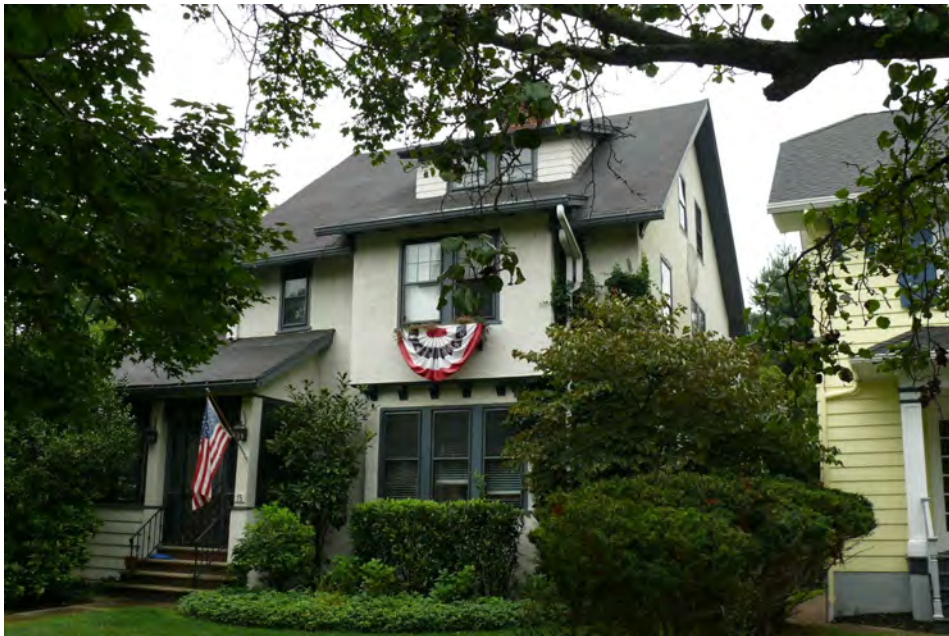
Property Photo:

Constructed prior to 1910 for Frederick A. Dibble, a broker York, the home was featured in the January 1910 edition of American Homes and Gardens. The building was designed by the architectural firm of Freeman and Hasselman of New York. Comparing the historic images with the current conditions, the only significant change appears to be the cladding of the low wall at the porch with wood clapboards. The garage, based on the 1986 Sanborn map, is newer construction. (Note: The Essex County tax records indicate a construction date of 1904; however, the building was one of the first new buildings constructed as part of the Oakcroft development, which did not begin construction until 1907.)

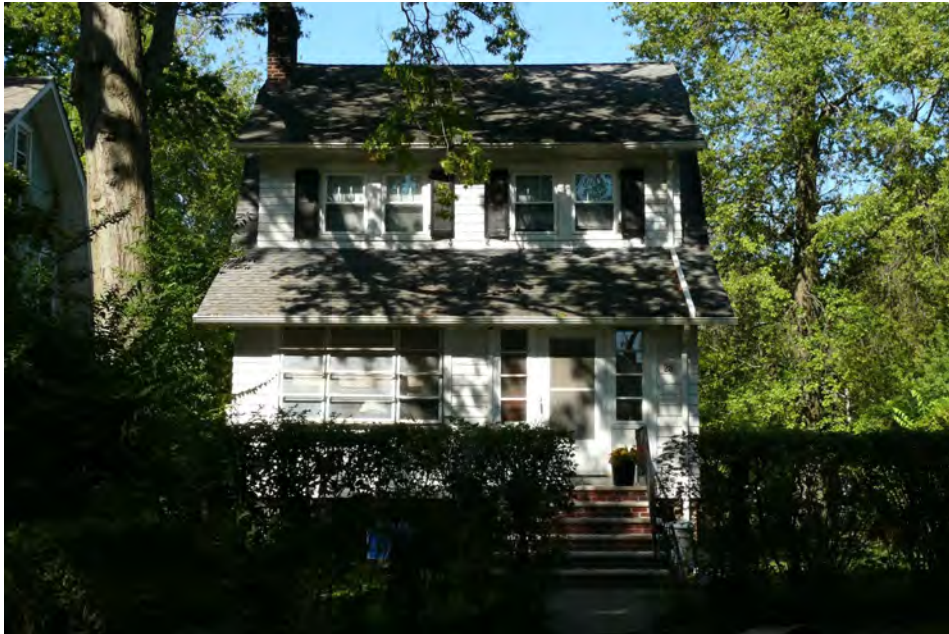
Property Photo:

This is a two-bay wide by four-bay deep, two-and-one-half story single-family residence in the Colonial Revival style. The front elevation faces northeast toward Carteret Street and the first floor is set several steps above grade. The foundation is brick, and the building is clad with wood shingles with mitered corners. The windows are typically three-over-one hung sashes with flat stock wood trim with drip cap and narrow wood sill. The roof is a side gambrel, which connects on both sloping sides with shed roofs over one-story extensions front and back. Centered on the front elevation is a wide shed dormer also clad with wood shingles. The roofing is asphalt shingles. The rafters are exposed at each overhang and molded wood brackets support the end wall eaves at each "bend" in the roof. A brick fireplace with chimney is set in the first bay on the south elevation. The entrance is set in the north bay at the one-story extension and consists of a wood paneled door with a storm door and two three-light over one-panel sidelights. Brick stairs with limestone treads and metal railings at each side lead to the front door. In the south bay are three grouped aluminum stacked hoppers. Centered in each bay of the dormer are paired sashes with a wood mullion. The south elevation, where visible, has regular fenestration. The north elevation has minimal fenestration with the same hopper window at the front one-story extension, a few randomly placed sashes, and one door about center leading to the basement. There is a two-story rear extension above the one-story extension. It interrupts the rear shed dormer but has limited impact to the building as a whole. The garage is two bays wide with a gable roof. The building is clad with wood shingles and the overhang of the roof is supported by narrow purlins. The doors are overhead flush panel metal with a dividing shingle-clad mullion. The rear extension, as noted, has little impact to the overall massing of the building. The front one-story extension was originally an

opening or screened porch and was enclosed probably in the mid-20th century based on the windows. It is unclear if the sashes are replacement material. Constructed in 1925, the building is deceptively large as the front façade is detailed in such a manner as to look small. The building employs the main expressions of the Colonial Revival in the choice of roof but also employs Craftsman style detailing at the roof overhang detailing. The building would be a contributing resource to the historic district.

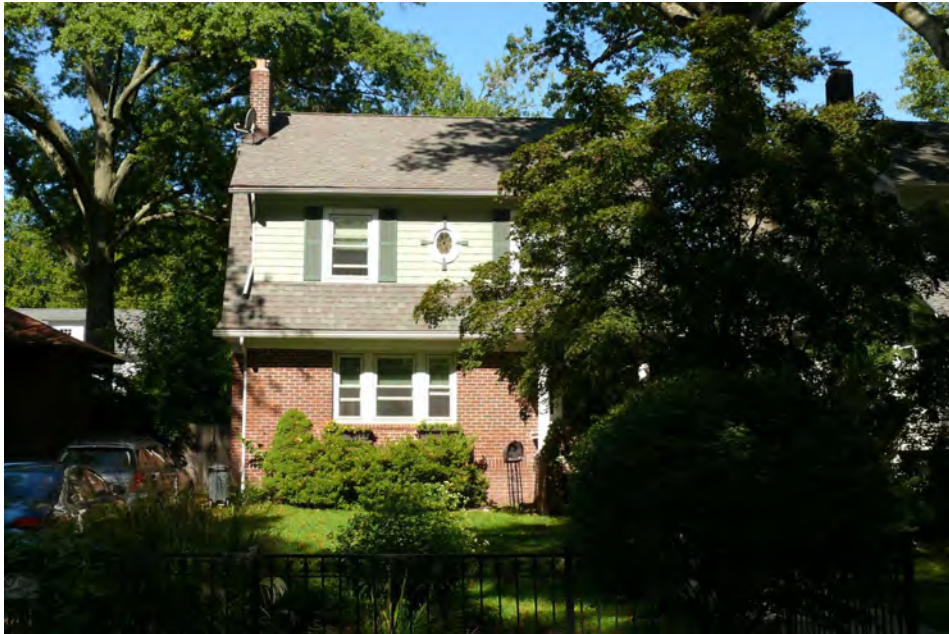
Property Photo:

This is a two-bay wide by two-bay deep, two-and-one-half story single-family residence with Craftsman style influences. The front elevation faces northeast toward Carteret Street and the first floor is set a few steps above grade. The first floor level and foundation are clad with red brick while the gable ends and dormers are clad with wood shingles. The windows are one-over-one replacement sashes with flat-stock trim with drip cap and narrow wood sill. The roof is a side gambrel with a full return on each end to create a pent roof. An almost full-width shed dormer is set on both sides. Each roof has an extensive overhang, and both are clad with asphalt shingles. A brick fireplace back with chimney is set in the first bay at the south elevation penetrating the roof here. The front door occupies the north bay. It is distinguished by a small hip roof that projects from the main roof and is supported by Doric columns at each side. The columns are set on brick sidewalls that enclose the stoop and brick stairs leading to the front door; the railing at the stoop is only a top rail. Off-center of the south bay are three grouped sashes separated by mullions; the center window is wider than the two flanking windows. Centered in each bay at the dormer is a single window; between these openings is an oval with key detailed at head, jambs, and sill, and leaded comes in a spiderweb pattern. The fenestration on the south elevation consist of square single-light openings set just under the pent roof, one on either side of the fireplace back and two in the west bay. A pair of windows occupies the center of the second floor and a single small sash is at the attic. The north, much of which is covered by vegetation, has a more regular fenestration with windows in each bay. There is a drive set on the south side of the property, but no garage is visible from the street.

Constructed in 1923 per the permit card, the most readily noted change is the replacement of the sashes.

The building is a fine example of a sedate Colonial Revival residence and would be a contributing resource in the historic district. The expression of the Colonial Revival is found in the gambrel roof, the detailing of the front entrance, and even in the small center window at the dormer.

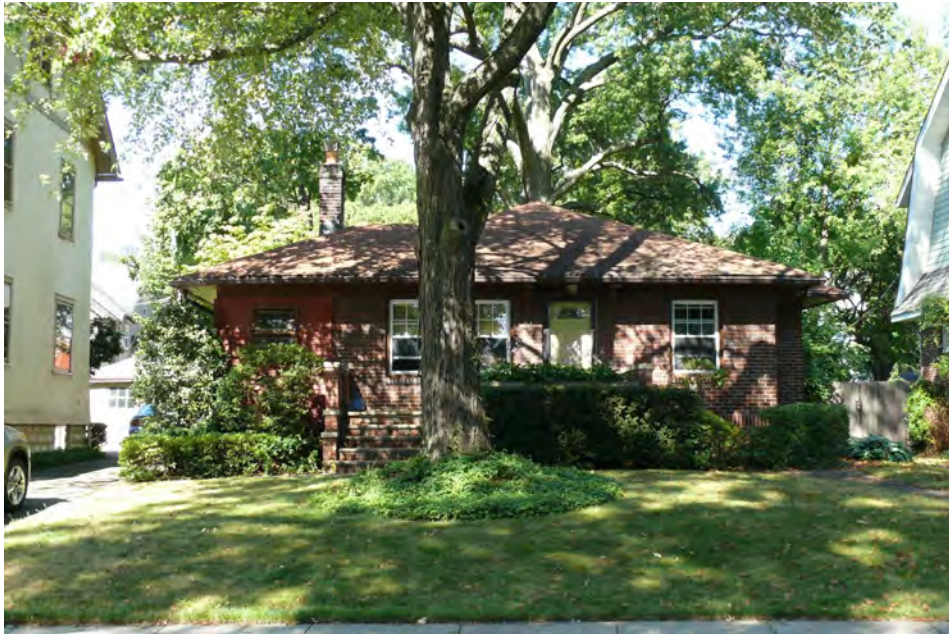
Property Photo:

There are no apparent modifications to this building other than the possible replacement of the sashes. Constructed in 1923, this is a unique building in that it is only one story in height, but it is also distinctive in its employment of Craftsman detailing such as the use of a rich red brick, the all-encompassing patio at the front that blends with the landscape, the low-slung hip roof, and the incorporation of wooden elements at the front extension. The building would be a contributing resource in the historic district.
