INTENSIVE-LEVEL ARCHITECTURAL SURVEY

WHEELER STREET AND OAKCROFT RESIDENTIAL AREAS
Township of Montclair, Essex County, New Jersey

OAKCROFT RESIDENTIAL AREA SUPPLEMENT

Project No. 1915C

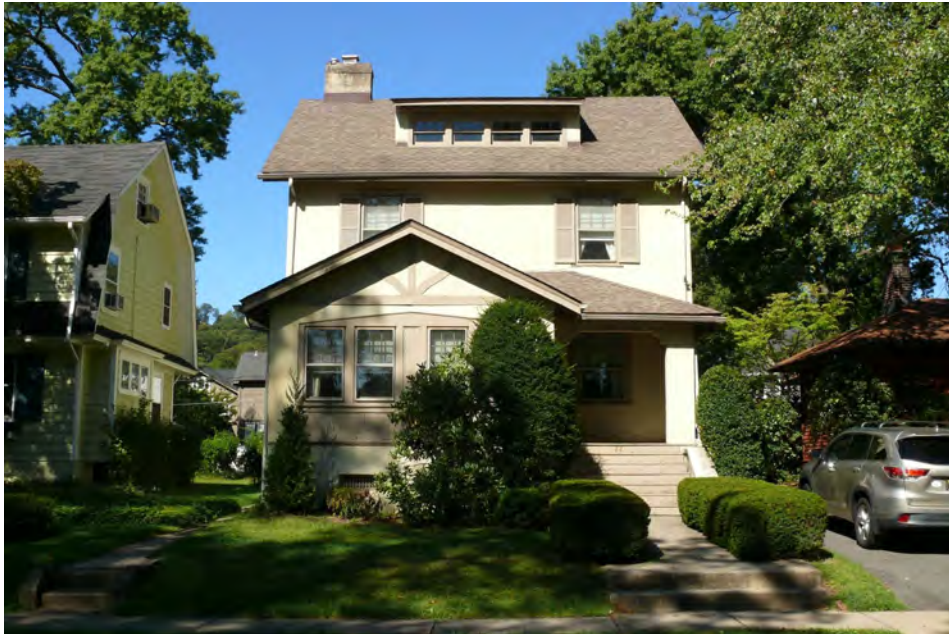
Property Photo:

This is a three-bay wide by two-bay deep, two-and-one-half story single-family residence in the Craftsman style with Tudor Revival influences. The front elevation faces northeast toward Carteret Street and the first floor is set several steps above grade. A drive is set on the north side of the property and leads to a garage set at the rear. The foundation is rock-face concrete block. The building is clad with stucco from the projecting stucco-clad water table to the underside of the roof. There is half-timbering at the gable ends. The windows are six-over-one wood-hung sashes with some variations. The trim is flat stock wood with a drip cap and narrow wood sill. The roof is a side gable that overhangs on all sides. A stucco clad chimney is inset from the south at the ridge. A wide shed dormer is set center of the roof. It is also clad with stucco and has four narrow one-over-one hung sashes grouped with narrow mullions. Both roofs are clad with asphalt shingles. The front elevation is dominated by an all-encompassing front porch. The porch is three bays wide with the south and center bays pulled forward of the north bay. The larger forward bays have a front gable roof and the shallower north bay a hip roof that connects with the gable roof to share a cornice line. The gable end is finished with half-timbering. There is one large pointed segmental-arched opening under the gabled section. It is infilled with two pairs of six-over-one sashes with a wide paneled mullion set between each pair. The whole assembly sits on a paneled low wall from deck to sill height. The same assembly is carried to the south elevation with three grouped windows and to the north elevation with a single window. Adjacent to this window is the opening to the front door set in the north side; it is a 15-light wood door. This door opens to a wood deck covered by the shallower hipped roof section of the porch. The front opening and north side opening both are flat arches with molded corners and lack fenestration. A window is set center of the opening at

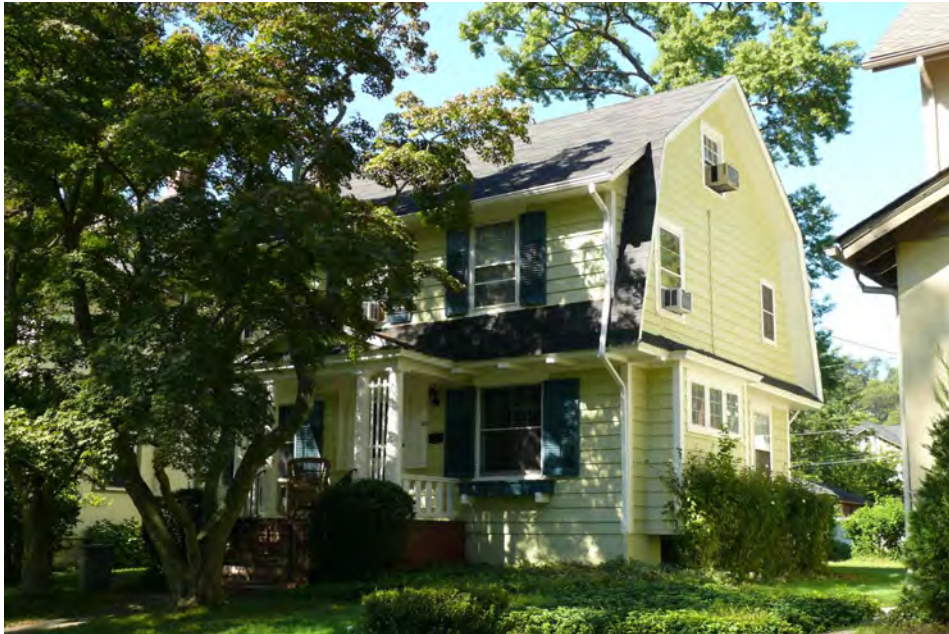
Property Photo:

This is a three-bay wide by two-bay deep, two-and-one-half story, single-family residence in the Colonial Revival style. The front elevation faces northeast toward Carteret Street and the first floor is set a few steps above grade. A driveway is set on the south side of the property. The foundation is parged masonry. The building is clad with wood clapboards with corner boards. The windows are hung and of different configurations with flat-stock trim and narrow wood sills. The roof is a side gambrel that overhangs the first floor and returns to a slight pent on each end. There is a shed dormer that runs almost the full width of the roof and it is detailed the same as the main building. Both roofs are clad with asphalt shingles. The overhang at the front is supported by thin, flat corbels with a narrow trim board set just below the soffit and above the head of the first floor window trim. The front entrance is set center of the elevation. It has a gabled overhang with the cornice aligned with the edge of the main roof and a full return at the front. The overhang is supported by a pair of Doric columns at each end that are set on a brick landing with brick stairs set center. The columns have molded capitals and bases with lattice set between each. The railings at the stairs are metal. The railing at the landing is composed of a top and bottom rail with wide balusters set a distance apart. The door is set behind a wood screen and has two infilled sidelights that are only partial height. Set to either side of the entrance in each outer bay is an eight-over-one hung sash. Centered in each bay at the dormer, three in total, are single six-over-one hung sashes. A brick fireplace back and chimney is set center of the south elevation. There are eight-over-one sashes in each bay at the first floor, six-over-one at the second, and a smaller six-over-one at the attic. The north side is similar but with a box bay projection at the first bay with three awning sashes grouped and set under a slight roof projection with cornice that aligns with the pent at the main

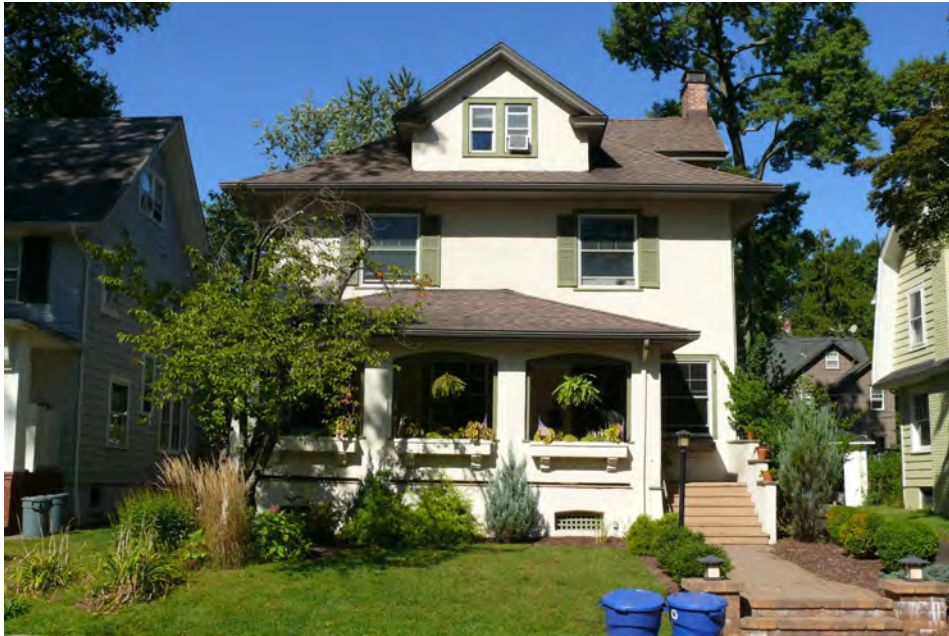
Property Photo:

This is a two-bay wide by two-bay deep, two-and-one-half story single-family residence in the Craftsman style. The front elevation faces northeast toward Carteret Street and the first floor is set several steps above grade. There is a drive set on the north side of the property which leads to a garage at the rear. The foundation is rock-face concrete block. The building is clad with stucco from grade, including a stucco-clad water table, to the underside of the roof. The windows are typically six-over-one hung sashes with narrow flat-stock wood trim with drip cap and narrow wood sill. The main roof is a hip with flared eaves to a projecting eave finished with soffit boards. Centered on the front and north gable roof are gabled dormers with projecting molded cornice with slight return on their face. A chimney is set center of the dormer on the north side; it is stucco clad from grade to dormer roof and then is brick above the roof. All roofs are clad with asphalt shingles. Slightly off-center to the south at the first floor is a three-bay wide stucco-clad porch with hip roof. Each bay of the porch is distinguished by stucco piers with segmental arched head openings between and a low stucco-clad wall at each opening; these walls have narrow slats to let the floor drain and below that are small segmental arched head openings with lattice. Set to the north are a wood stair and landing enclosed by a low stucco-clad wall on its north end. This leads to the porch level where the front door is set aligned with the first bay of the porch. At the top of the landing at the main block is a typical sash. The door is next to it. Spaced equal distant apart along the balance of the first floor are two typical window openings. At the second floor there is one typical sash in each outer bay. At the gable there is a pair of one-over-one hung sashes with wood mullion. The fenestration at the south elevation is fairly regular with a window or a pair of windows approximately in each bay. The north elevation only has windows at the first floor. There is a one-story shed roof

structure at the rear that appears to be original based on the maps and detailing. The garage is one-bay wide with a gable roof and clad with clapboard siding with corner boards. The door is either non-existent or open at the time of the survey. The Essex County tax records indicate a construction date of 1912 and this is confirmed by the city directories. The window sashes appear to be replacement material simply based on their detailing. The building is a fine example of a simply detailed Craftsman style influenced residence with prominent front porch, prominent hip roof, and asymmetrical placement of porch with the side stair filling out the composition. The building would be a contributing resource in the historic district.

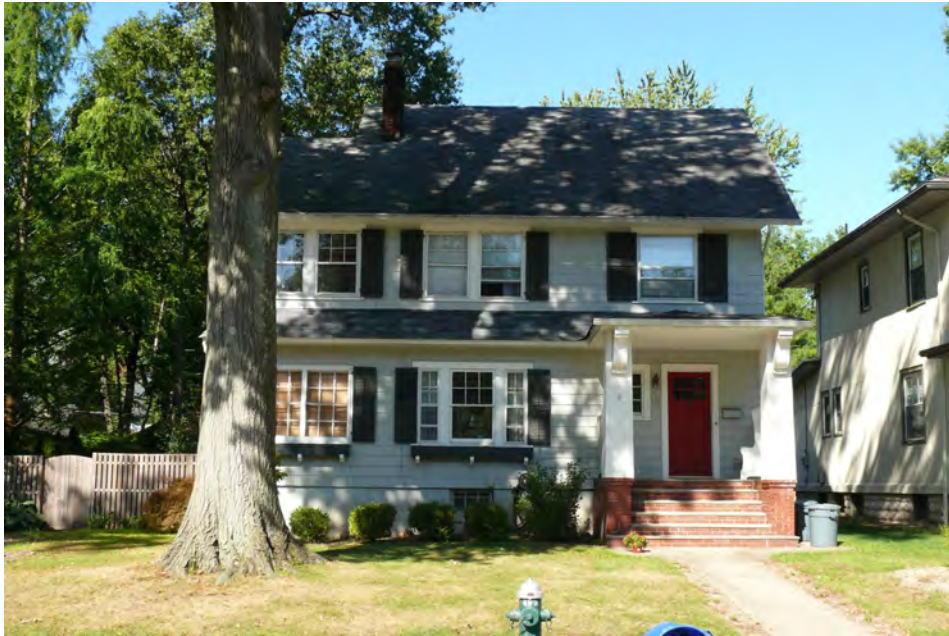
Property Photo:

This is a three-bay wide by two-bay deep, two-and-one-half-story single-family residence with Craftsman style detailing on a traditional Colonial Revival form. The front elevation faces northeast toward Carteret Street and the first floor is set several steps above grade. There is a drive set on the south side of the property. The foundation is parged masonry. The building is clad with wood shingles with mitered corners. The windows are typically six-over-one wood-hung sashes with some variation. The trim is flat stock wood with drip cap and narrow wood sill. The main roof is a side gable with simple boxed overhang with flush soffit boards. A two-story extension, shallower than the main block, is set on the south side; it also has a side gable and the downward slope of both gables align and the eave condition continues. A brick chimney is set downslope to the front on the south side of the main roof. A pent roof is set between the first and second floors, which connects with a shallow hip roof projection over the front entrance in the north bay of the main block. Two massive canted posts with large molded brackets set at their front face support the end of this roof. These posts are unadorned, other than the brackets, and rest on brick piers with a brick wall behind that enclosing the brick stairs and landing treated with limestone treads. At each side of the landing are built-in benches with the backs being tall wide wood balusters set between a top and bottom rail. The seat is set just short of the posts creating a solid bench end. The front door, set off-center to the north, is eight-light over one-panel wood with a six-light casement set next to it but apart. In the center bay are three grouped sashes: two flanking four-over-one hung sashes with a center, wider six-over-one hung sash. Centered in the extension are a pair of six-over-six hung sashes. At the second floor across the main block and extension from north to south are a single eight-over-one hung sash, a pair of six-over-one hung sash, and another pair of six-over-

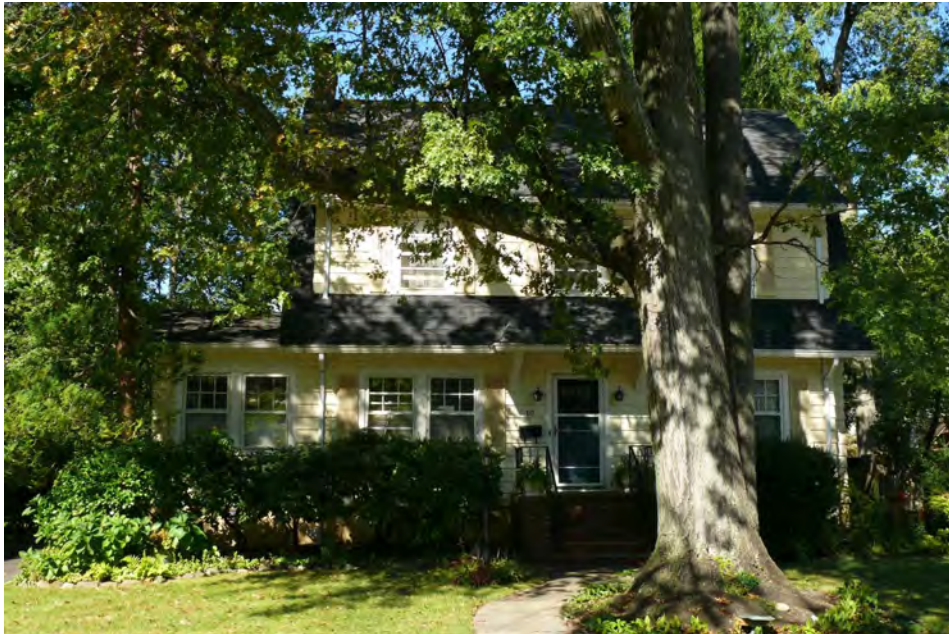
Property Photo:

This is a three-bay wide by two-bay deep, two-and-one-half story single-family residence in the Colonial Revival style. The front of the building faces northeast toward Carteret Street and the first floor is set a few steps above grade. The building has a wide frontage and the driveway is set to the north side. The foundation is parged masonry. The siding is wood clapboard with mitered corners. The windows are typically six-over-one hung (they appear to be replacements) with flat-stock trim with drip cap and narrow wood sill. The roof of the main block is a side gambrel with an almost full shed dormer set along its front. The gambrel returns at its ends to create a pent above the first floor at each side. This is interrupted on the south side by a one-story extension with shallow gable roof that sits within the expanse of the pent. This roof also returns on its gable end. All roofs are clad with asphalt shingles and the roofs project on all sides with molded cornice and rakes. A brick chimney is set abreast of the south wall at the ridge of the main roof. The front door is set center of the main block and is a four-light over two-panel wood door set behind a storm door. A shallow hip roof projects from the section of main roof below the dormer over the brick stoop. This projection is supported at each end by large molded wood brackets. The stoop and stair are brick with metal railings; the stoop is wider on both sides than the stair. In each of the outer bays at the main block on the first floor are a pair of typical sashes with wood mullion. The same windows are carried to the one-story extension to the south. At the dormer, there is a single typical sash in each bay, three in total. The south side of the extension has three grouped sashes with narrow wood mullions. To either side of the chimney at the second floor and attic levels are typical sashes with the attic windows being smaller in size. On the north side, there is a box bay projection with its roof being the pent of the gambrel return, it has two 12-light clerestory sashes.

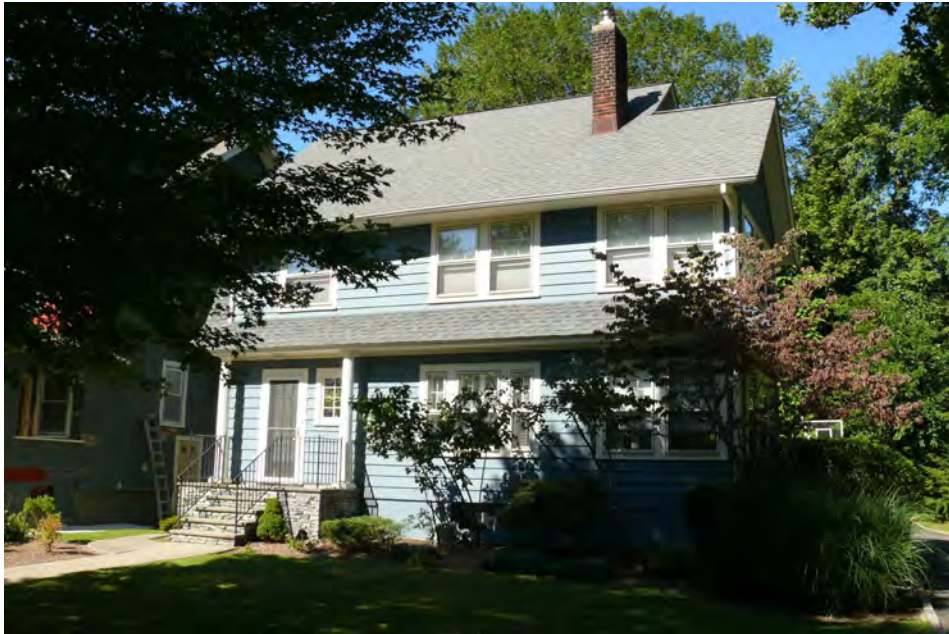
Property Photo:

This is a three-bay wide by two-bay deep, two-and-one-half story single-family residence with Colonial Revival influences. The building faces northeast toward Carteret Street and the first floor is set a few steps above grade. The foundation is parged masonry. The building is clad with wood clapboards with beaded corner boards. The windows are typically six-over-one hung sashes with flat-stock trim with drip cap and narrow wood sill. The building has a main block to the south and a narrower two-story block to the north that aligns with the front of the main block. The main block has a side-gambrel roof and the extension a side-gable roof. Across the gambrel is a shed dormer. The dormer and the downward slopes of the gable align at the break of the gambrel so it presents a continuous eave line at the front at the second floor. The roofs overhang slightly on both sides. At the two-story extension, where the lower portion of the gambrel sits at the first floor ceiling height is a pent roof so that this lower cornice line also aligns and continues the perimeter of the building. A brick chimney is set on the downward slope, mid-way on the south end. The front entrance is set in the south bay of the main block and is a 15-light door with an eight-light casement next to it. To either side are fluted Doric columns set just under the eave of the main roof. These are set on a wide stone-clad stoop with stone-clad steps set center and a metal railing on all open sides. In the center bay are three grouped sashes with two narrow four-over-one flanking a typical sash. Centered in the north bay of the two-story extension are a pair of sashes with mullion. At the second floor are a single sash in the south bay, a pair of sashes in the center bay and another pair in the north bay. The fenestration pattern is fairly regular along the south elevation with a mid-floor central window between the first and second floors. The extension has three grouped sashes at the first and second floors. The balance of the elevation is not readily visible from the street.

Despite the changes noted above, the building continues to reflect the Colonial Revival influences in its architecture with the treatment of the roofs in a well-thought-out manner to present a seamless whole in terms of composition especially along the front. The building would be considered a contributing resource in the historic district.

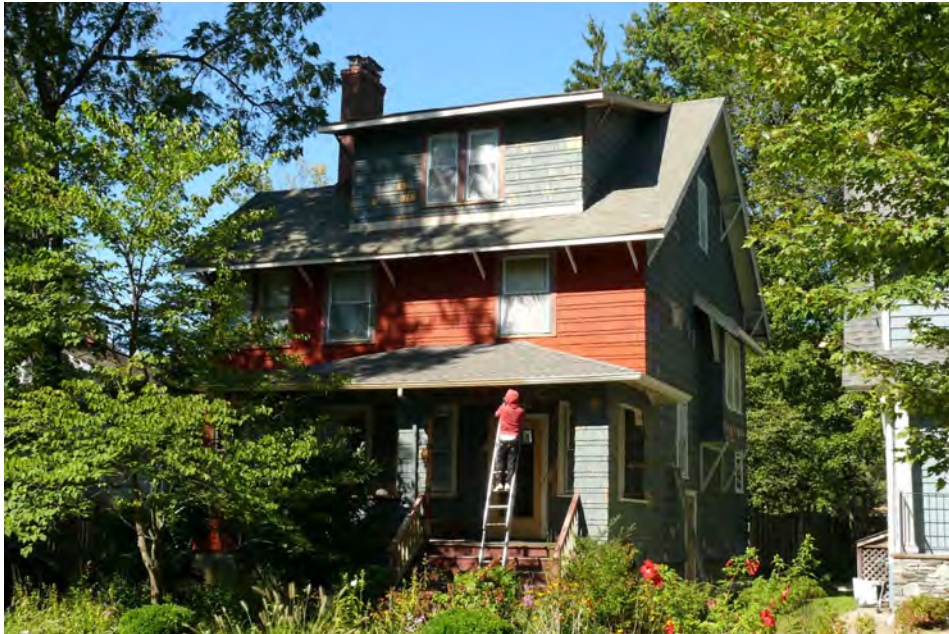
Property Photo:

This is a three-bay wide by two-bay deep, two-and-one-half story single-family residence in the Craftsman style. The building faces northeast toward Carteret Street and the first floor is set several steps above grade. The foundation is parged masonry. The building is clad with wood shingles with alternating deep and narrow exposure. The windows were covered at the time of survey as the building was being repainted; they appear to be one-over-one hung sashes. The trim is flat-stock wood with a narrow wood sill. The building has a main block to the north and a narrower two-story block to the south that aligns with the front of the main block. Both have side-gable roofs with their front downward slopes aligning. The roofs are clad with asphalt shingles and there is a deep overhang with rafter tails exposed. From the front face of the building, wood brackets are set at an angle to support the eave. A large shed dormer with the same detailing as the main roof except for the brackets is centered on the main roof. It is clad with wood shingles and there are a pair of tall hung sashes with mullion set center of the dormer. A brick chimney is set abreast of the south end wall at the ridge. The first floor has a one-story porch that is set across the main block. It is clad the same as the main building, is two equal bays wide, and has a hip roof. A low wall is set at each bay except the north, which aligns with the front entrance. The stairs to the porch are wood and there is a wood railing with newel, top and bottom rail, and wood balusters set to either side. The north bay at the first floor of the main block contains a window to the north and one-light wood door to the south, while the south bay has two windows. At the second floor of the main block there are single windows in each bay that are set slightly off-center to the south. The two-story extension has two typical windows at each the first and second floor at the front, and four windows at the both floors at the south side. The fenestration on the north side is regular with a door to

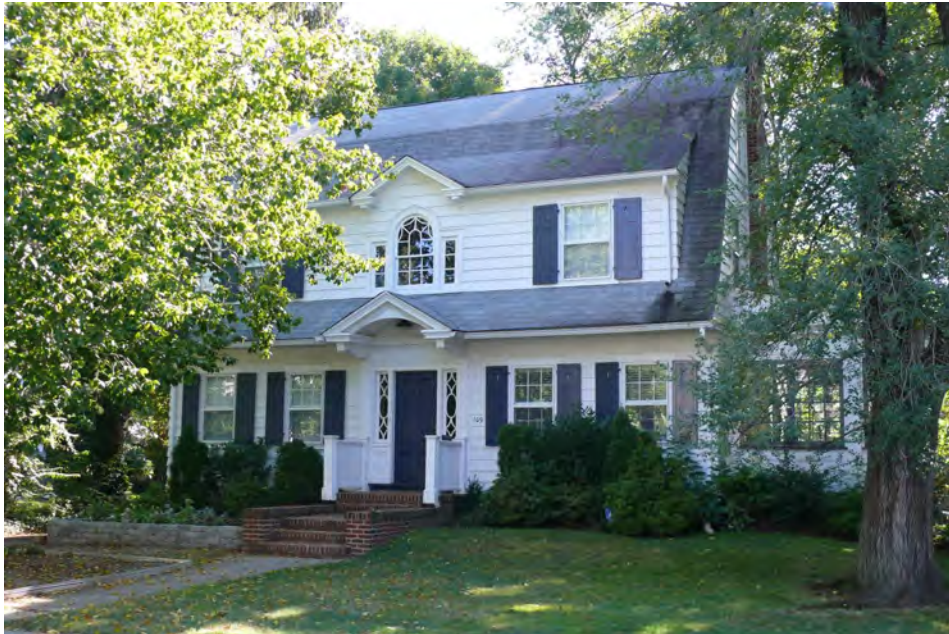
Property Photo:

This is a three-bay wide by two-bay deep, two-and-one-half story single-family residence executed in the Colonial Revival style. The front elevation faces northwest toward Edgemont Road and the first floor is set a few steps above grade. There is a one-story enclosed porch on the south side. The property front lawn is set level with grade. The foundation is parge-clad masonry. The building is finished with wood clapboards with mitered corners. The windows are typically six-over-six wood-hung sash with flat-stock trim with drip cap. The main roof is a front gable with a full-width shed dormer with a small gable peek at its center with corbels supporting each end of the gable. The roof over the enclosed porch is a shed. Both roofs are clad with asphalt shingles. A brick chimney rises along the south wall and is centered on the ridge. In the center bay at the first floor is the main entrance; a six-panel wood door with sidelights. The sidelights are composed of a center circle with diamond panes top and bottom with one-panel below each sash. Set to either side of the door assembly are fluted pilasters with molded capitals and bases. The door is set under a gabled hood with a half-round arch detailed with dentils and set between each gable return. The whole assembly is supported by wood bracket that are set above the pilasters. Brick stairs with brick side walls lead to a brick stoop with wood railing set to either side. The railing has a large square newel at each end with top and bottom rail set between with square wood balusters. To either side of the door in each outer bay are two typical sashes set apart. The enclosed porch is similarly detailed to the main entrance. It is three unequal bays wide by three unequal bays deep. The front is articulated with a wide north bay and a narrow south outer bay. Set between each is a plain wood pilaster set under a deep molded entablature. An eight-light casement with wood panel below occupies the narrow bay and a pair of 12-light casements with panels below occupies the north

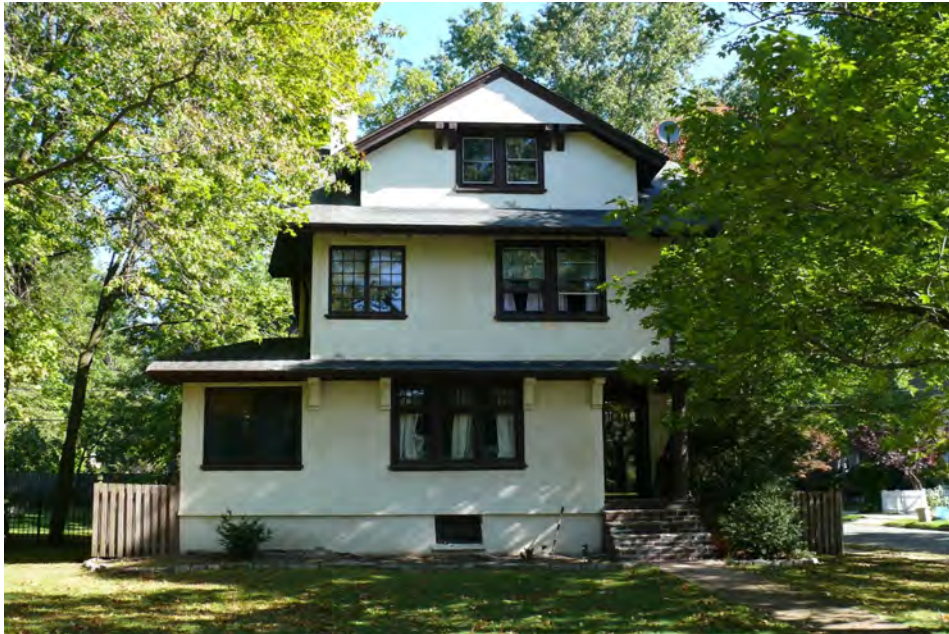
Property Photo:

This is a three-bay wide by three-bay deep, two-and-one-half story single-family residence in the Craftsman style. The building is set at the corner of Carteret Street and Godfrey Road and is set back on each side for substantial lawn pretty much on all four sides of the property. The front faces southeast toward Godfrey Road and the drive is set along Carteret Street along the north side of the property. The first floor is set several steps above grade. The foundation is parged and the building is clad with stucco from the flared edge above the foundation to the underside of each level of roof. The windows vary including the surrounding treatment. The main roof over the two-story section is a side gable with jerkinhead detailing at each gable end. The roof is clad with asphalt shingles and the roof overhangs substantially on all sides. Rafter tails are exposed on the sloping sides and the soffits of the gable ends are flush boards. Centered on the main roof is a large gabled dormer that also overhangs and has exposed rafter tails. The peak of the gable is a stucco-finished projection set flush with the rake and supported by a pair of wood brackets set to either side of a pair of six-over-six wood-hung sash. The sashes have a dividing mullion, projecting wood sill and flat-stock trim with a molded outer edge. The body of the dormer is finishes with stucco. A stucco chimney is set to the west of the dormer just below the ridge. The west bay at the first floor is a one-story projection with a hip roof. The roof edge extends to a pent roof across the first floor and it is supported by stucco-clad brackets set about center of the main block. Centered in the west bay are a pair of 15-light in-swing casement set behind storms. The trim is very narrow and the sill is molded and slightly projects. In the center bay are three grouped ten-light over one-light hung sash with the upper sash being half the height as the lower sash. The trim is molded wood with a projecting sill. Centered under this window at the basement is a three-light awning in a

The Essex County tax records indicate at construction date of 1910; however, a building permit is noted in the Montclair Times in May 1911 by Godfrey's development company, and the cost of construction is noted as \$ 4,590 (The Montclair Times 5/20/1911). There appear to be few changes to the building other than the addition of exterior storms and a rear deck.

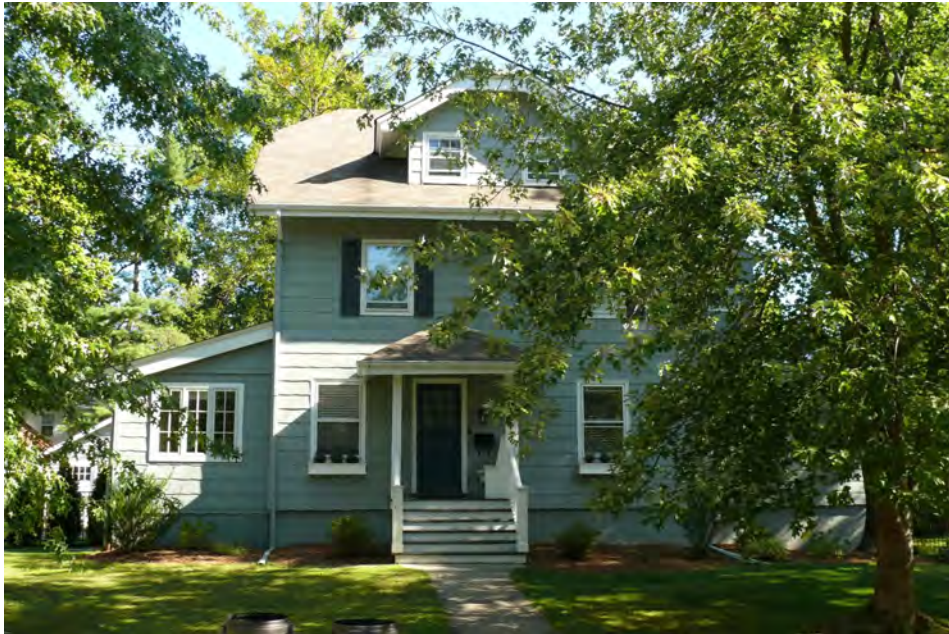
Property Photo:

This is a two-bay wide by two-bay deep, two-and-one-half-story single-family residence with Craftsman style influences. The building faces northwest toward Godfrey Road and the first floor is set several steps above grade. The building is set back from the sidewalk with lawn on the front and two sides as it is a wide lot for the block. The driveway is set to the west side and leads to a garage at the rear of the property. The foundation is parged masonry. The building is clad with shingles with a narrow corner treatment. The windows vary. The trim is typically a narrow molded outer edge with a narrow sill. The main roof is a side gable with jerkin head details at both ends clad with asphalt shingles. Centered on the roof is a gabled dormer also with the jerkinhead detail. The walls are clad with wood shingles and there are two sashes, one each six-over-one spaced apart. At the first floor of the main block, the entrance door is set off-center to the west. It is a nine-light over two-panel wood door access from a narrow wood porch and wood stairs. Over the stoop is a hipped roof hood that overhangs the stoop on all sides and is supported by two square posts supported by parged masonry piers. The railings set to either side of the stair and porch landing are wood with paneled newels, a top and bottom rail, and square balusters. The east side of the landing is a built-in wood deal. Immediate to the west of the door and hood are a one-over-one wood hung sash. Centered in the east bay at the main block is a similar sash. At the west side of the main block is a one-story extension with shed roof. It is clad the same as the main block. There are three group six-light casement sashes set at the center with flat-stock trim and narrow sill. The roof edge is treated with a wide flat-stock rake board. The roof is clad with asphalt shingles. The same pattern of windows is carried to the west side, which is set back from the main block slightly, but extends the full depth of the main block. The window pattern is two groups of three casements and

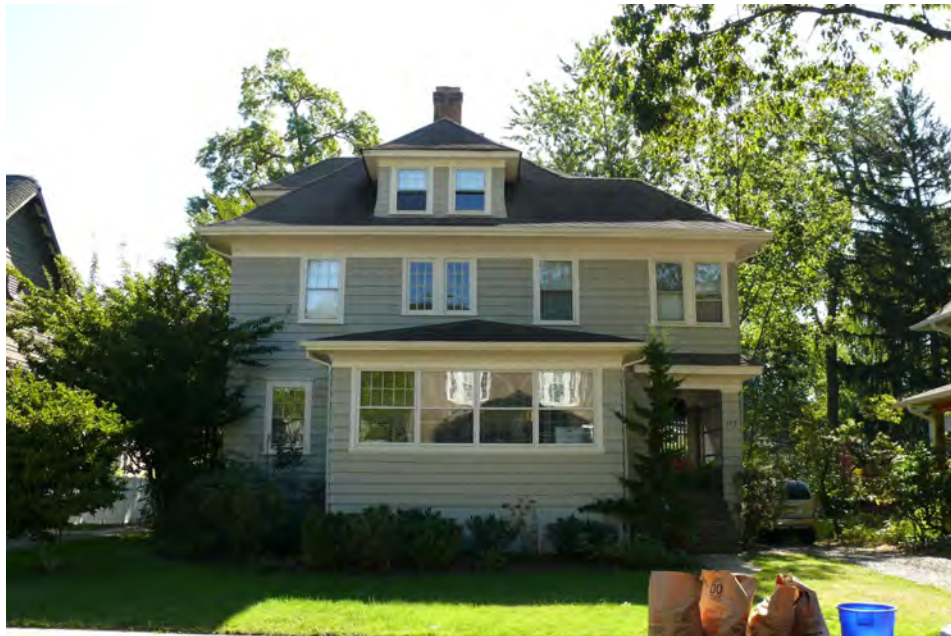
Property Photo:

This is a four-bay wide by two-bay deep, two-and-one-half story single-family residence. The front elevation faces southwest toward Edgemont Road and the first floor is set several steps above grade. A drive, set on the south side of the house, leads to a garage at the rear of the property. The foundation is parged masonry. The body of the building is clad with wood clapboard with mitered corners. The windows are typically six-over-one wood-hung sashes with flat-stock trim detailed with molded drip cap and narrow projecting wood sill. The main block, which is three bays wide, has a truncated hip roof clad with asphalt shingles and a built-in gutter with a cornice of curved soffit boards set on a narrow entablature that also serves as the head of the second floor windows. As part of the original construction is a one-bay, two-story extension to the south that has its own hip roof that joins the main hip roof about center of its ridge. The built-in gutter and cornice are continuous between the main roof and the extension. Centered on the main roof at the front and north side are dormers with hipped roof and a projecting cornice with soffit and narrow entablature. These are clad with asphalt shingles at the roof and wood clapboard at the walls. Centered in each are six-over-one wood-hung sashes set apart. A shed roof dormer, similarly treated, sits behind the south extension about center of the roof, and a chimney is set center of the roof at the upper hip. Centered on the entire first floor level is a two-bay front extension with hip roof and similar built-in gutter and cornice as the main roof. There are four, 10-over-one wood-hung sashes grouped together with a narrow mullion. The same pattern is set on both sides of the extension but with narrower, six-over-one wood-hung sash. To the north of this extension at the first floor is a single typical sash. To the south is the front entrance. An entry porch is set under the second floor of the two-story extension and is articulated with a corner post clad with wood clapboards. The corner

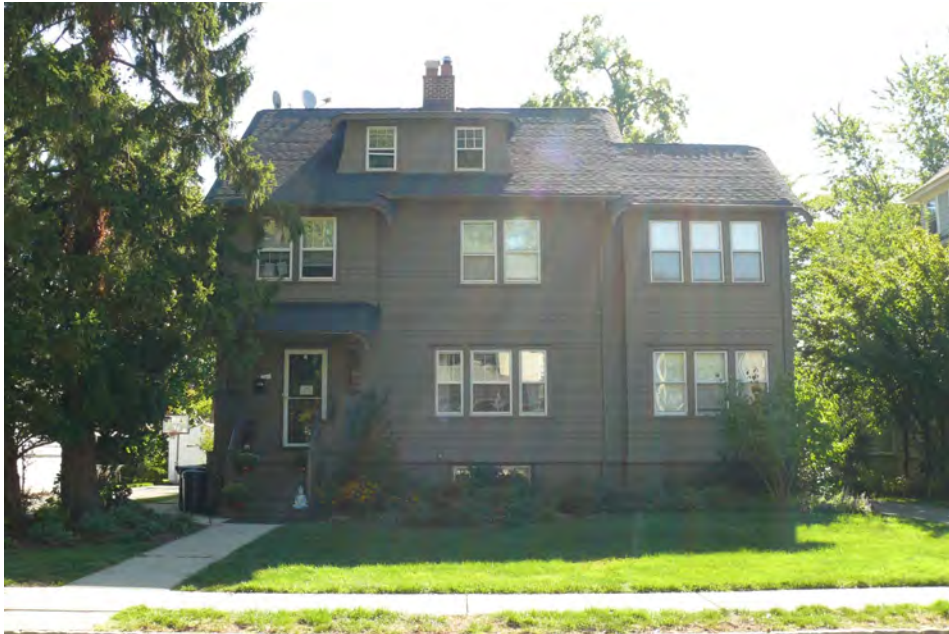
Property Photo:

This is a three-bay wide by two-bay deep, two-and-one-half story single-family residence with Craftsman style influences. The front elevation faces southwest toward Edgemont Road and the first floor is set several steps above grade. A drive is set along the south side of the property and leads to a garage at the rear. The foundation is parged masonry. The upper levels are clad with wood shingles of alternating deep and narrow exposure. The windows are six-over-one wood-hung sashes with flat-stock trim detailed with drip cap and narrow wood sill. The building has two components: a two-bay main block and a one-bay south extension. The extension is two stories and aligns with the front wall of the main block but it is shallower than the main block. Both sections have a side-gable roof with the eaves curved so the asphalt shingles overhang; the overhang is supported by a series of projecting purlins and the end rafters at each gable project at the start of the curve. The roof slopes of both gables align at the front and the roofs project further of the north bay at the main block and over the extension creating a varied roof edge of curves and straight runs. Centered on the main roof is a wide shed dormer with the same roof treatment at its edges. It is clad with wood shingles that flare slightly where they meet the roof. There are two typical windows set apart. The north bay is narrower than the center bay and projects slightly at the second floor over the door. The door is covered by a shed hood with the same covered edges. The shed hood has exposed rafters supported by a center purlin that rest on heavy curved brackets on each side of the door. The door opens to a wood stoop with wood stairs and wood railings on each side. The railings are detailed with newels, top and bottom rails, and square wood balusters. Centered above the door at the second floor are a pair of hung sashes with wood mullion. Centered on the wider bay at the main block on the first floor are three grouped windows and at the

The tax records indicate a construction date of 1913 and the city directories confirm this. The only noted possible changes are the windows; it is not clear if these are original or newer or a mix of both as their white color against a very dark opening make the materials difficult to read.

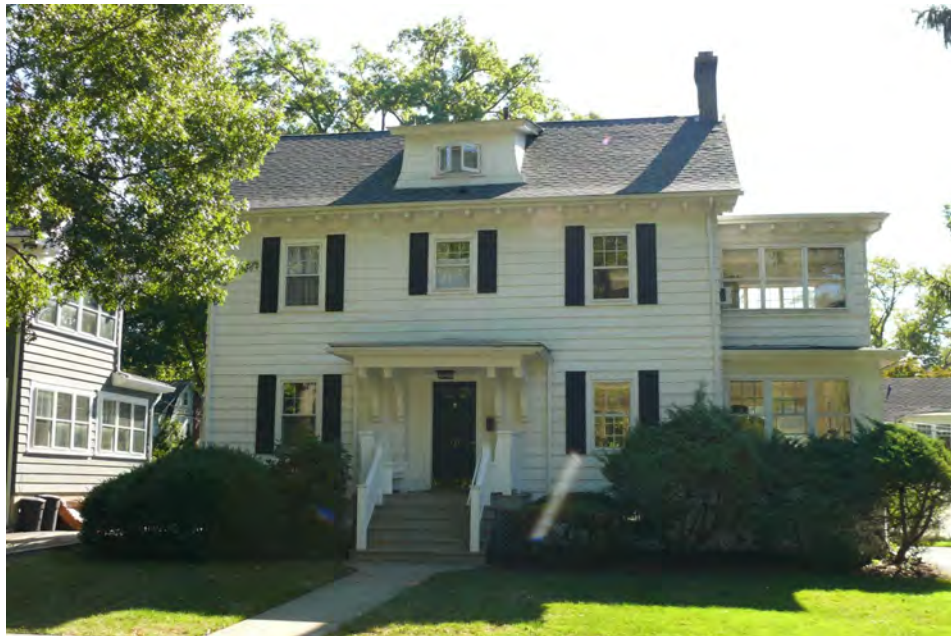
Property Photo:

This is a three-bay wide by two-bay deep, two-and-one-half story single-family residence in the Colonial Revival style. The front elevation faces southwest toward Edgemont Road and the first floor is set several steps above grade. A drive is set along the south side of the property. The foundation is parged masonry. The building is clad with wood clapboards with mitered corners. The windows are typically six-over-one wood-hung sashes with flat stock wood detailed with molded edge and beaded inner edge and a narrow wood sill. The roof is a side gable clad with asphalt shingles with a flare before transitioning to a built-in gutter with substantial molded cornice supported by shallow molded corbels set on a molded entablature. The cornice returns at each corner of the gable end. A brick chimney is set proud of the south wall at the gable peak. A shed dormer is set center of the main roof; it is clad with wood shingles that flare slightly where it transitions to the roof. Centered in the dormer is a pair of one-light casement sashes. The front door is set center of the main block. Wood steps and stoop lead to the paneled door. Built-in seating is set at the side of the stoop and wood railings with square newels, top and bottom rail and square balusters are set to either side of the stair. Covering the stoop is a deep and wide projecting hip with building in gutter, molded cornice and deep architrave that is supported by pairs of molded brackets at each end. To either side of the door in the outer bays are single typical sashes. This same pattern is carried to the second floor with a smaller typical sash over the door. To the south of the main block is a two-story extension that is two-tiered. The first tier has a hip roof with a projecting cornice clad the same as the main building. There are three grouped windows in the front elevation and two groups of three at the south side. At the second level there is another wood enclosure inset from the first floor roof similarly clad with a cornice matching the main roof. Here there are just

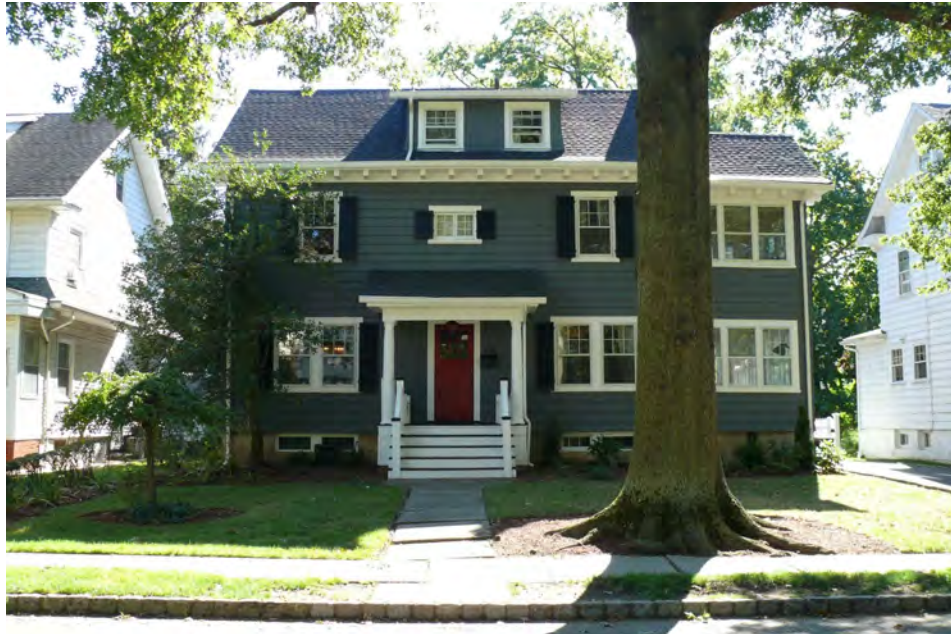
Property Photo:

This is a three-bay wide by two-bay deep, two-and-one-half story single-family residence in the Colonial Revival style. The front elevation faces southwest toward Edgemont Road and the first floor is set several steps above grade. A drive is set along the south side of the property that leads to a garage at the rear. The foundation is parged masonry. The building is clad with wood clapboards with mitered corners. The windows are typically six-over-one wood-hung sashes with flat stock wood with a drip cap and a narrow wood sill. The roof is a side gable clad with asphalt shingles that flares before transitioning to a built-in gutter with substantial molded cornice supported by shallow molded corbels set on a plain entablature. The cornice returns at each corner of the gable end. A brick chimney is set proud of the south wall at the gable peak. A shed dormer is set off-center of the main roof slightly; it is clad with wood shingles. Centered in the dormer are two small typical sashes set apart. The front door is set center of the main block. Wood steps and stoop lead to the paneled door. Built-in seating is set at the side of the stoop and wood railings with square newels, top and bottom rail and square balusters are set to either side of the stair. Covering the stoop is a deep and wide shed roof with molded cornice that is supported by Doric columns at each end of the stoop. Each column has a molded capital and base set on the wood deck which is supported by masonry walls. To either side of the door in the outer bays are paired typical sashes with mullions. This same pattern is carried to the second floor with single openings in the outer bays and paired small six-light casement sashes in the center bay. To the south of the main block is a two-story extension with a side gable roof set lower than the main roof. The roof is similarly treated as the main including flare and built-in gutter with corbel-detailed cornice. At the first floor are three grouped sashes, and at the second is the same but with one-over-one hung

The Essex County tax records indicate a construction date of 1917 and this is confirmed by the city directories. The two-story extension is similarly detailed to the main building indicating it is likely original to the building. The building, at the time of the survey, looked very clean and new so there was some suspicion the siding and trim were all replacement material. However, an image taken in 2013 shows the building a different color but with all the detail present, just needing a paint job, indicating it was painted rather than replaced. The roof, cornice, the overhang at the front door, and the apparent symmetry of the façade are all key features of the Colonial Revival influences and these have been maintained. As such, the building would be a contributing resource in the historic district.

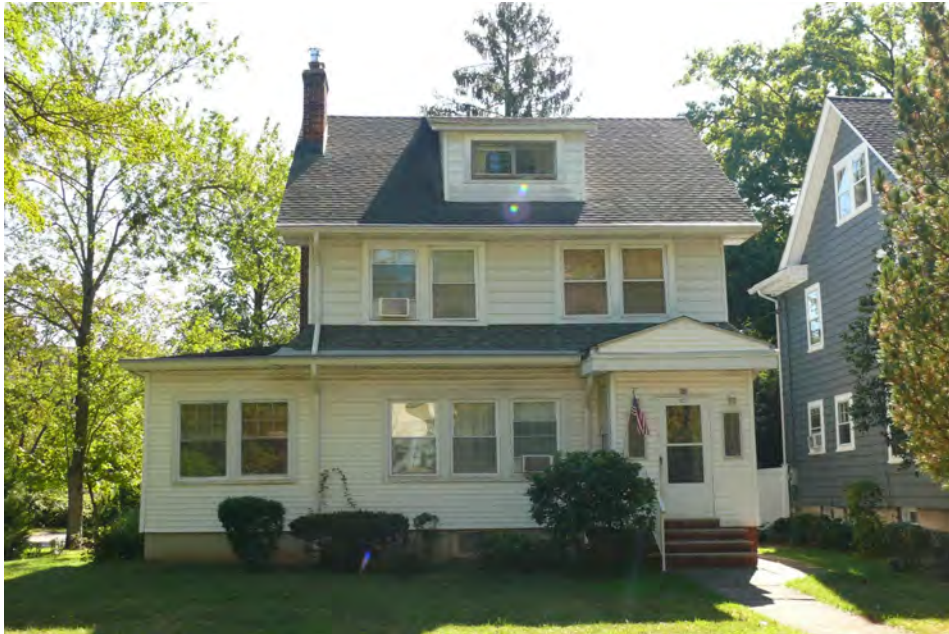
Property Photo:

This is a two-bay wide by two-bay deep, two-and-one-half story, single-family residence with Colonial Revival influences. The front of the building faces southwest toward Edgemont Road and the first floor is set a few steps above grade. The property occupies the corner of Edgemont Road and Parkside Street. There is a driveway at the east end of the property on Parkside Street that leads to a garage. The foundation is parged masonry. The building is clad with aluminum siding with corner treatments. The windows are typically one-over-one hung sashes with aluminum trim and cladding at the sill. The roof is a side gable clad with asphalt shingles with a projecting overhang on all sides with aluminum soffits. A shed dormer is set about center of the roof at the front and rear. It too is clad with aluminum and there is a single opening at the center; it appears to be a jalousie window. A brick chimney is set abreast of the north wall in the west bay. A pent roof, also clad with asphalt with aluminum soffits is set between the first and second floor on all sides of the building. From this pent in the south bay is a gable roof overhang atop a projecting entrance enclosure set on a brick stoop. All features of these elements are clad with aluminum. Brick stairs lead to a storm door set center of this enclosure. To either side of the door, set a distance from the opening, are two small fixed sashes. In the side walls of the enclosure are hung sashes. Set off-center in the north bay are three grouped hung sashes with mullions. A one-story extension is set on the north elevation, which extends a little more than half of this side of the main core. The extension has a hip roof, and its cornice aligns with the pent roof at the main core. Centered in the extension at the front are paired six-over-one hung sashes, and on the north side there are four grouped six-over-one hung sashes. The second floor at the front elevation has a pair of sashes in each bay. The fenestration on the south elevation is regular including a small hung sash at the attic.

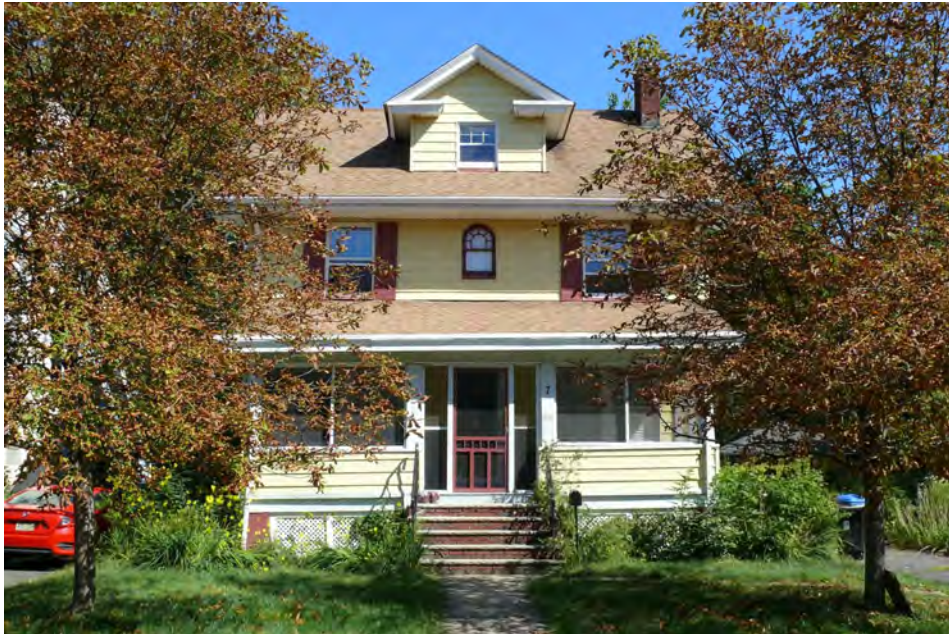
Property Photo:

This is a three-bay wide by two-bay deep, two-and-one-half story single-family residence in the Colonial Revival style. The front elevation faces southwest toward Godfrey Road and the first floor is set several steps above grade. The building is set fairly close to the sidewalk with a narrow lawn at front and a drive is set on the east side of the property. The foundation is parged masonry. The building is clad with aluminum siding with narrow corner treatments. The windows are typically six-over-one replacement sash with half screens. The trim is covered with aluminum so there is only a corner bead of aluminum and the narrow sills are clad with aluminum. The roof is a side gable clad with asphalt shingles and having a deep overhang. The cornice and soffits are clad with aluminum and the cornice returns at each gable end. A gabled dormer is set center of the roof; it has a similar overhang to the main roof, is clad with aluminum siding and has a small six-over-one hung sash. A brick chimney is set below the ridge on the east side of the roof. A one-story porch spans the entire front at the first floor level. The roof is a shed clad with asphalt shingles; the roof assembly is supported by four square posts set on parged masonry piers with lattice set between. Between the two outer bays of the porch are a pair of screened openings above a low wall, also clad with aluminum siding. Center is a screen assembly with a paneled screen and two screened side panels. Leading to this is a set of brick stairs with limestone treads and metal railings on each side. Minimally visible behind the screen are a pair of typical sash set apart in each of the outer bays and a door opening at the center bay. At the second floor, there is a typical window in each of the outer bays and a small half-round window in the center bay. It has a semicircular light configuration at the top sash with a single light at the bottom sash. The west elevation is simply adorned with one window each in the two bays at the first floor, a pair of windows at the center

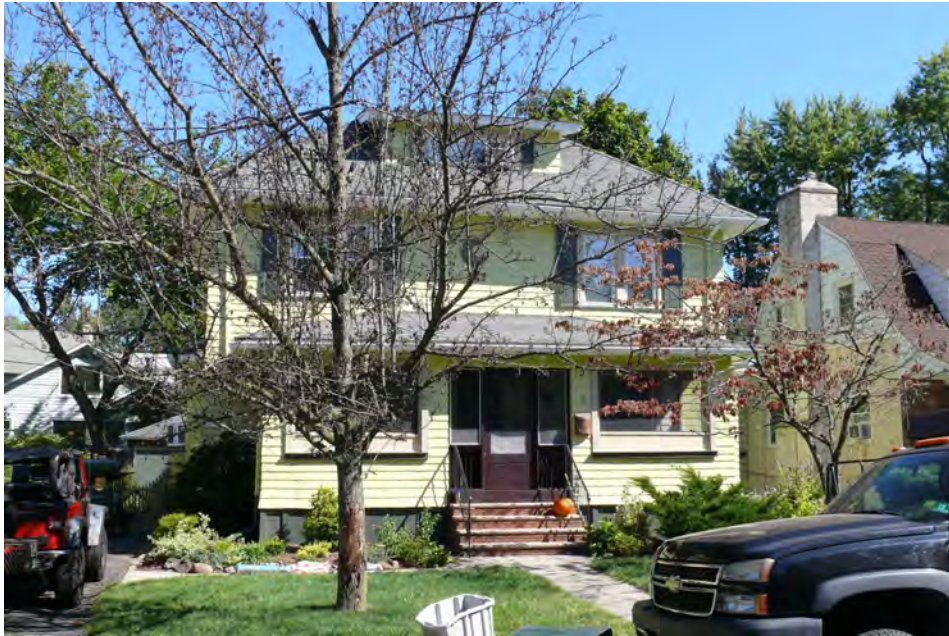
Property Photo:

This is a three-bay wide by two-bay deep, two-and-one-half story single-family American Foursquare with Craftsman style detailing. The building takes up much of its lot with a front lawn and a drive set on the west side of the property leading to a garage. The front elevation faces southwest toward Godfrey Road and the first floor is set a few steps above grade. The foundation is parged masonry. The body of the building is clad with wood shingles with mitered corners. The windows are typically one-over-one hung vinyl sash with flat stock wood trim with molded trip cap and a narrow projecting wood sill. The roof is a hip with its ridge running parallel with the street. A shed dormer is set at the center. Both roofs are clad with asphalt shingles and have sweeping overhangs. The main roof is boxed and the shed roof is angled. A one-story partially enclosed porch is set at the front. It has a hip roof clad with asphalt shingles. The porch is clad with the same shingles as the body so that all structure is covered and the whole assembly sits on a parged masonry piers with solid plywood board set between the piers. The entrance is set center and is composed of a single screen door with panel below and two screened sidelights with panels below. It is accessed by a brick stair with limestone treads and metal railings on each side. To either side of the door are large screened openings with a narrow, inset panel below before transition to the siding at the wall. The screened and paneled opening is trimmed with flat stock wood with a projecting sill. These same opening are centered in the side walls of the enclosed porch. At the second floor are paired sashes with mullions in each of the outer two bays. A sliding sash is set center of the shed dormer. On the west side, there is a box bay projection that cantilevers from the building at about center. It has three typical sash and a hip roof. Center above are two typical sashes spaced apart. A chimney is inset on the main roof this elevation. On the east side there is another boxed bay in

the south bay with foundation. It has a basement sash and a three-light clerestory window set under the hip roof. At the second floor there is a single window in each bay. There is a small one-story rear extension that appears original to the building. The garage is one bay wide with hip roof. The building is clad with narrow clapboard and there appear to be plywood doors in what was a garage opening. The Essex County tax records indicate a construction date of 1912 and this is confirmed by the city directories. The building is little changes since original construction with the possible exception that the windows appears to be replacement material. The detailing of the openings at the porch and the brick stairs are also newer material fabric. The changes to the building noted above do not diminish the overall architectural detailing of this American Foursquare and the building would be a contributing resource in the historic district.
