INTENSIVE-LEVEL ARCHITECTURAL SURVEY

WHEELER STREET AND OAKCROFT RESIDENTIAL AREAS
Township of Montclair, Essex County, New Jersey

OAKCROFT RESIDENTIAL AREA SUPPLEMENT

Project No. 1915C

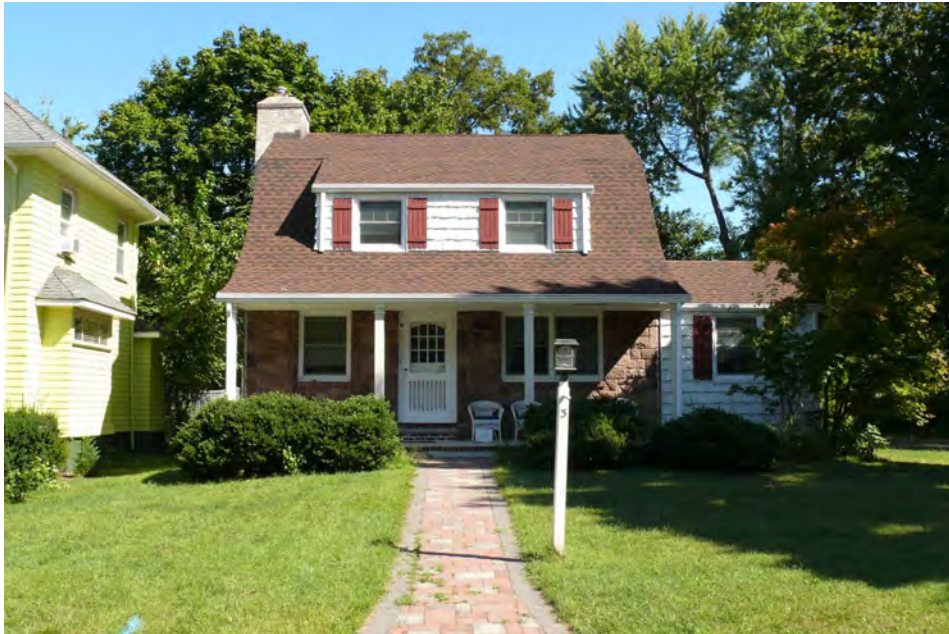
Property Photo:

This is a three-bay wide by two-bay deep, two-story single-family residence executed with Colonial Revival style detailing at its core with numerous extensions including at its front but primarily to the rear. The building is set at the corner of Oakcroft and Godfrey roads and the front of the building faces southwest toward Godfrey Road. The first floor is set only two steps above grade and there is lawn to the south and east of the property. The foundation is parged masonry. The building is clad with brownstone veneer laid in a random ashlar patten at the first floor at the front and stucco at the sides. The dormer and extensions are finished with a rough vinyl shingle. The windows are typically one-over-one sash with false muntins with flat stock vinyl trim with clad sills. The main roof is a side gambrel with a sweep at the front that extends over the front porch. The roof is clad with asphalt shingles and does not overhang at the sides. There are shed dormers set center of the roof on both sides. These are clad with the vinyl shingles and the front has a pair of windows set apart. A brick chimney and fireplace back are set center of the west gambrel end. The main roof is supported by four square wood posts set equal distant apart. They have molded capitals and shallow plinths and rest on a brick and concrete patio. The front door is set off-center to the west. It has a flat-stock wood surround and the door is eight-light over three panel wood with the lights set in a segmental arched head. To the west is a single window and to the east is a pair of windows. A one-story extension is set on the east side. It has a side gable roof, is clad with vinyl shingles and has a single window centered in its south and east sides. The west side of the main building has a single window to each side of the chimney at the first and second floor. There are two windows at the second floor on the east side and a single sliding sash to the rear of the extension. The extensions off the rear of the building and visible along Oakcroft are two stories with a cross

gable to the main roof; at the main block the second floor extends over the first and there is a shed one-story addition to the rear. The driveway, accessed from Oakcroft is set in front of these extensions and the garage partially occupies the first floor. This building was constructed in 1937. All of the extensions, although to the rear but visible along Oakcroft Road, almost double the size of the main building. The stucco finishes at the sides appear to be a modification but unclear how, and the vinyl siding and replacement windows are also changes to the building.

The front elevation and roofline including the sweep over the front porch are well executed with regard to the Colonial Revival detailing but the rear extension and the other noted changes tend to negate this especially since much of the changes are visible along Oakcroft. As such, the building would not be a contributing resource in the historic district.

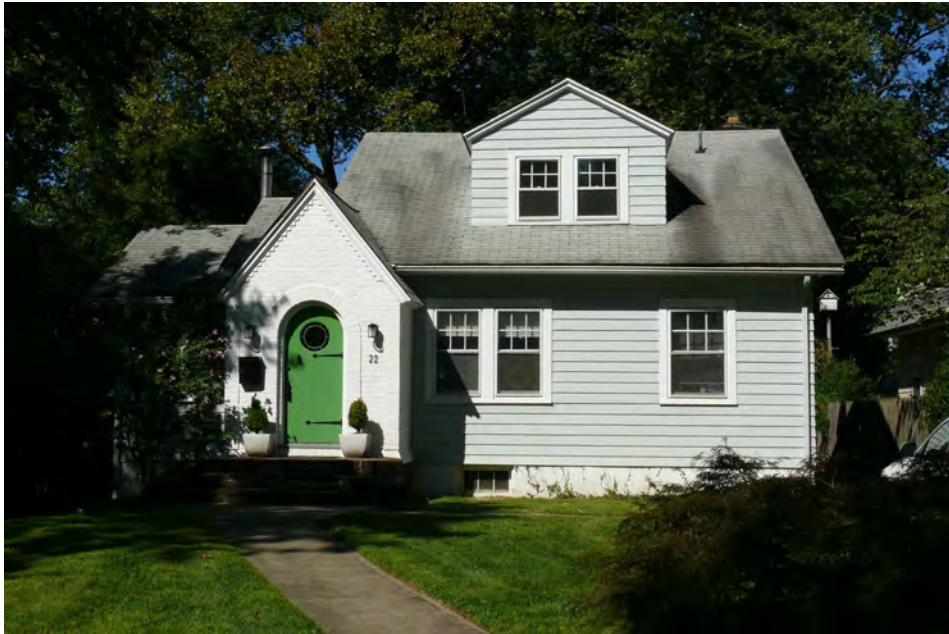
Property Photo:

This is a three-bay wide by two-bay deep, one-and-one-half-story single-family Cape Cod residence. The front of the building faces northeast toward Oakcroft Road and the first floor is set a few steps above grade. The street is set at an angle and there is a small area of lawn to the front with a short driveway on the north side of the property. The foundation is parged masonry. The building is clad with clapboard siding with mitered edges. The windows are typically six-over-one sash, of replacement composite material. The trim is flat-stock wood with a drip cap and a narrow projecting wood sill. The main roof is a side gable with slight overhang on all sides and clad with asphalt shingles. Center on the roof is a gabled dormer similarly treated to the main building with a pair of sashes with mullion centered on it. There is a one-story extension set in the south bay with a front gable roof. Set to the west and south of this is a one-story extension also with a side gable with its front downward slope aligned with the main roof. Both of these extensions are original to the building. Beyond this smaller extension to the south is a one-story addition with a side gable set just below the gable of the extension so the whole addition is stepped in slightly at the roof and both sides to frame the larger extension. The front extension serves as the main entrance. It is clad with painted brick with a slight corbel detail set below the molded rake. The door is centered on the extension, has a half-round head delineated with slightly proud soldier-laid brick. The brick at the corners is also set slightly proud. To the north in the center bay are a pair of sashes with mullion and at the north bay is a single opening. There is a single three-light awning sash in the basement. The south side addition is covered with vegetation but there appears to be large, single-light sash (operation unknown) at the front and sides. The north side is almost devoid of fenestration; there is a three-light clerestory in the north bay with a small casement next to it and a

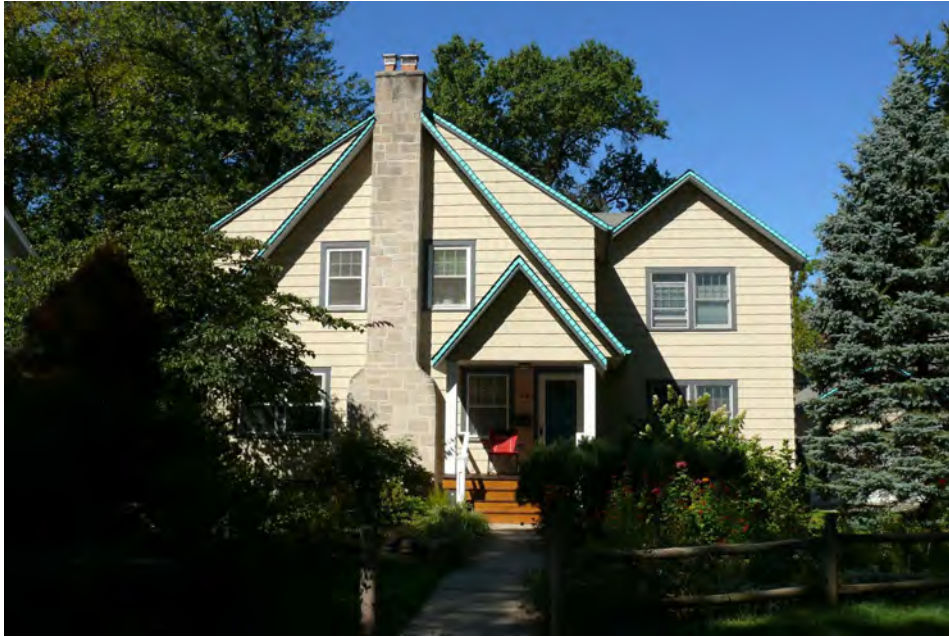
Property Photo:

This is a two-bay wide by two-bay deep, two-story, single-family residence with a large two-story addition located northwest of the main block. The main block has Craftsman style influences that are carried to the addition. The building is set back from the sidewalk creating a front lawn and the driveway is set on the north side of the wide property with a garage set toward the rear property line. The foundation is parged masonry. The main block and addition are clad with wood shingles with mitered corners. The windows, which are replacements, are one-over-one hung sash with false muntins. The trim is flat-stock wood with narrow wood sills. The main roof is steeply pitched gable with two full shed dormers set on either side of the gable. Centered in the main gable on the front elevation is a brownstone fireplace back and chimney laid in a random ashlar pattern. The two-story extension also has a front gable with a much shallower pitch. All of the roofs are clad with asphalt, have a deep extension with beaded board soffits. There is a shingled detail along the edge of the roof that is painted a contrasting color instead of a rake board or laid on top of the rake board. The dormers at the main roof each have typical sash, one on the north side and two on the south side. The downward slope of the extension dies into the downward slope of the main building creating a cricket condition at these roofs. The main entrance is set under a gabled roof porch extension in the north bay of the main block. The roof, detailed the same as the main roof, is supported by two square posts set on a wood deck, which is supported by parged masonry piers with lattice set in between. The wood stairs span almost the full width of the deck and have a simple wood railing ended at paneled newel posts at each side. The railing, consisting of a top and center rail, continue at the two open sides of the

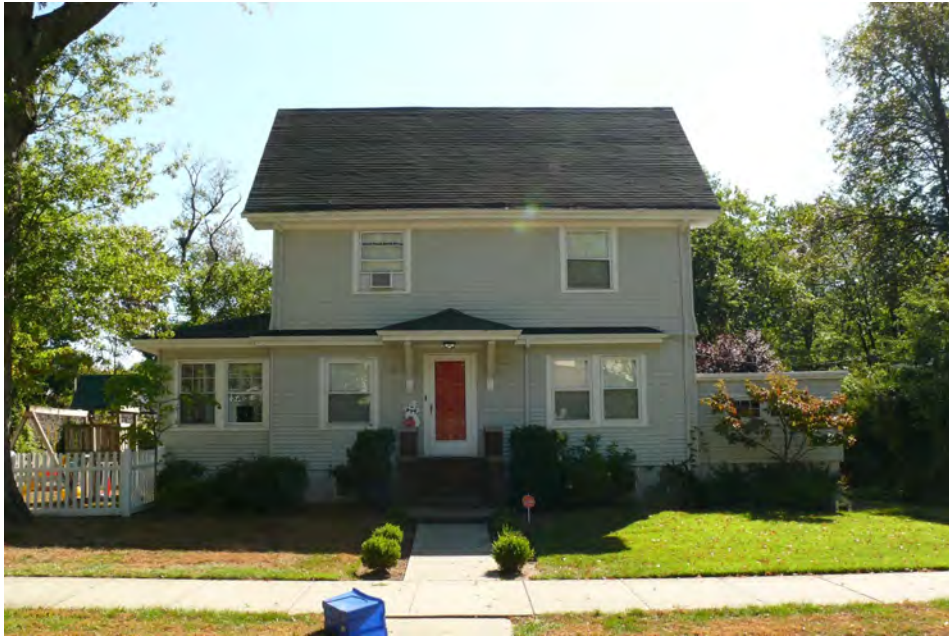
Property Photo:

This is a three-bay wide by two-bay deep, two-and-one-half story single-family residence. The front elevation faces southwest to Carteret Street and the building occupies the corner where Oakcroft Avenue and Carteret Street meet. The first floor is set a few steps above grade. The foundation is parged masonry. The building is clad with vinyl siding with corner treatment. The siding is flared between the first and second floors. The windows are hung sashes (appear to be replacement material) with vinyl cladding at the trim and sills. The main roof is a side gable with boxed cornice that returns slightly at each gable end. It is clad with asphalt shingles. There is a pent roof at the front, also clad with asphalt and set on a shallow molded cornice. Off-center to the north is the front door. Over it is a hip roof with its cornice aligned with that of the pent. It is supported by two wood, angled brackets. The stoop and steps are brick with brick side walls with limestone copings. To the south of the door is a pair of hung sashes with clad mullion. To the north is a single sash. Centered in each bay at the second floor is a single hung sash. On the south side is a one-story addition with flat roof similarly treated as the main building. It has a pair of awning sashes with mullion at its center. This same sash grouping is set center of the north elevation. This addition appears to cover pairs of windows in each bay at the first floor. There are single windows in each bay at the second floor and a pair at the attic level. On the north side is a one-story extension that appears to be original to the building. It has a hip roof and extends two-thirds along the north elevation. It has two windows at the front and three at the side. In each remaining bay of the main block are single windows at the first and second floors and a pair of windows at the attic level. There is a shed dormer at the rear with a brick chimney set at its north end. The one-story extension on the south side is the garage which is accessed from Oakcroft Avenue at the rear

This building was constructed in 1922 and modified in the early-21st century including the addition of the garage and the replacement of the sashes.

The building tries to reflect the Colonial Revival in its roofline and other detailing but the lack of symmetry and any type of detailing other than a simple hood over the door as well as an imbalance of scale between the first and second floors shows a failure in the execution of the key component of the style. The building would not be a contributing resource in the historic district.

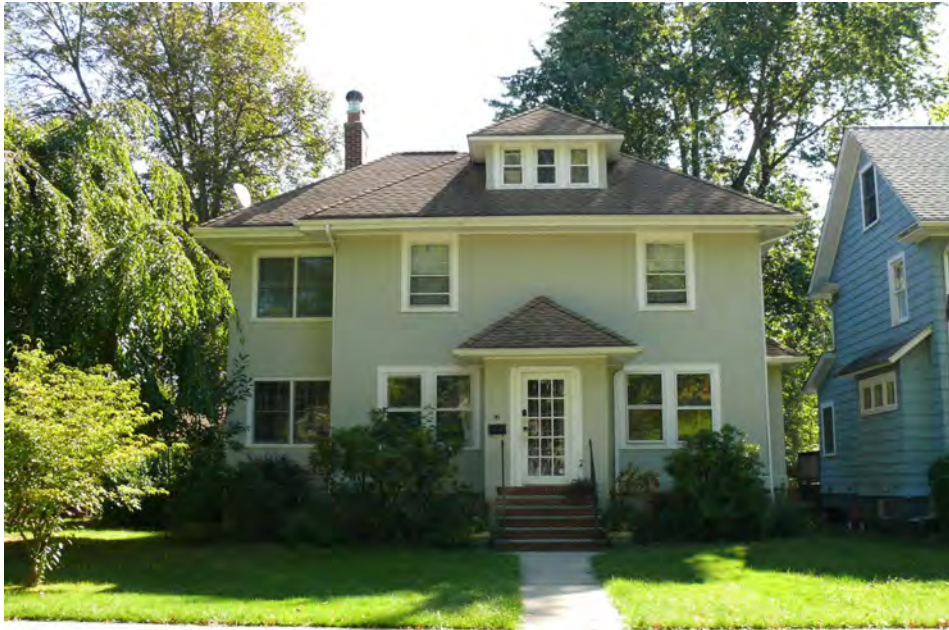
Property Photo:

This is three-bay wide by two-bay deep, two-and-one-half story single-family residence with Craftsman style influences. The front elevation faces southwest toward Carteret Street and the first floor is set several steps above grade. There is a drive on the east side of the property accessed from Oakcroft with a garage that has been reoriented to face the rear yard. The building is clad with stucco from grade to underside of roof with a stucco-clad water table at the perimeter. The windows are one-over-one hung sashes, possibly replacement, with flat-stock wood trim with drip cap and narrow wood sill. The main roof is a hip that projects on all sides to a boxed cornice with flush boards at the soffits. This connects with another hip roof about center of the north façade, which is set over a two-story extension. This roof is similarly detailed to the main roof. Centered on the main roof is a wide dormer with hip roof that projects slightly and is also detailed similarly to the main roof. There are three small hung sashes grouped with narrow mullions at the center and the walls are clad with stucco. All the roofs are clad with asphalt shingles. The front entrance is set center of the main block. It is a stucco-clad enclosure with a hip roof similar in detail to the main roof. At its center is a 15-light wood door that leads to brick stairs with limestone treads and metal railings on each side. In each of the side walls of the enclosure is a single hung sash. The heads of the openings, both door and window, are slightly different than the main block in that they are slightly rounded at the outer edges at the trim, and the sills are molded at their bottom edge. In each of the outer bays at the first floor of the main block are paired hung sashes with center wood mullion. Above these at the second floor are single sashes with no fenestration at the center bay. The two-story north extension has a pair of sashes at each floor level; the trim here is the same as found at the front enclosure. The first floor sashes have lights of six-over-

The Essex County tax records indicate a construction date of 1930 and this is confirmed by the city directories. The sashes appear to be replacement due to their lack of lights and their detailing in the opening.
